BUILDING SURVEY REPORT

PROPERTY: Farmville Road,
Splott,
CF24 2JN

REF: TN_0602

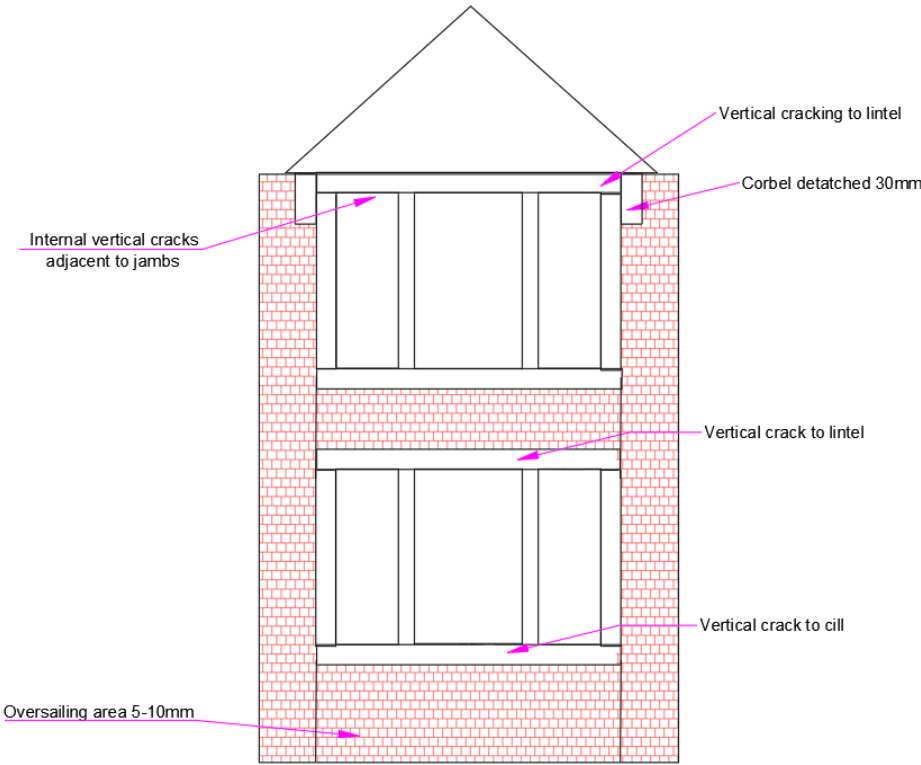
<p>Bay window 2.5m wide</p><p>Bay windows in houses built around 1900 were often constructed with shallower foundations compared to the main structure. This difference in foundation depth can make bay windows more susceptible to movement due to changes in soil conditions or groundwater levels.</p></div>

The most likely remedial treatment would be providing restraint ties (helical bars) through the main walls into the jambs. Further helical bars providing lateral restraint through the joists and into the lintel.

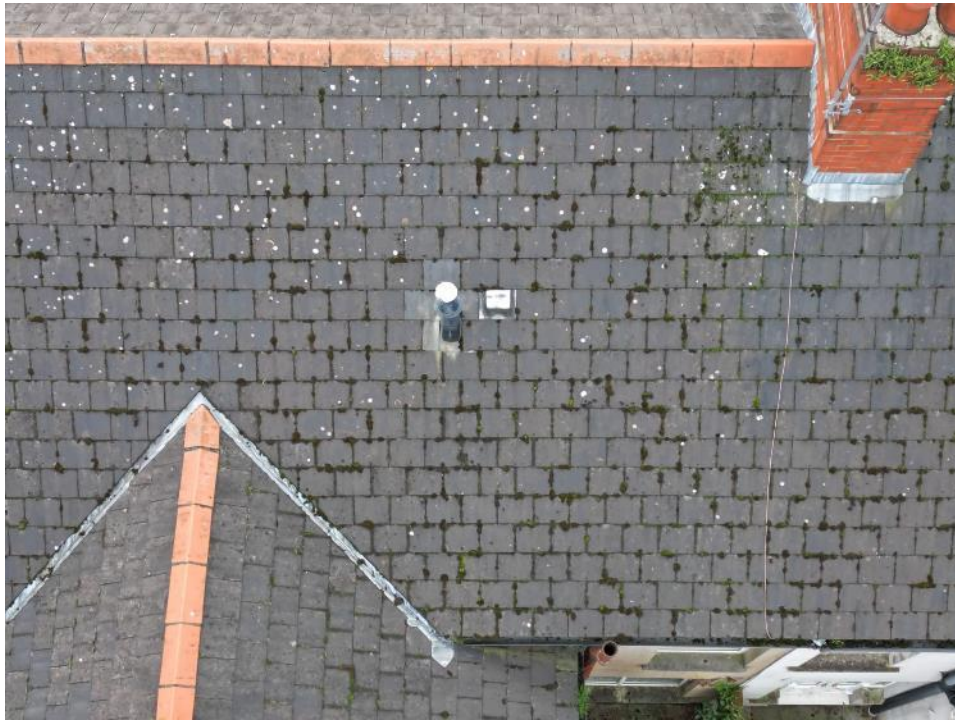
Photograph 7: Roof – rear pitch condition (note moss growth)

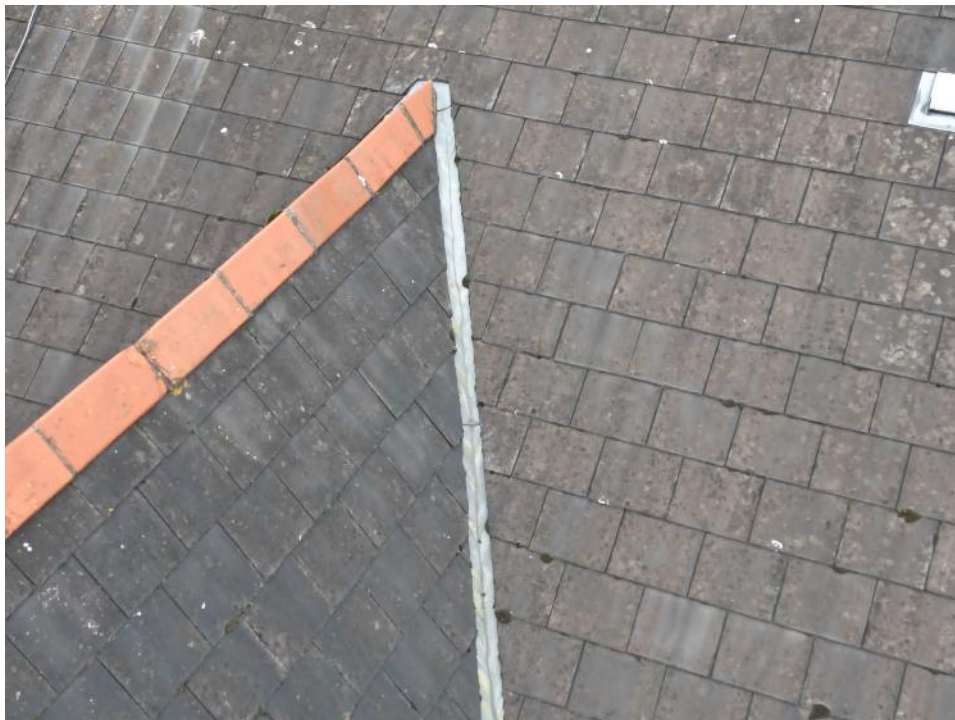
4.2 Roof coverings	Condition Rating	1
Construction & Type and Limitations	<p>The roof is formed from a single ridge running across the width of the property, with pitches to the front and rear. There is a further ridge covering the rear projection (kitchen/bathroom). The roof pitches being covered with synthetic slate fibre tiles.</p> <p><i>The roof was examined from ground level with the aid of binoculars for possible defects including sagging, collapse, broken/missing/damaged tiles, holes, and other evidence of failure.</i></p>		
Condition	<p><i>No significant defects were noted and the roof was found to be structurally stable.</i></p> <p><i>No evidence was seen of unusual sagging or other movement which might indicate that the structure is failing. No significant numbers of slipped, chipped, cracked or missing tiles were noted and the roof was relatively clear of moss/vegetation.</i></p> <p>Synthetic slate tiles (fibre cement): Older synthetic slate roof tiles, particularly those manufactured before the 1990s, may contain asbestos cement as a reinforcement material.</p> <p>Asbestos was commonly used to improve durability, fire resistance and weatherproofing in roofing products. These tiles were an alternative to natural slate and often contained chrysotile (white asbestos) bound within the cement, making them low-risk unless disturbed.</p> <p>While asbestos cement tiles do not pose an immediate hazard when intact, cutting, drilling, or breaking them can release harmful fibres. If a roof contains suspected asbestos-based synthetic slates, it is recommended to have a professional asbestos survey before any repairs, maintenance, or replacement work.</p> <p>Removal and disposal must follow UK HSE (Health and Safety Executive) regulations, with specialist contractors required for safe handling. Modern fibre cement slates are now asbestos-free and offer a safer, compliant alternative for re-roofing projects.</p> <p>Ridge tiles: There appears to be a very minor amount of mortar loss to the ridge tiles. They would require re-bedding to provide a watertight seal. An alternative would be a dry-ridge system whereby the new ridge tiles would be fixed with screws/mechanical fixings. (Photo.5)</p> <p>Moss growth: There was a moderate amount of moss growth of the north facing pitch. (Photo.7) Moss acts like a sponge, absorbing large amounts of moisture and resulting in your roof being constantly wet. When wet it can expand when it freezes, disturbing tiles. If this moisture travels underneath the tiles, it could rot the wooden components of the roof, threatening structural integrity and leading to costly repairs. It also has the potential to block gutters and cause further problems to the fascia/rafter tails. We recommend that the moss be removed.</p> <p>Valley condition: The valleys were noted as being lead and in good order where visible (Photo.8)</p>

Photograph 8: Roof – front elevation valley condition

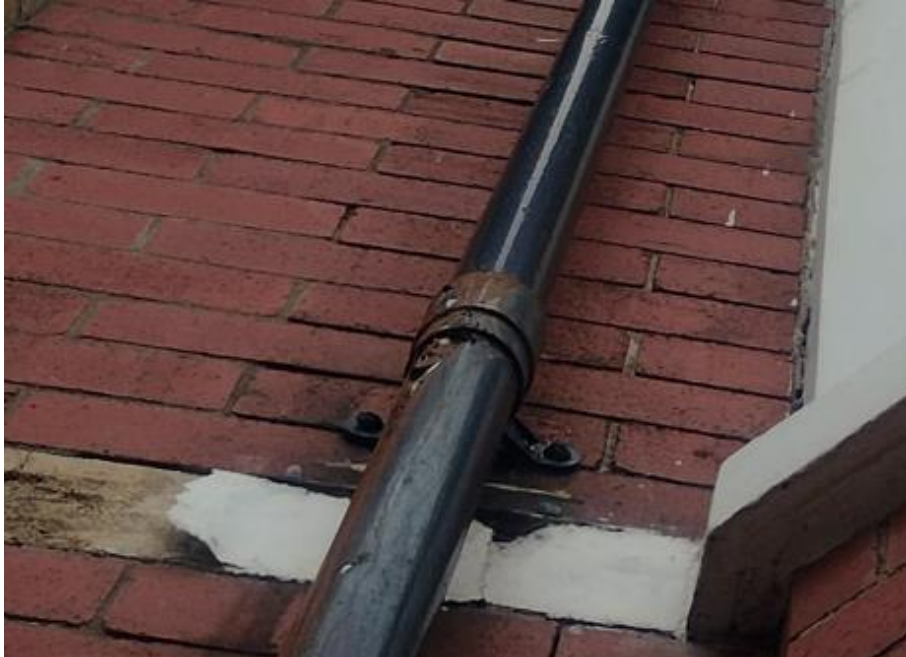
Photograph 13: Drainage – replacement of front downpipe required

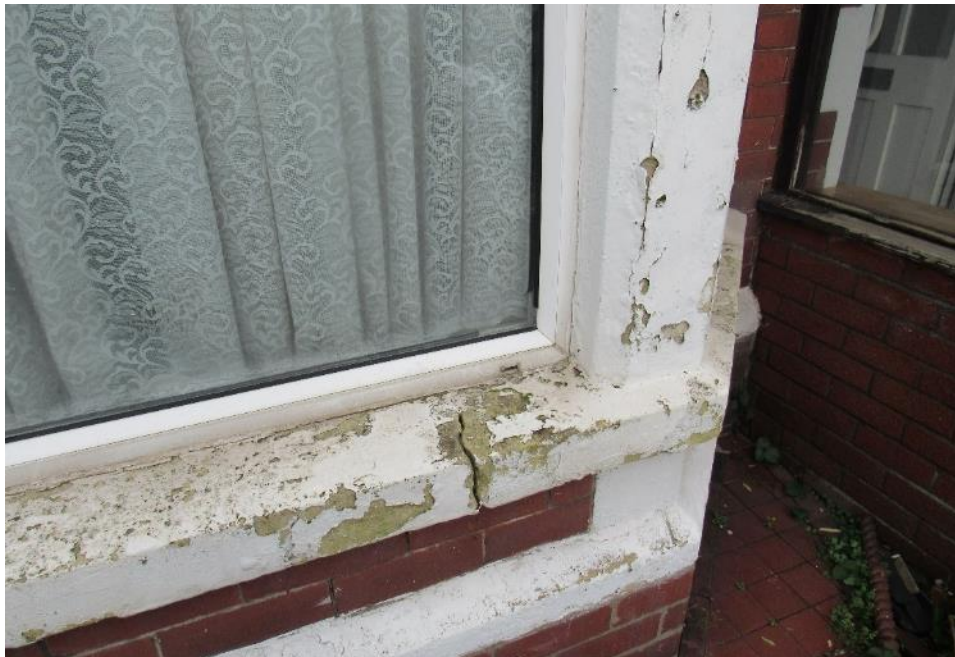
Photograph 14: Bay window – fracture to lower sill

Further to this either underpinning the main bay windows area or installing a number of Heli-piles which in turn tie into the brickwork at the foundation:

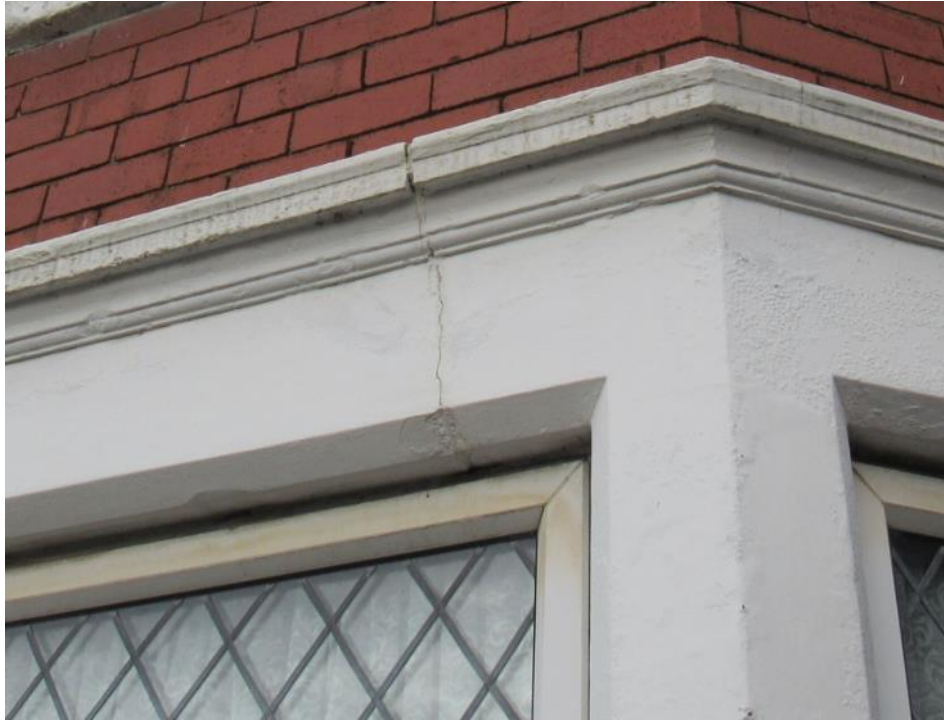
Photograph 15: Bay window – fracture to upper sill

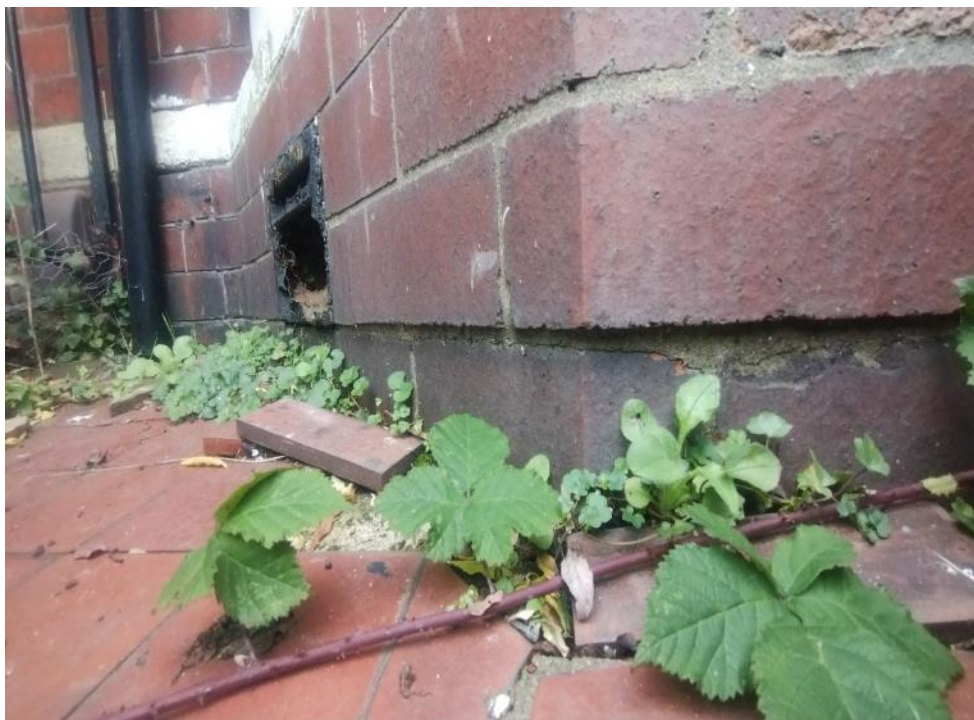
The oversailing is thought to be unrelated as there is lime mortar in the joints (original mortar), there was possibly a template issue when constructing the walls. The 2008 footage (**Photo.22**) clearly shows no cracking to the lintels suggesting that this subsidence is relatively recent and possibly active.

Photograph 16: Bay window – historic oversailing (mortar original/good condition)

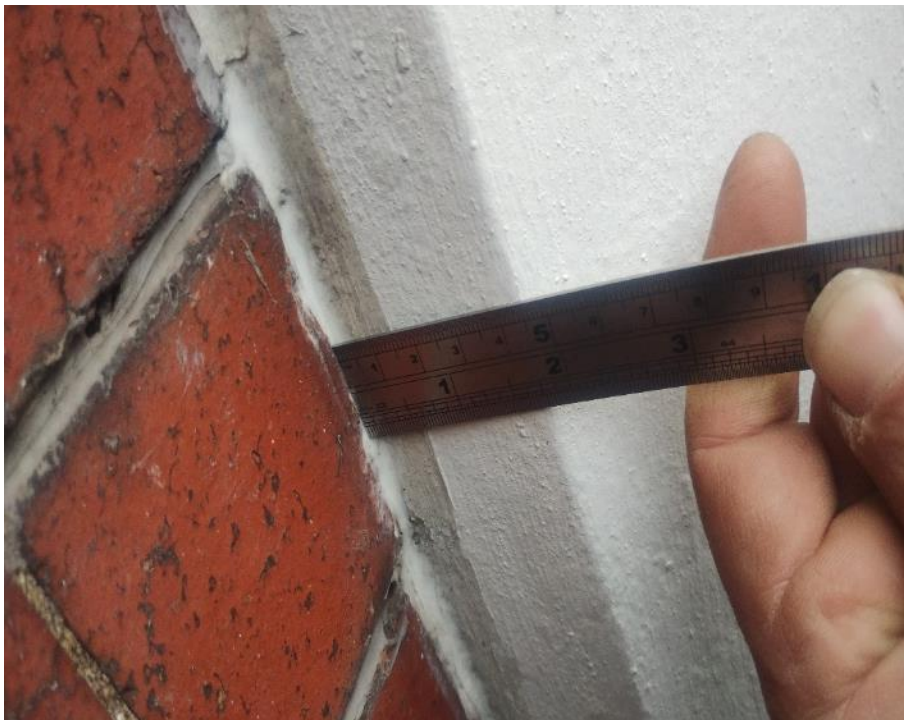
Photograph 18: Bay window – no significant movement to jambs noted

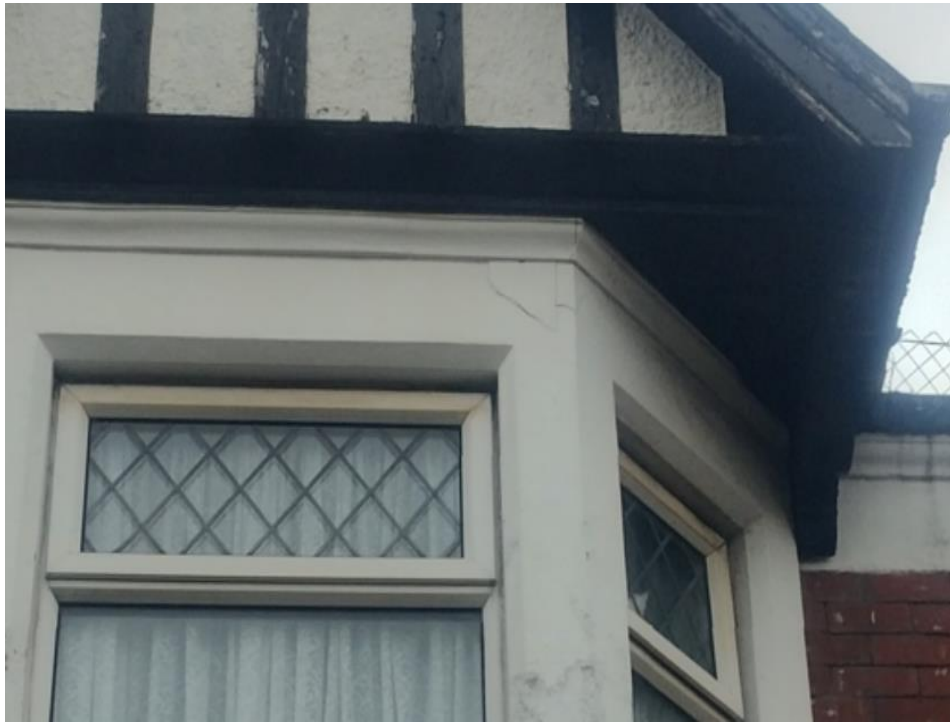
Photograph 19: Bay window – fracture area to upper

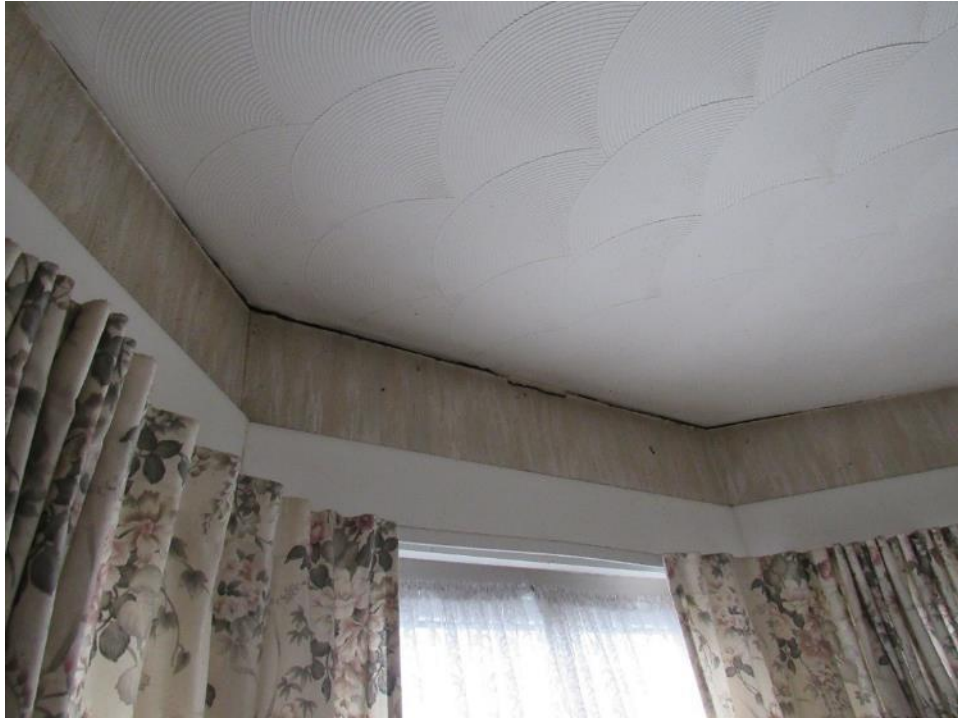
Photograph 21: Bay window - internal view/fracture to upper

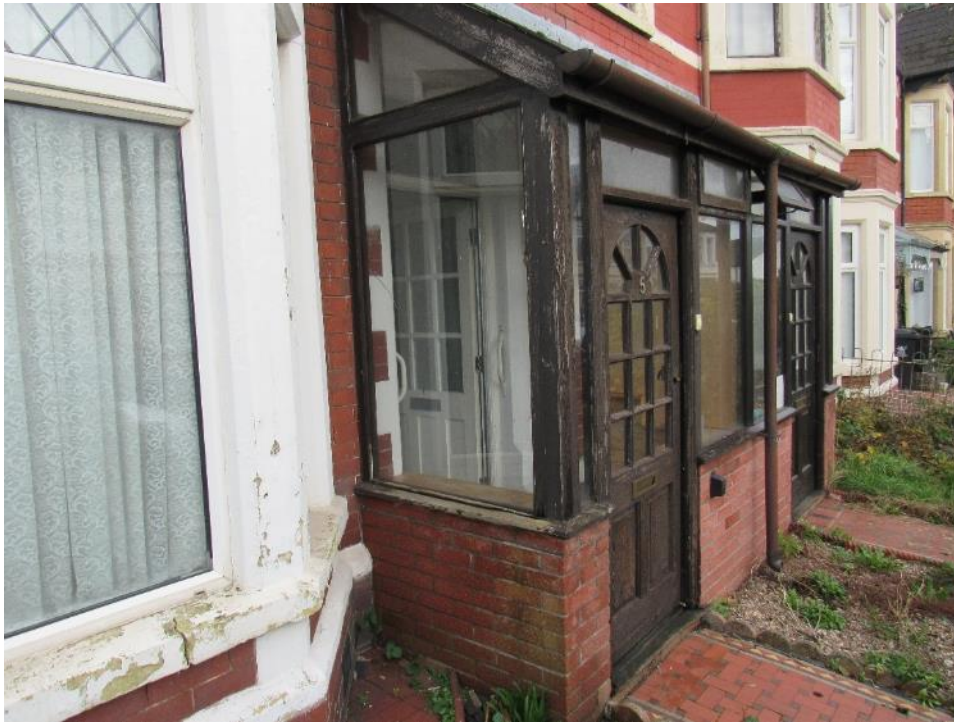
Photograph 35: Porch – wooden elements in poor condition

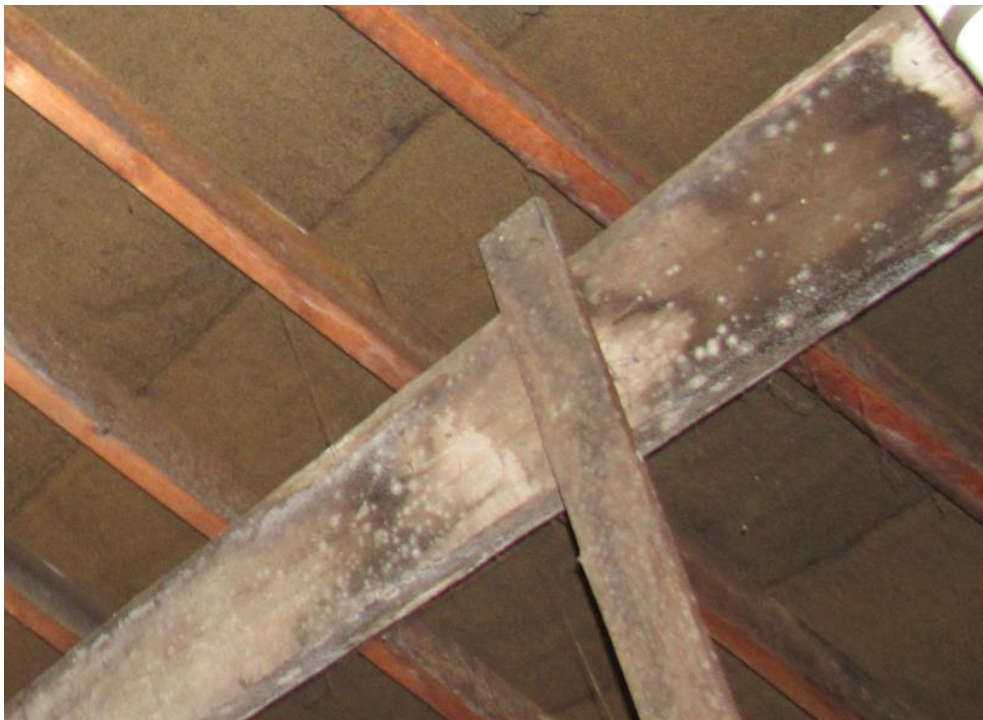
Photograph 38: Mould growth/damp to purlins

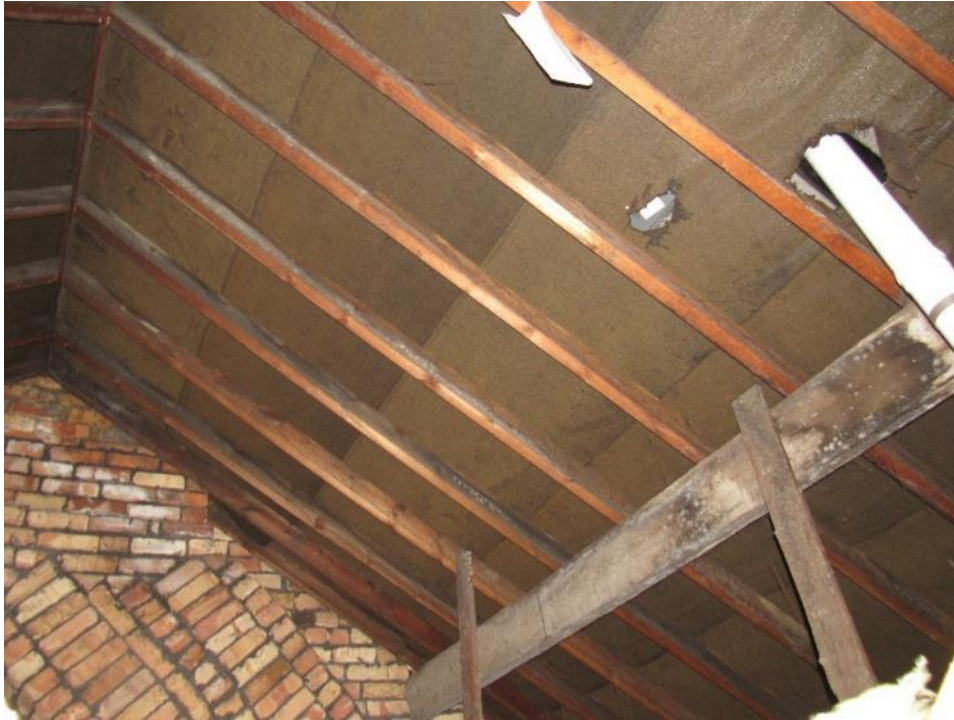
Photograph 39: Roof internal – sarking mostly in fair condition, isolated patch repairs noted

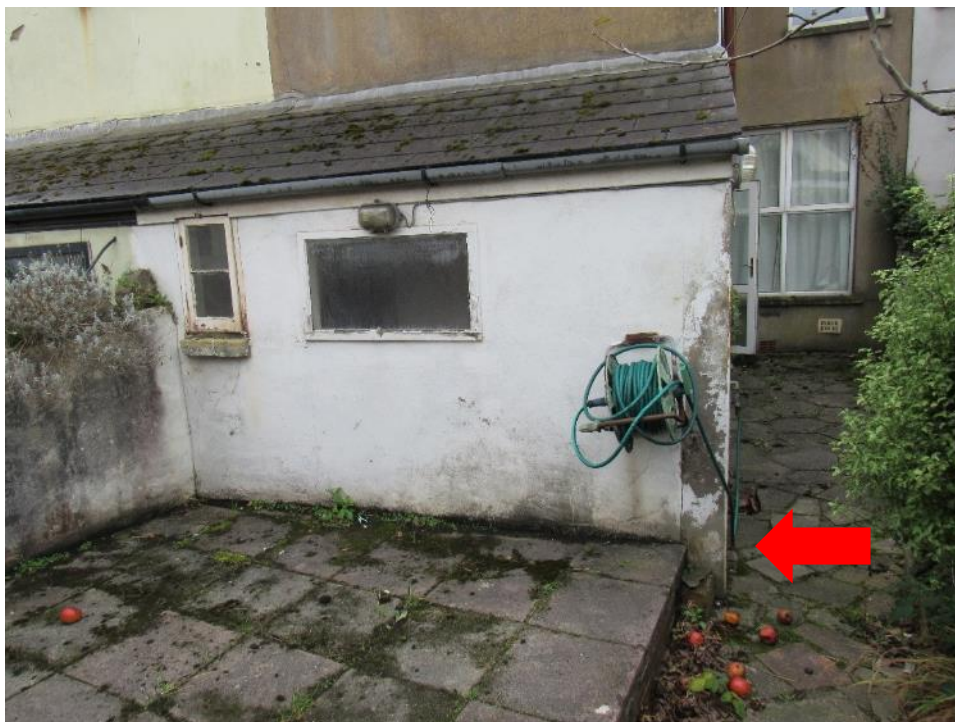
Photograph 52: External view of the downstairs toilet/utility room (note height of patio)

We recommend at minimum ground levels be reduced outside the extension to stop the penetrating damp. A French drain would also be a welcome addition. Further to this monitor the situation and adjust accordingly. Ideally a full cavity with second wall needs to be added but this would be a costly endeavour.

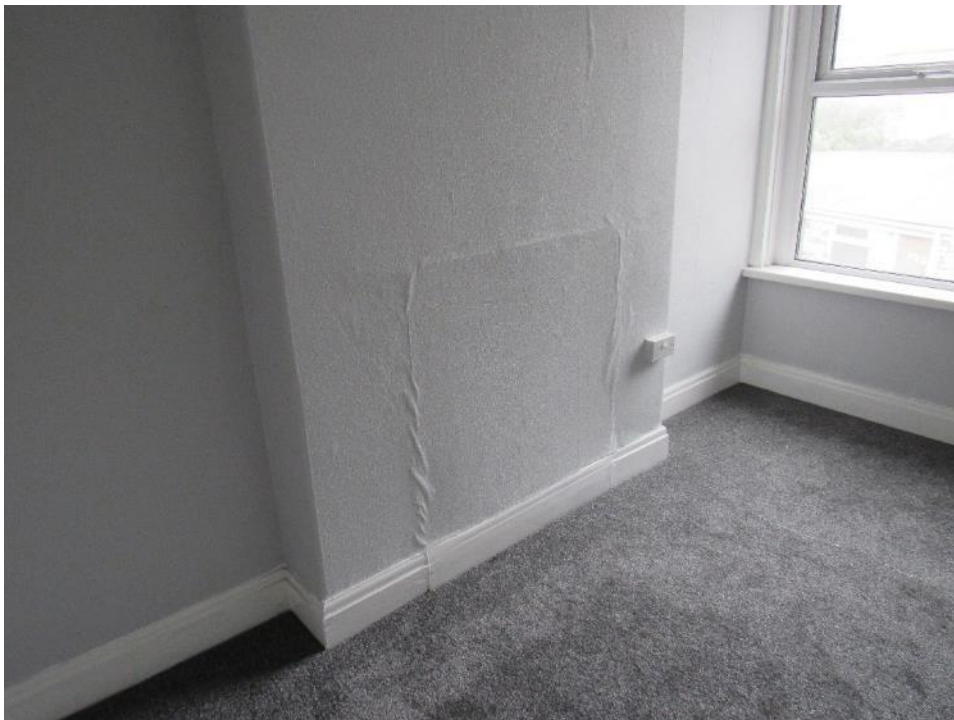
Photograph 58: Rear chimney breast – second bedroom (poor repair)

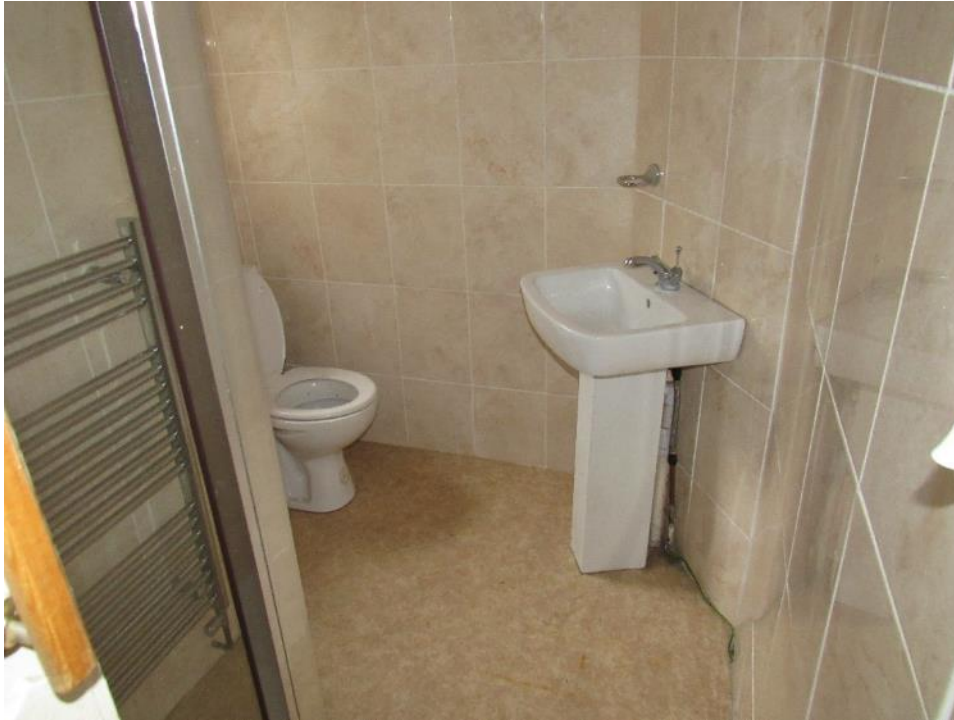
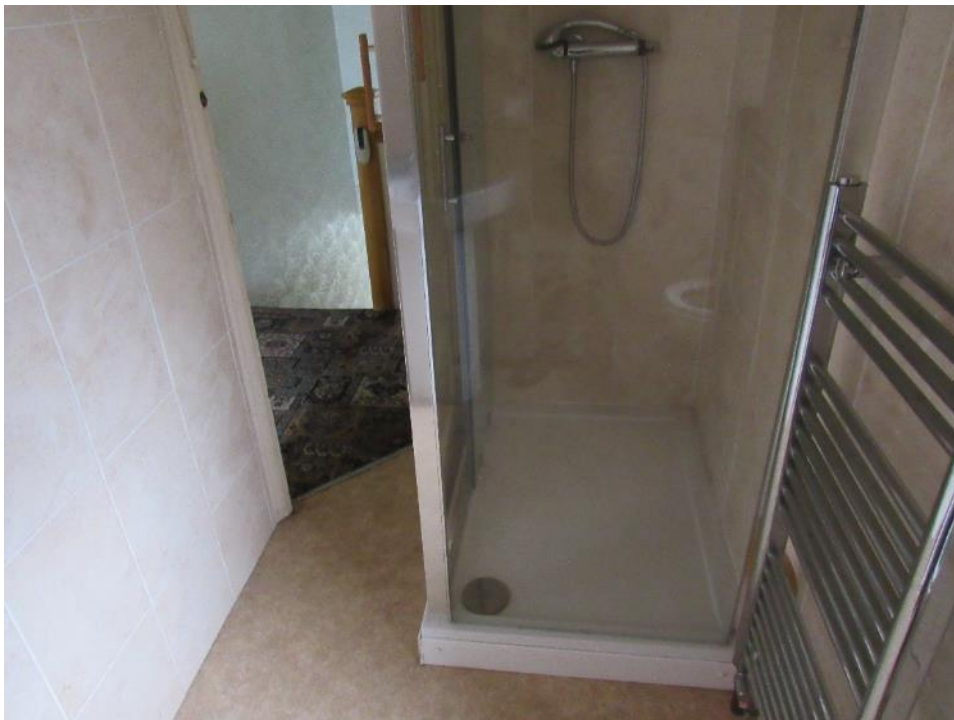
Photograph 63: Bathroom – sealant repairs

Photograph 64: Bathroom – sealant repairs

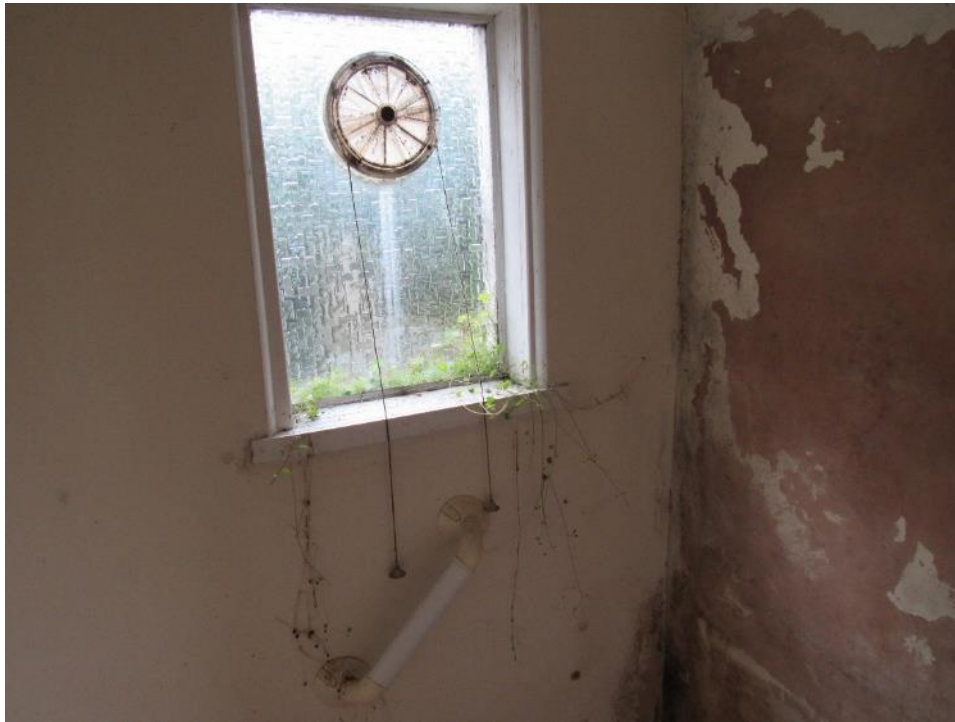
Photograph 65: Downstairs toilet – no extractor fan

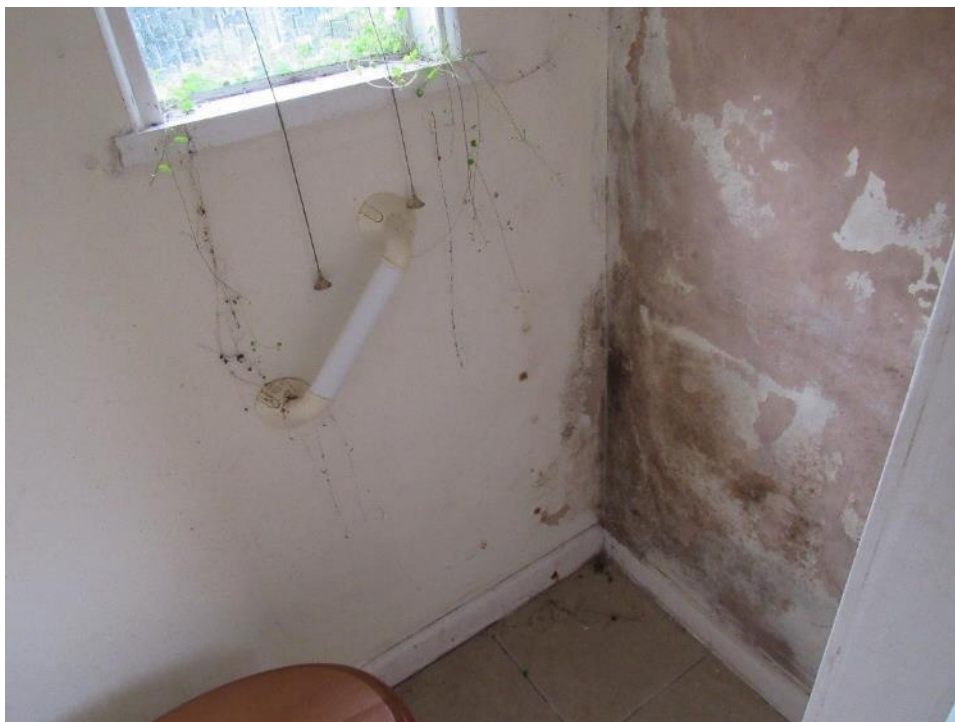
Photograph 66: Downstairs toilet – penetrating damp

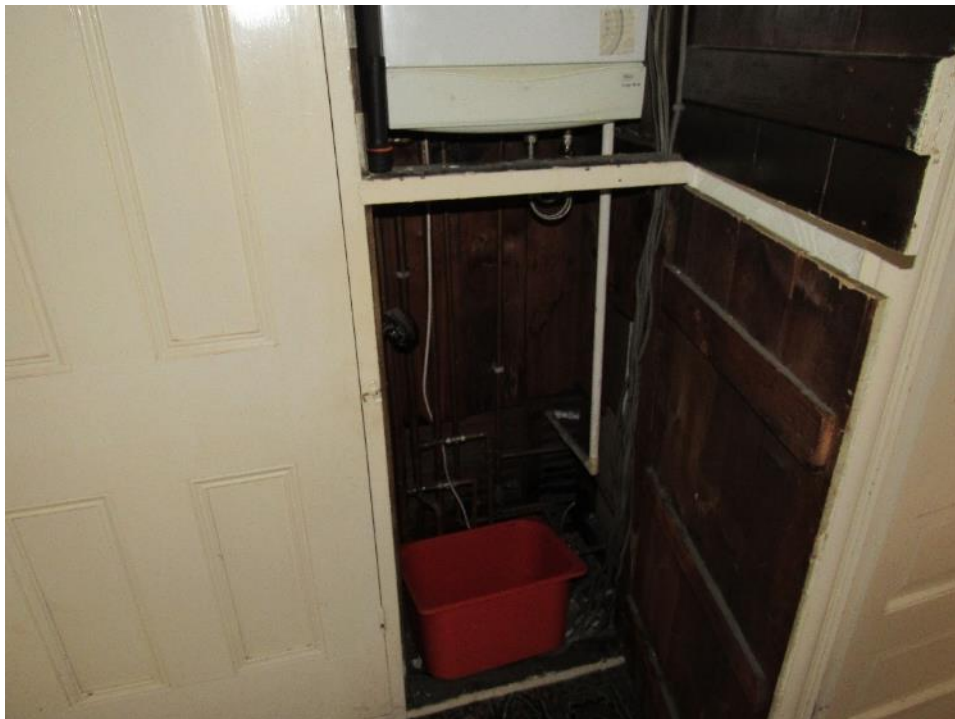
Photograph 70: Boiler – possible active leak
