# BUILDING SURVEY REPORT

**PROPERTY:** Blanche Street,  
Splott,  
CF24 1QS

**SURVEY  
DATE:** 30 May 2025

**REF:** TN\_0691

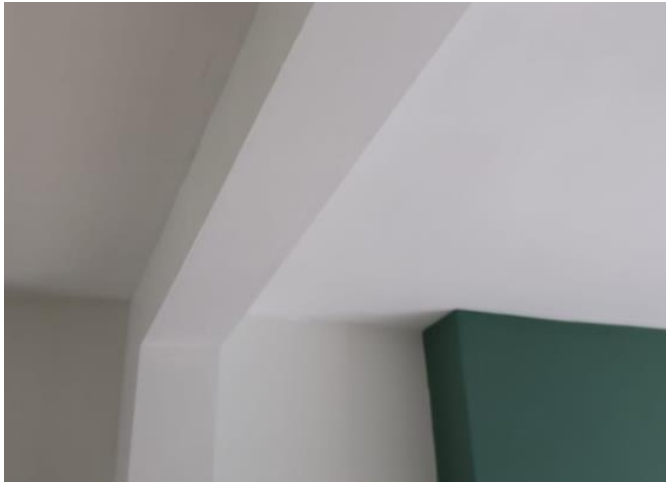
<p>There was a knock through and installation of an RSJ in the sitting/dining room. Detection confirmed this was a steel I-beam. The depth of the plasterboard covering suggests a suitable web was utilised and it was noted as level. You should request if this has been signed off by building control and has the associated paperwork.</p>

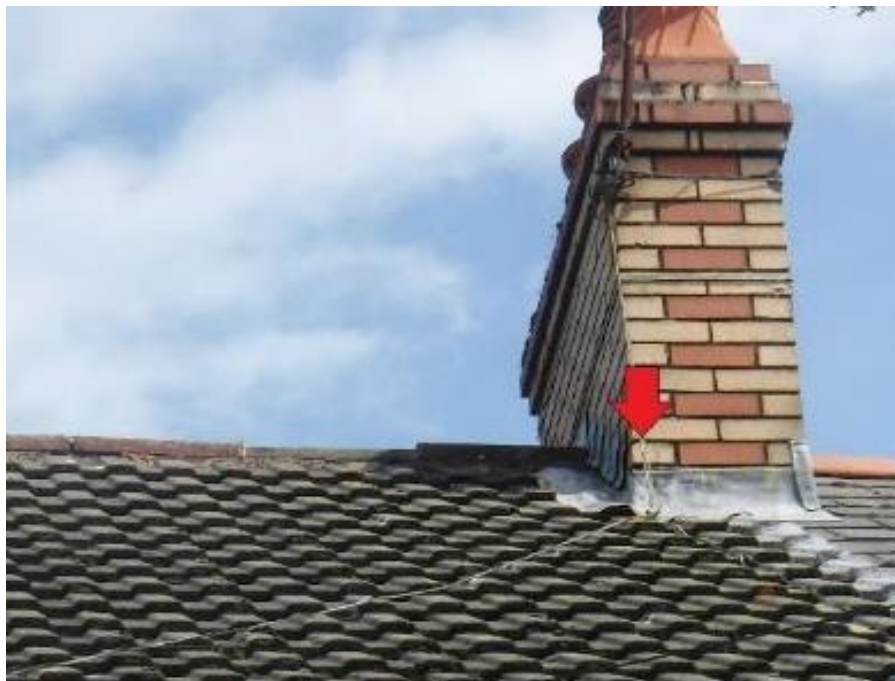
**Photograph 3:** Chimney – corner flashing at base missing

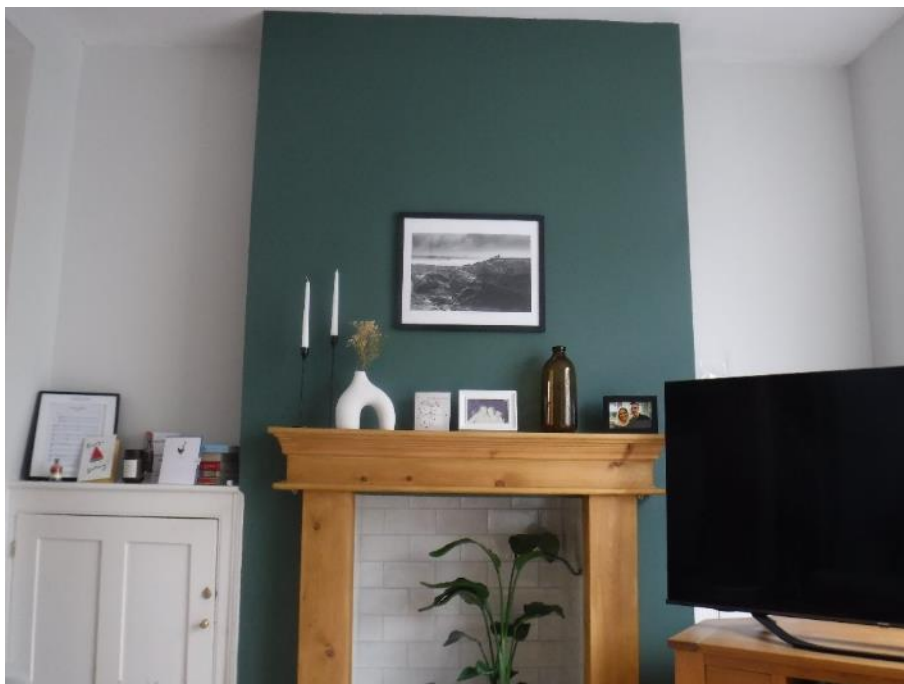
**Photograph 4:** Chimney – stacks noted as supported (view of front room fireplace)

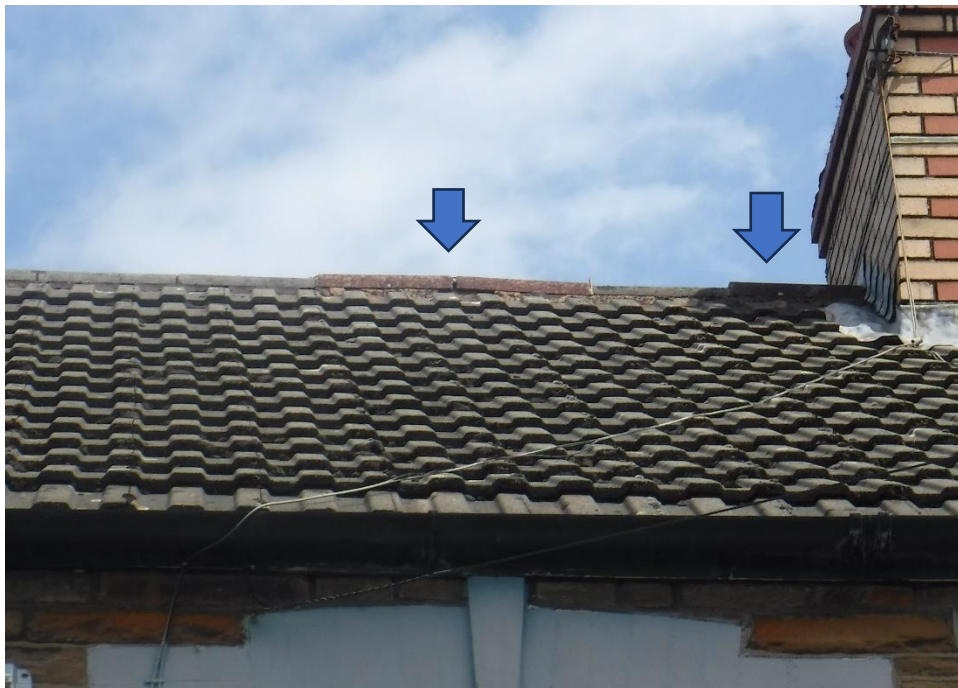
**Photograph 6:** Roof - several ridge tiles require re-bedding

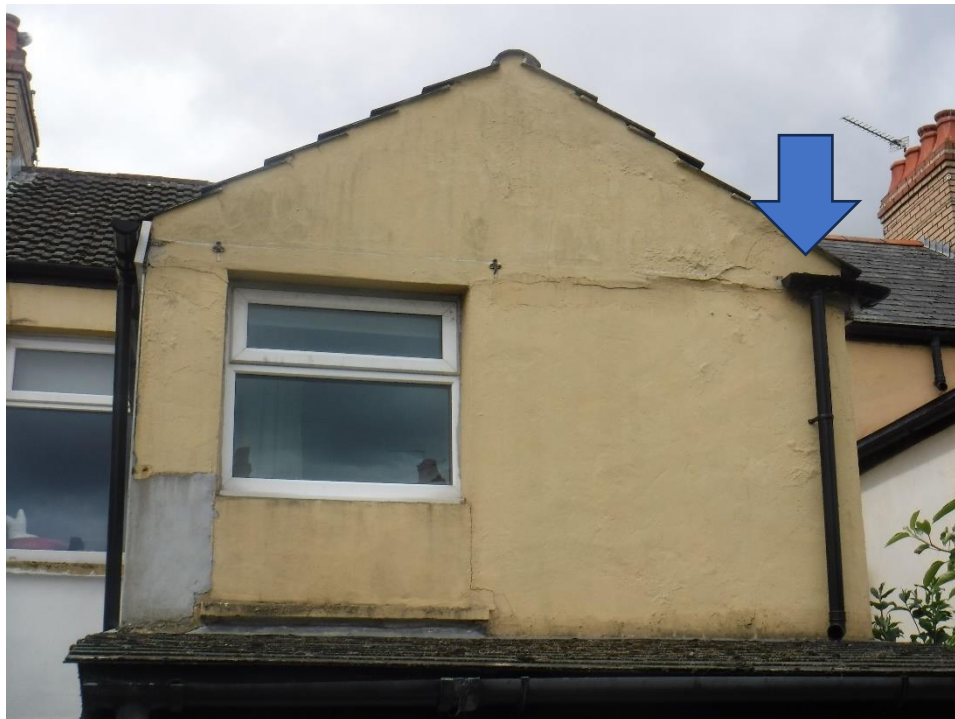
**Photograph 7:** Rear projection - downpipe dispels onto bathroom roof...

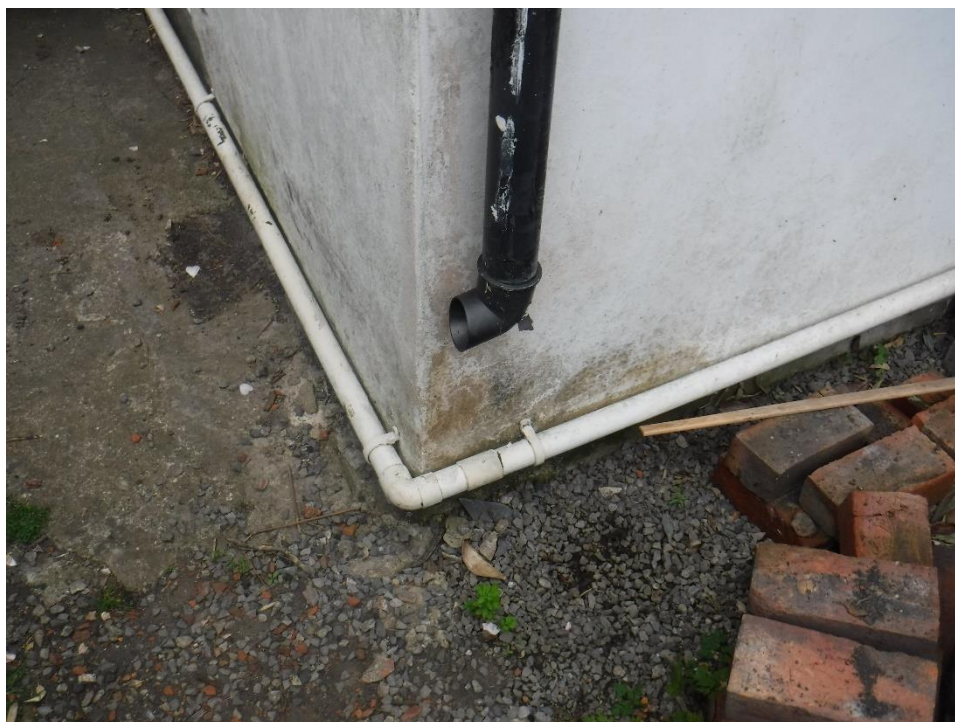
**Photograph 8:** ...which in turn dispels onto the ground at the rear of the property (inclined towards the sitting room)

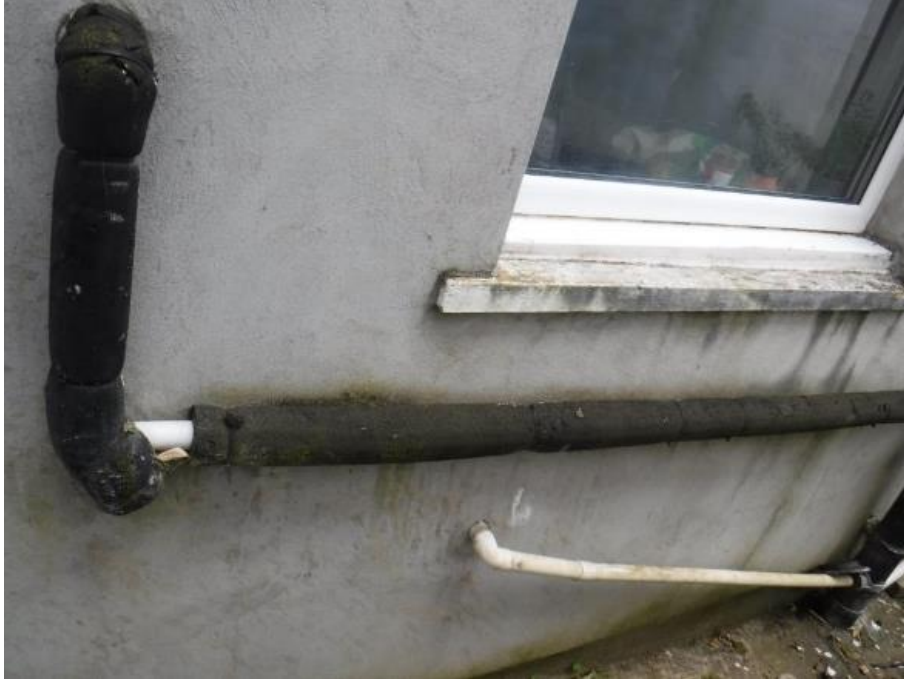
**Photograph 9:** Exterior - condensate pipe – failed lagging

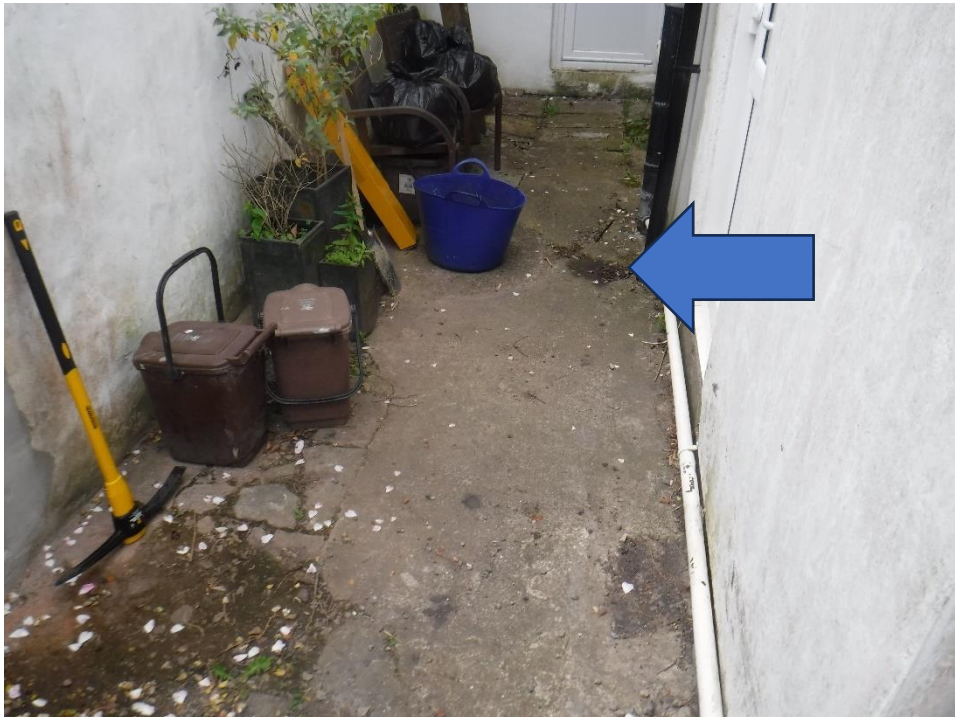
**Photograph 10:** Exterior - fall to rear (drain inlet location highlighted)

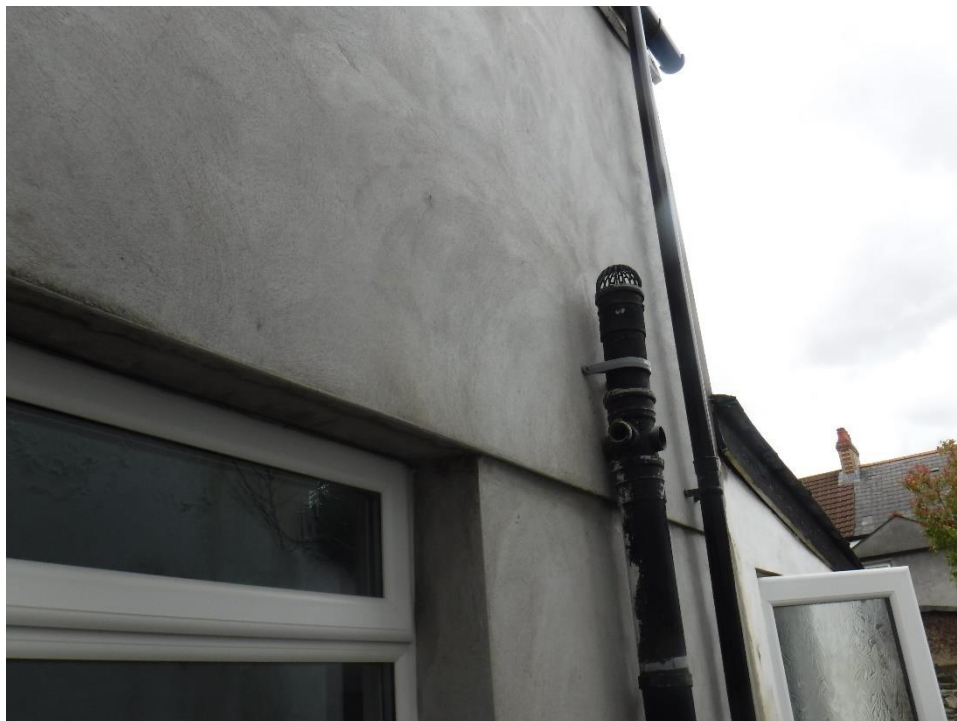
**Photograph 11:** Exterior - the soil vent pipe is adjacent to the window

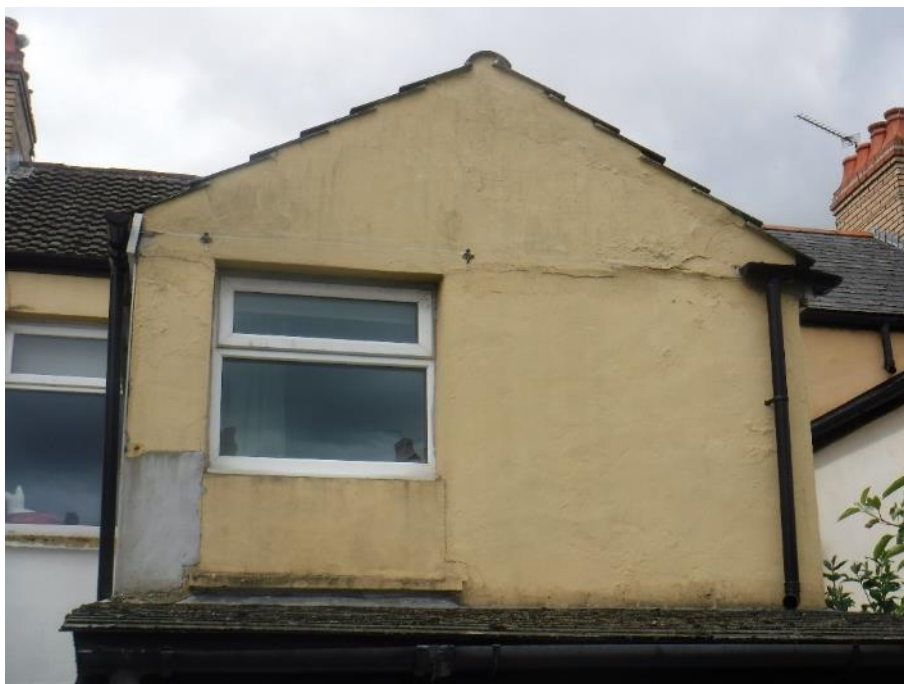
**Photograph 12:** Rear elevation – render repair required

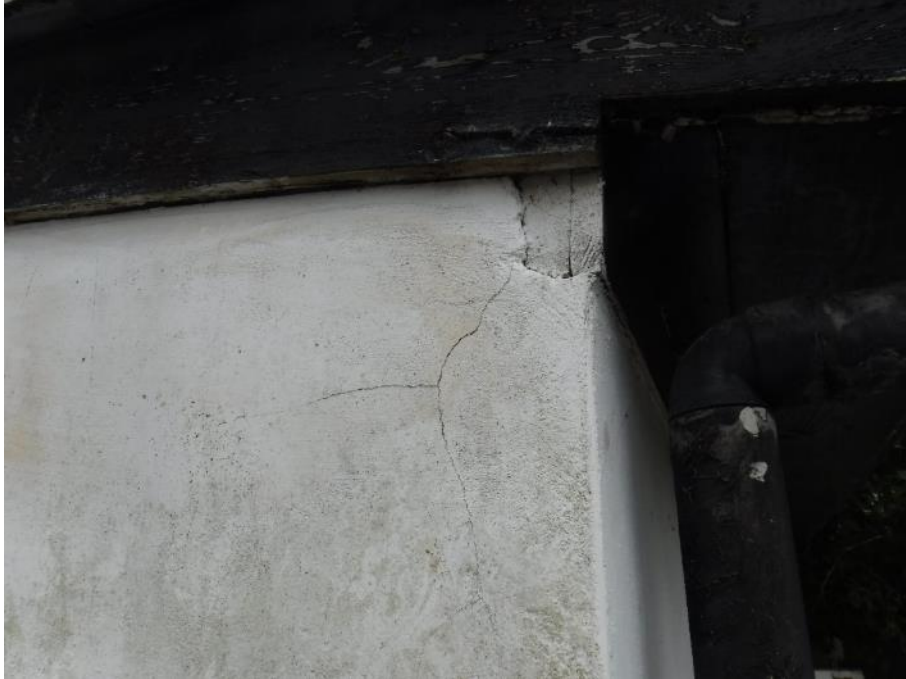
**Photograph 13:** Bathroom extension high level – hairline crack

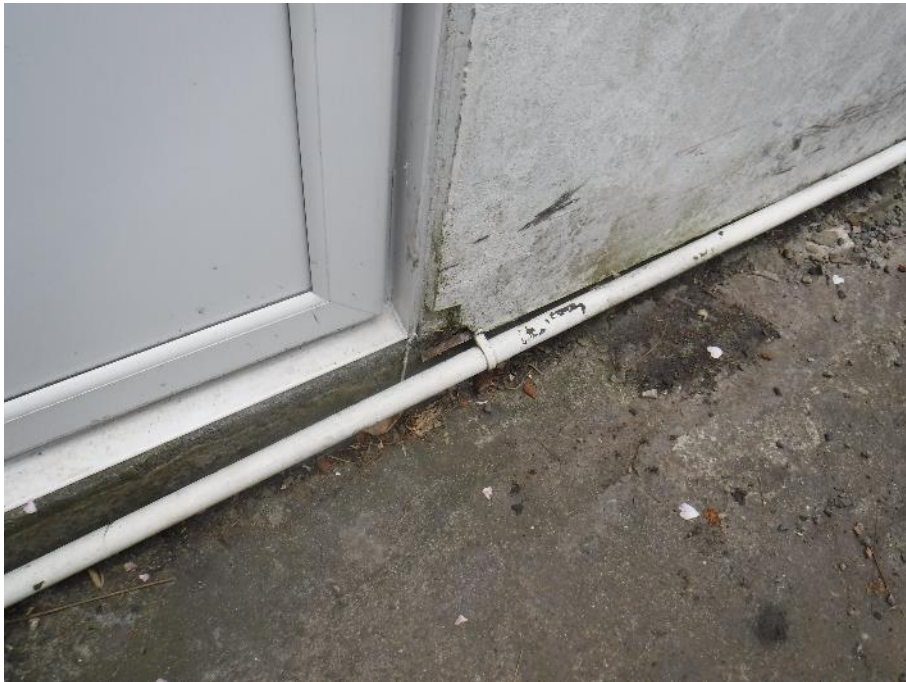
**Photograph 14:** Kitchen door low level – patch render repair

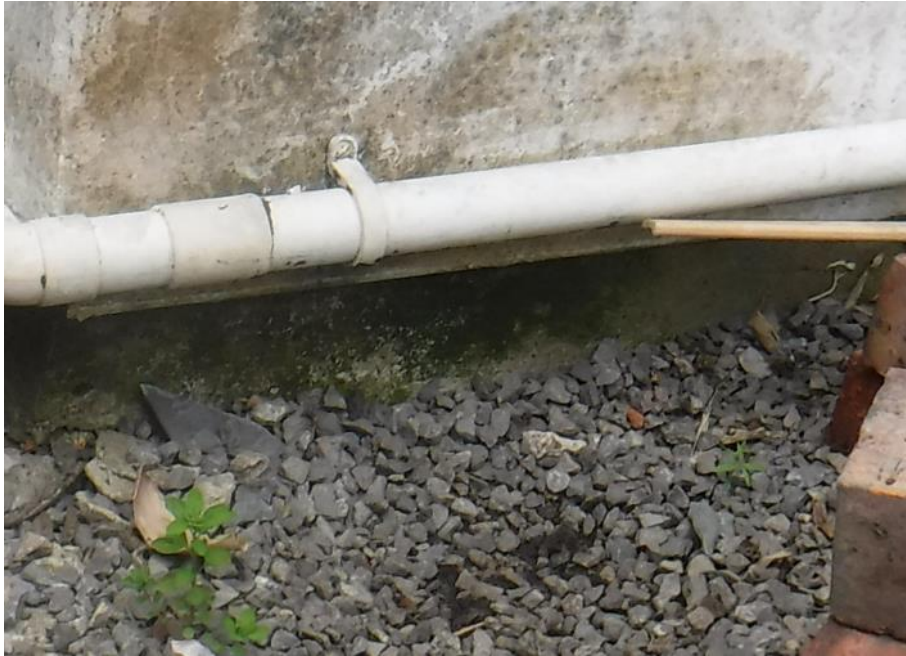
**Photograph 15:** Bathroom extension - the render extends to ground level possibly bridging DPCs

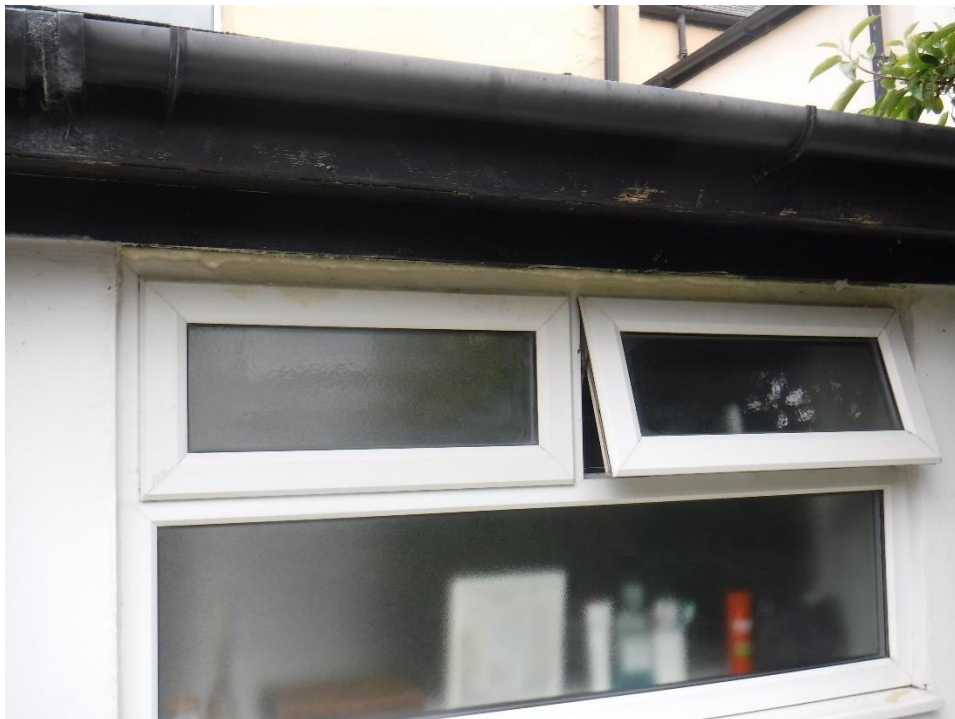
**Photograph 16:** Bathroom missing upper trim/expanding foam still present

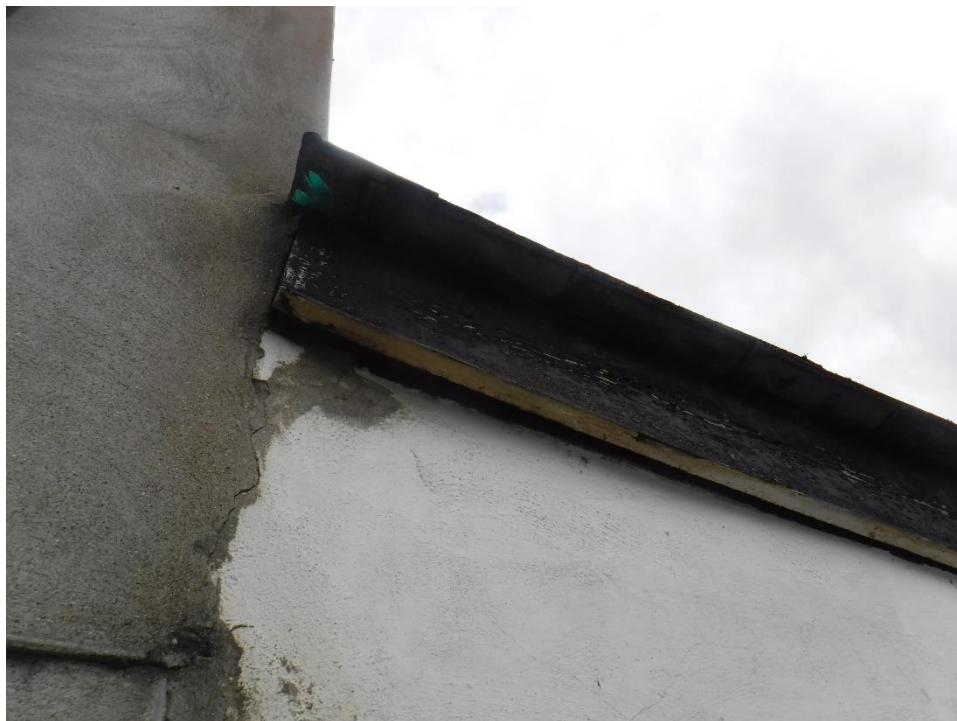
**Photograph 17:** The fascias require updating or treating

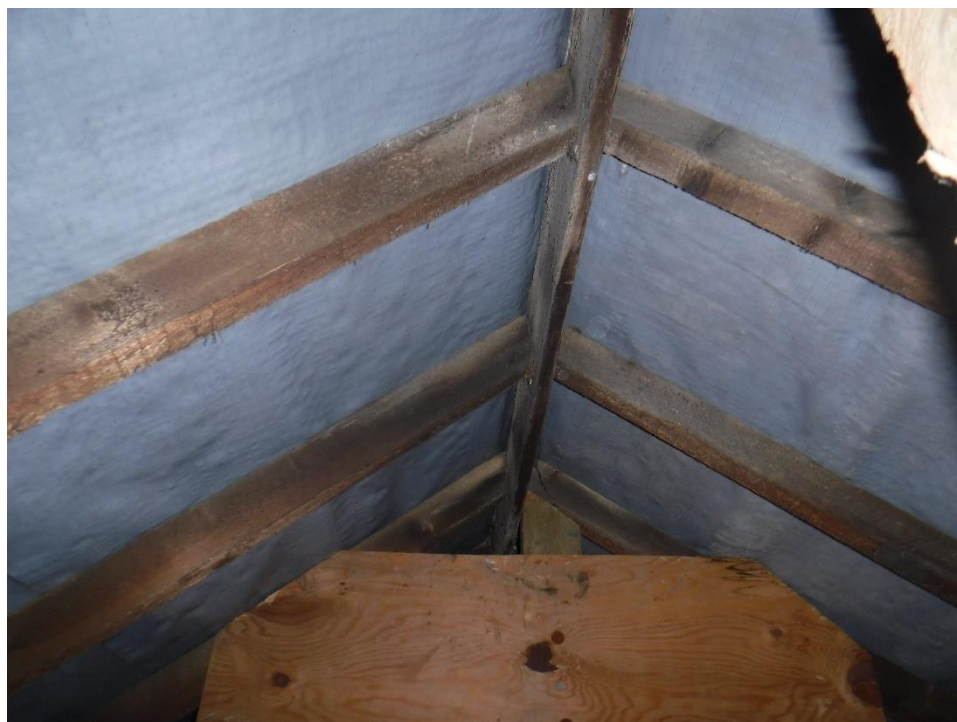
**Photograph 18:** Roof space - ridge plate, in good order

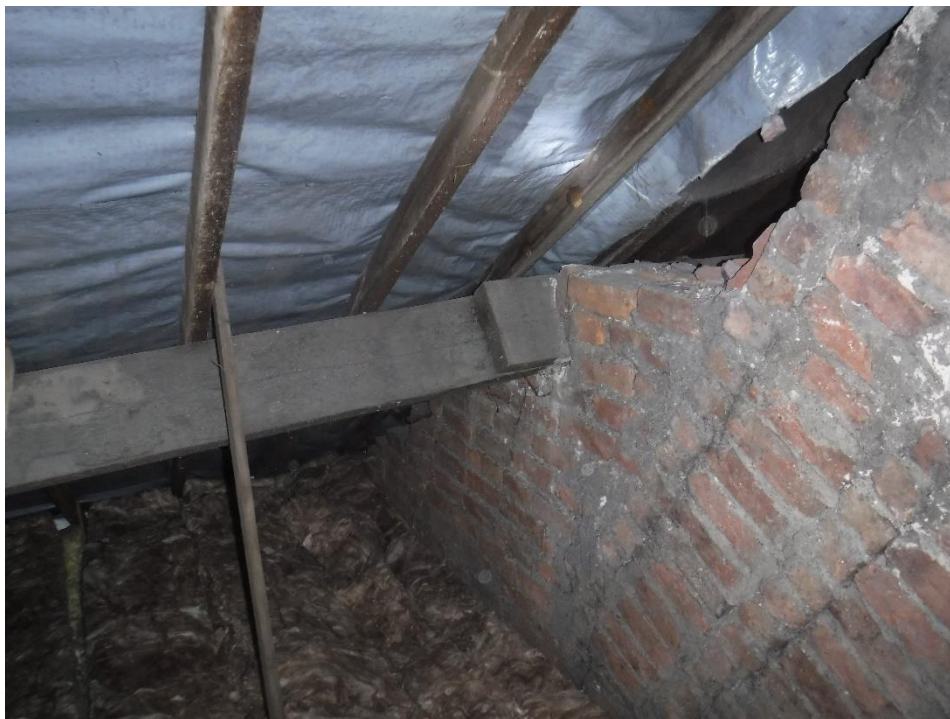
**Photograph 19:** Roof space - purlins – supported by the party walls

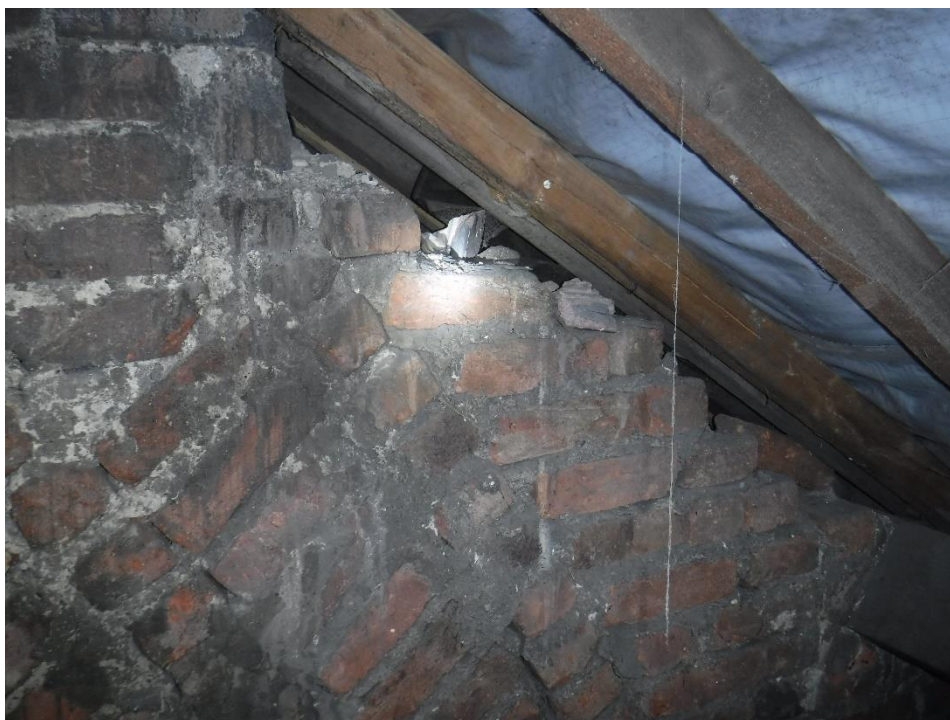
**Photograph 20:** Roof space - Lack of fireproofing up to top

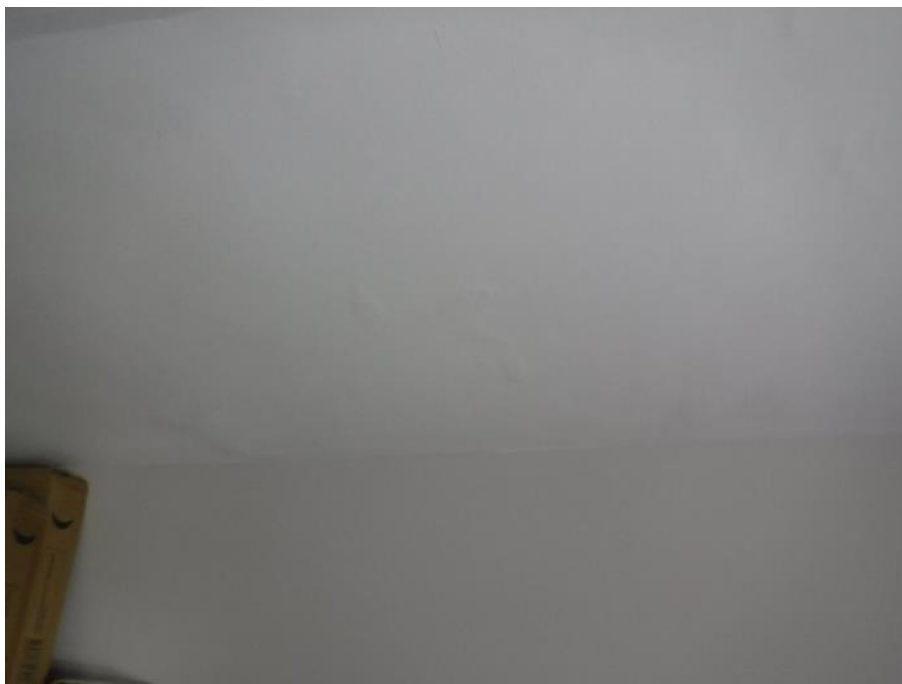
**Photograph 24:** Rear bedroom - minor cosmetic issues (sand/repaint)

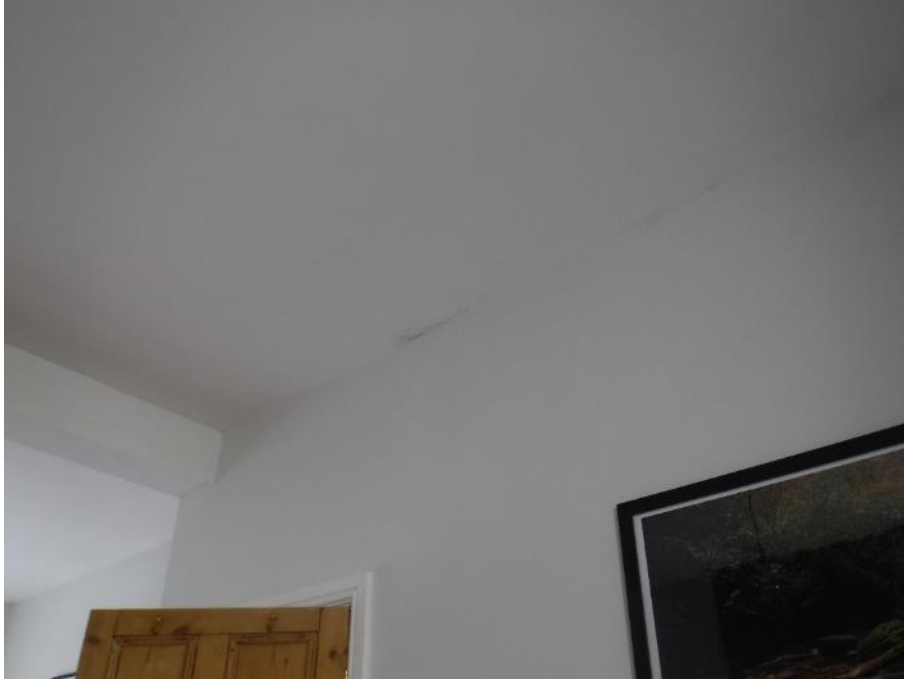
**Photograph 25:** Sitting room – minor cosmetic issue

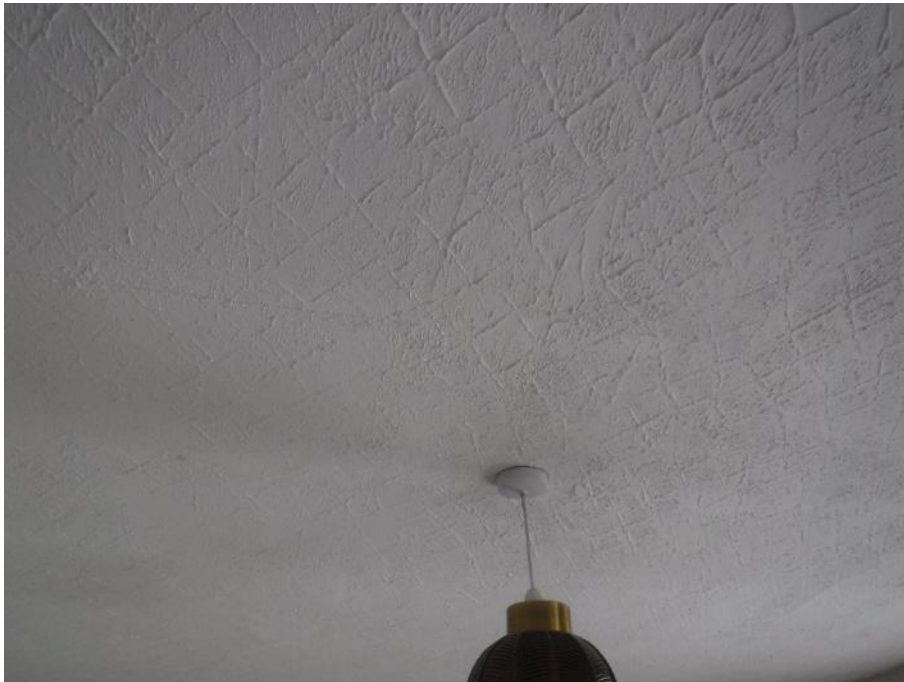
**Photograph 26:** Main bedroom - Artex ceiling noted

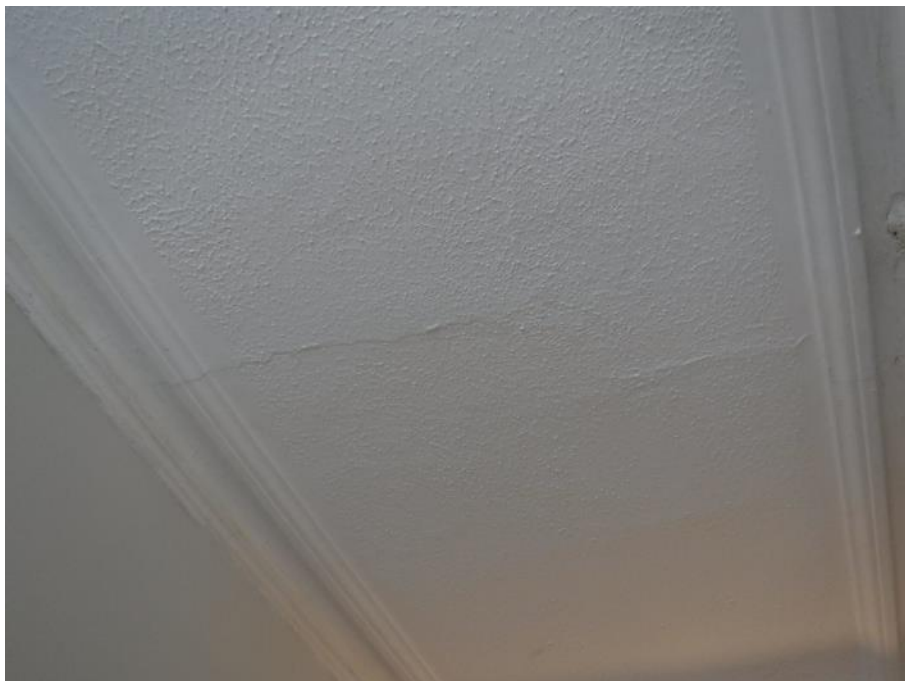
**Photograph 27:** Hallway - artex ceiling and minor cracking

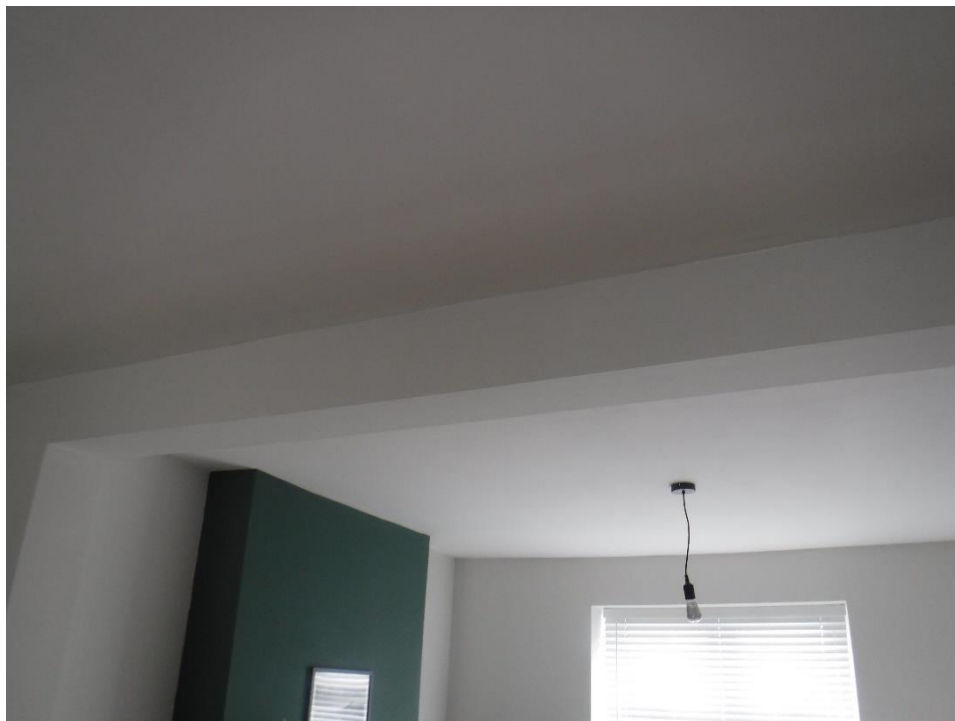
**Photograph 29:** Sitting room RSJ

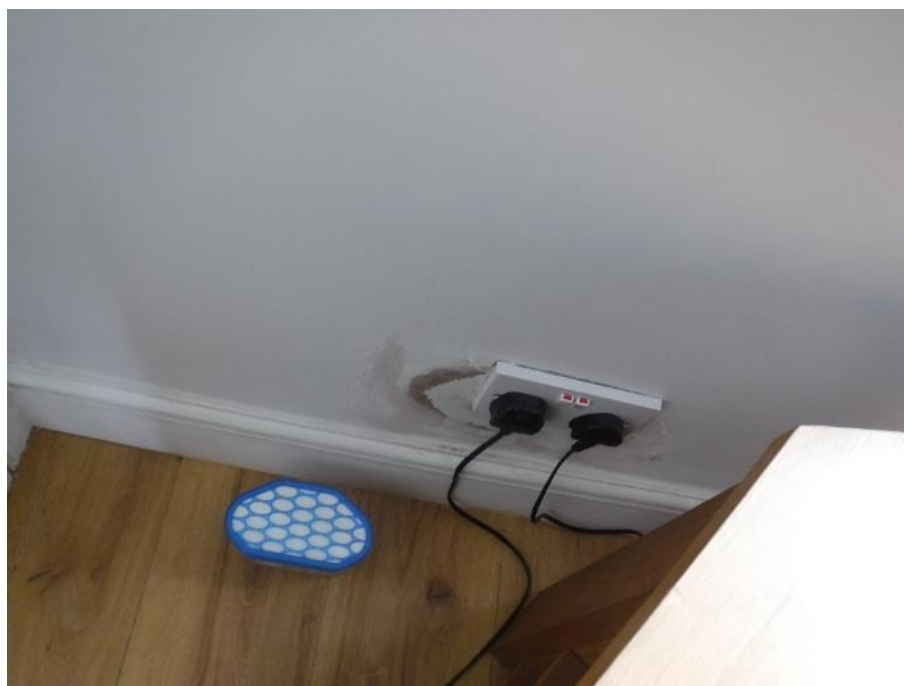
**Photograph 30:** A small damp patch was noted in the sitting room on the SW corner

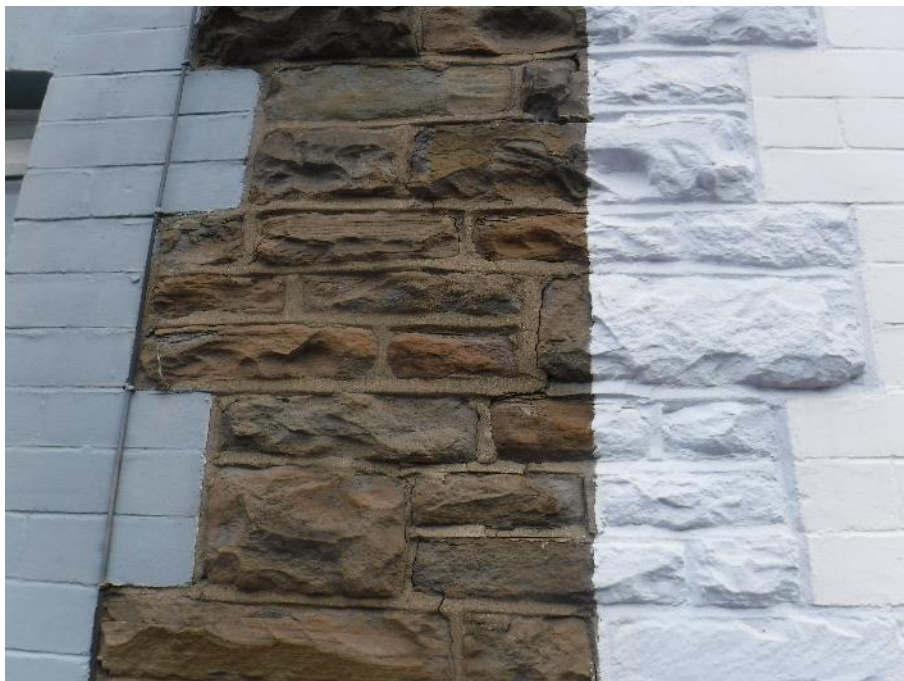
**Photograph 31:** Condition of wall to exterior of damp patch

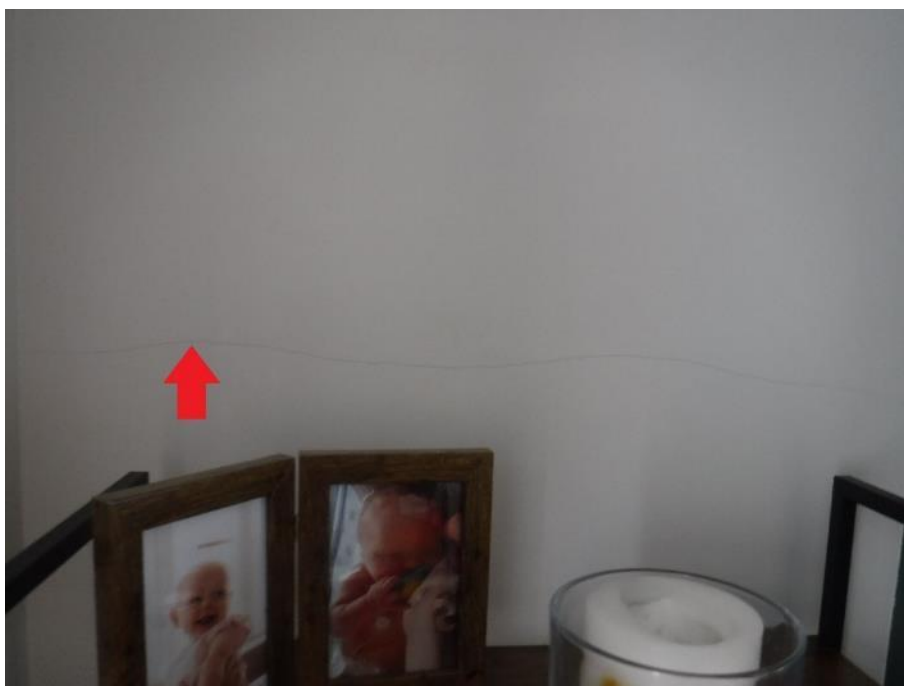
**Photograph 32:** Hairline plaster crack to dining room adjacent to chimney stack

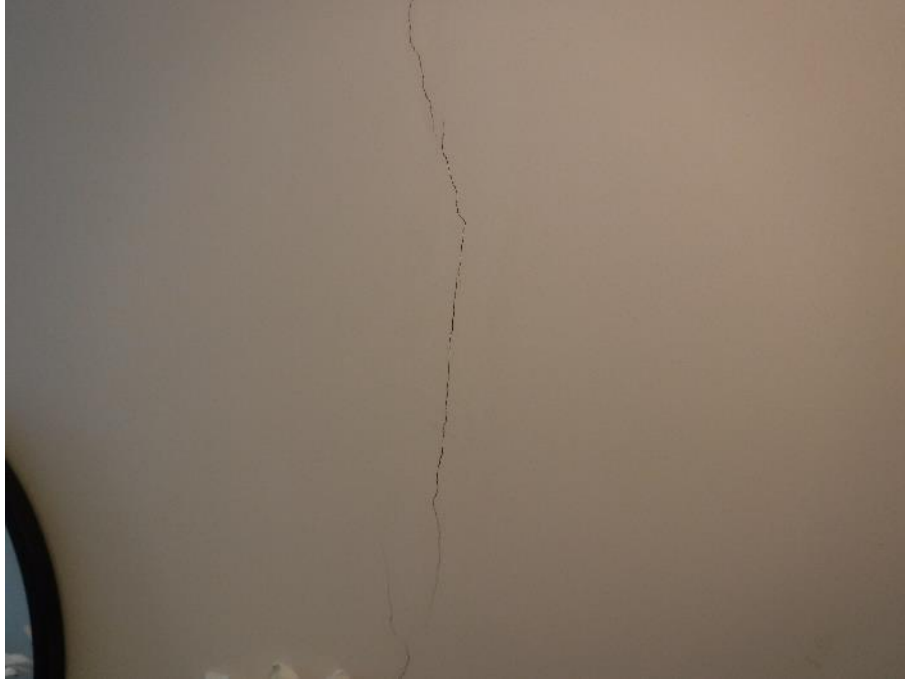
**Photograph 33:** Hallway – vertical 1-2mm crack

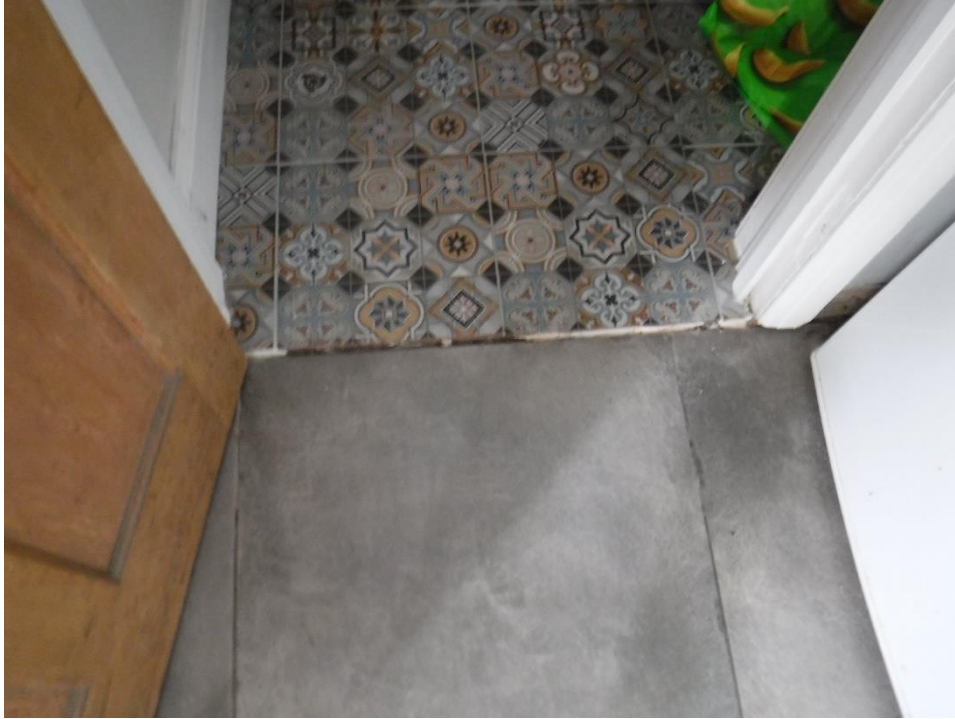
**Photograph 35:** Floors - missing threshold

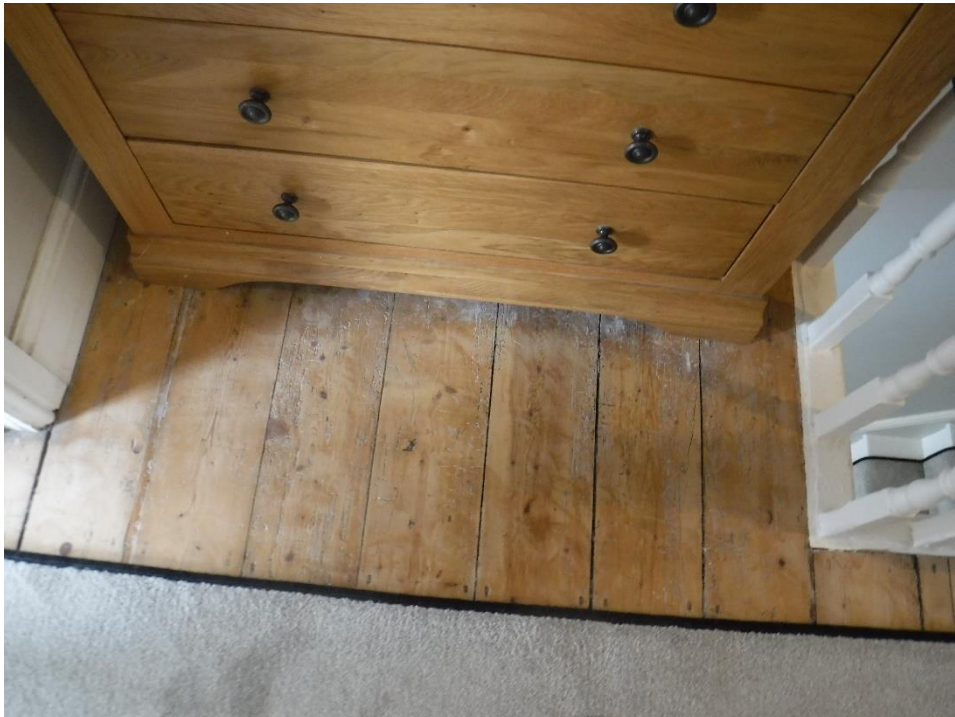
**Photograph 36:** Floors – historic woodworm

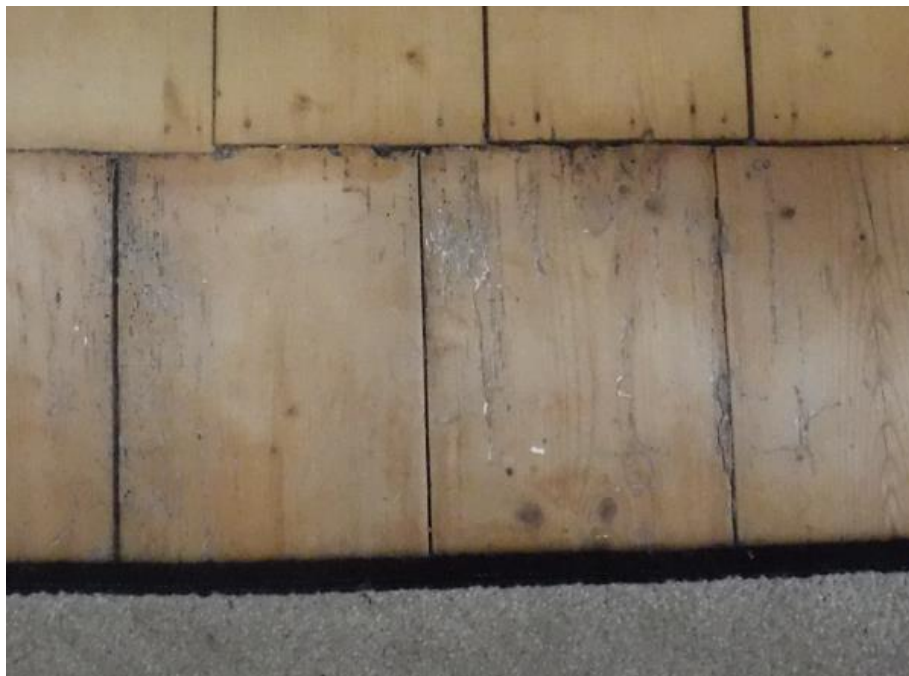
**Photograph 37:** Floors – historic woodworm (further view)

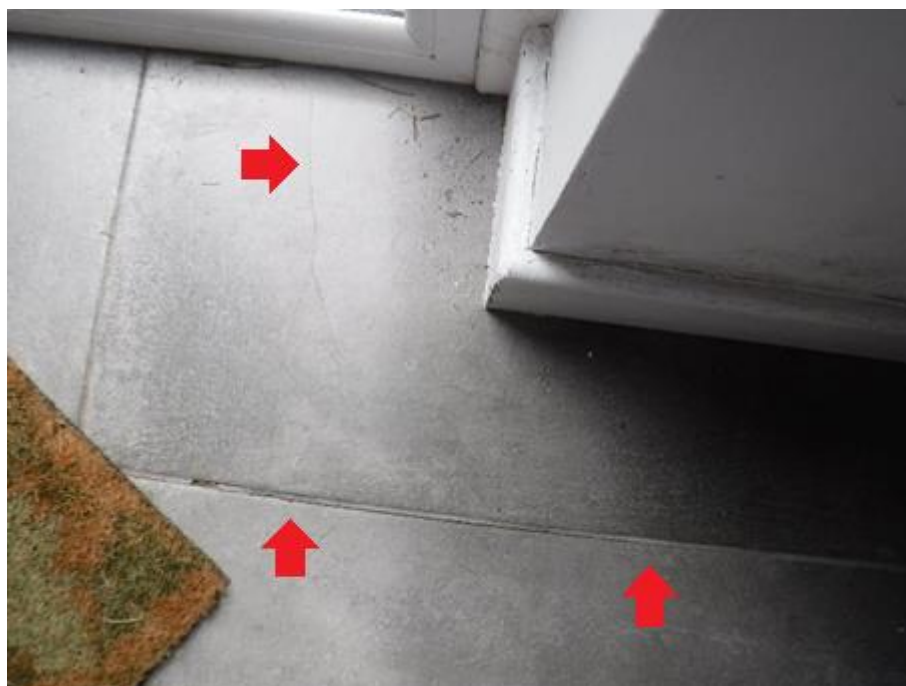
**Photograph 38:** Kitchen – cracks noted to single tile

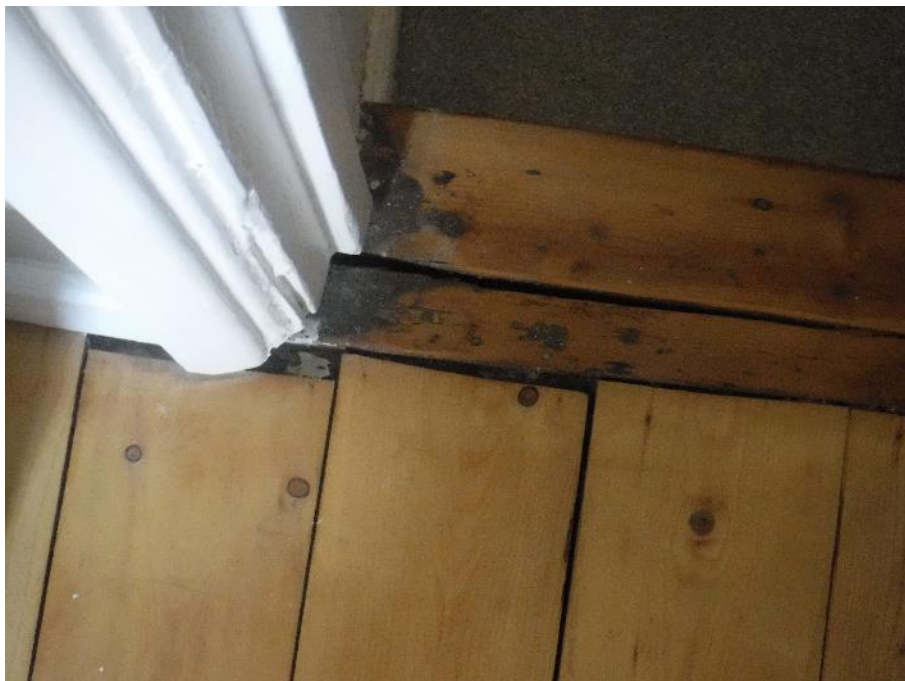
**Photograph 39:** Some minor gaps to upstairs wooden floors in rear bedroom

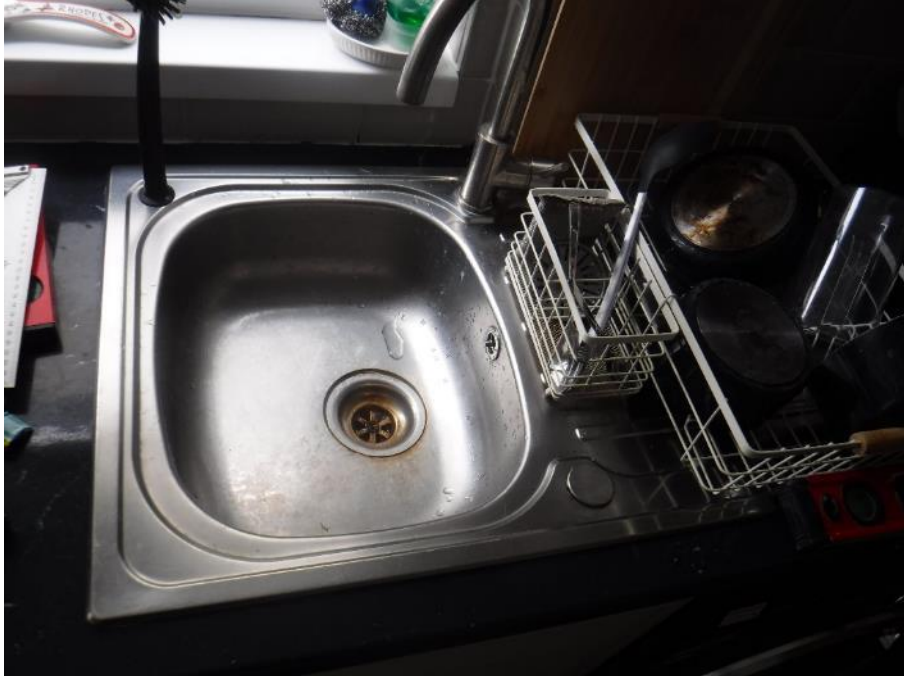
**Photograph 43:** Minor sealant repair required around kitchen sink

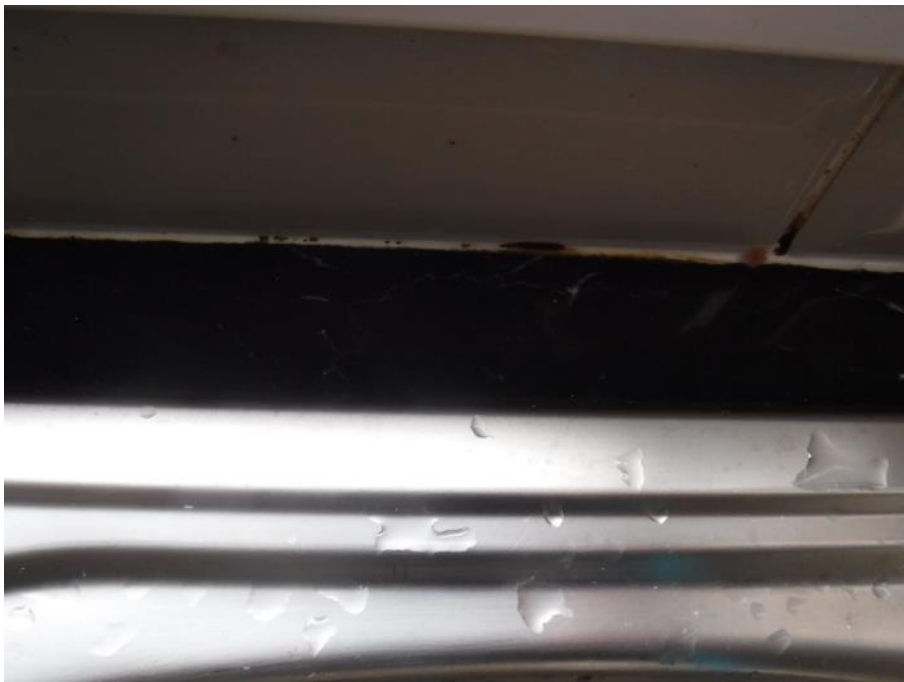
**Photograph 44:** Minor sealant repair around some of the tiled areas in the kitchen area

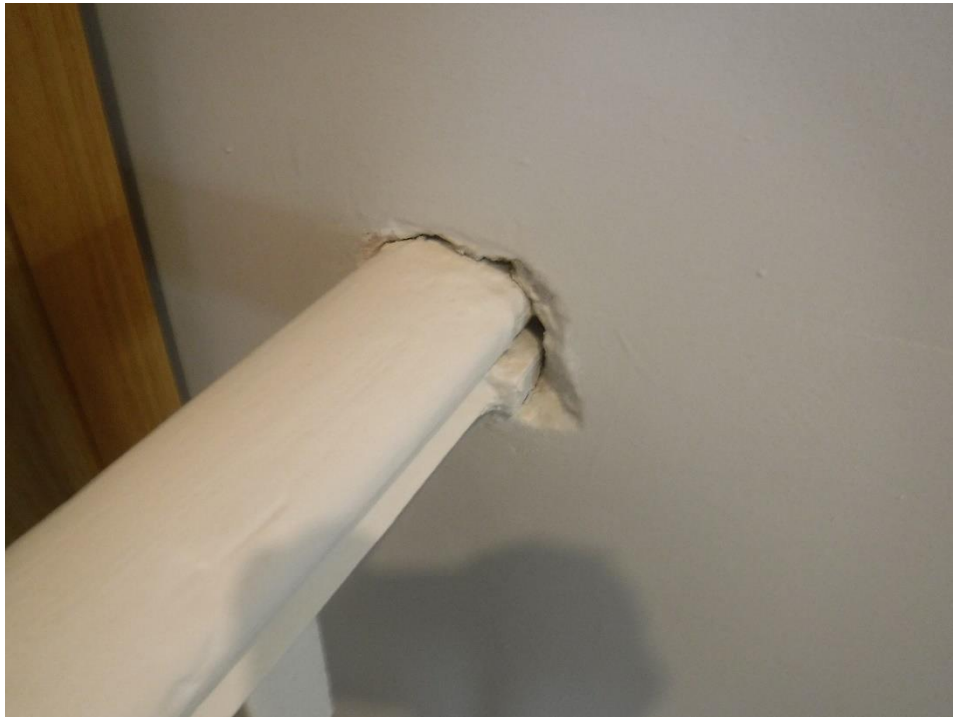
**Photograph 46:** Balustrade interface – plaster breakdown
