# BUILDING SURVEY REPORT

**PROPERTY:** Blanche Street,  
Splott,  
CF24 1QS

**SURVEY  
DATE:** 30 May 2025

**REF:** TN\_0691

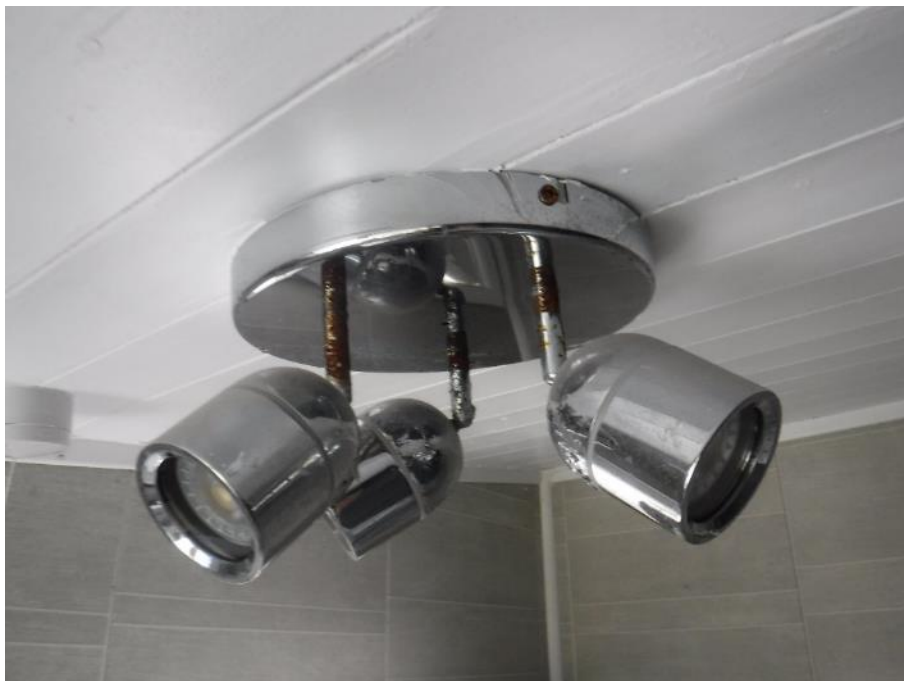
**Photograph 47:** Surface corrosion to light-fitting in bathroom

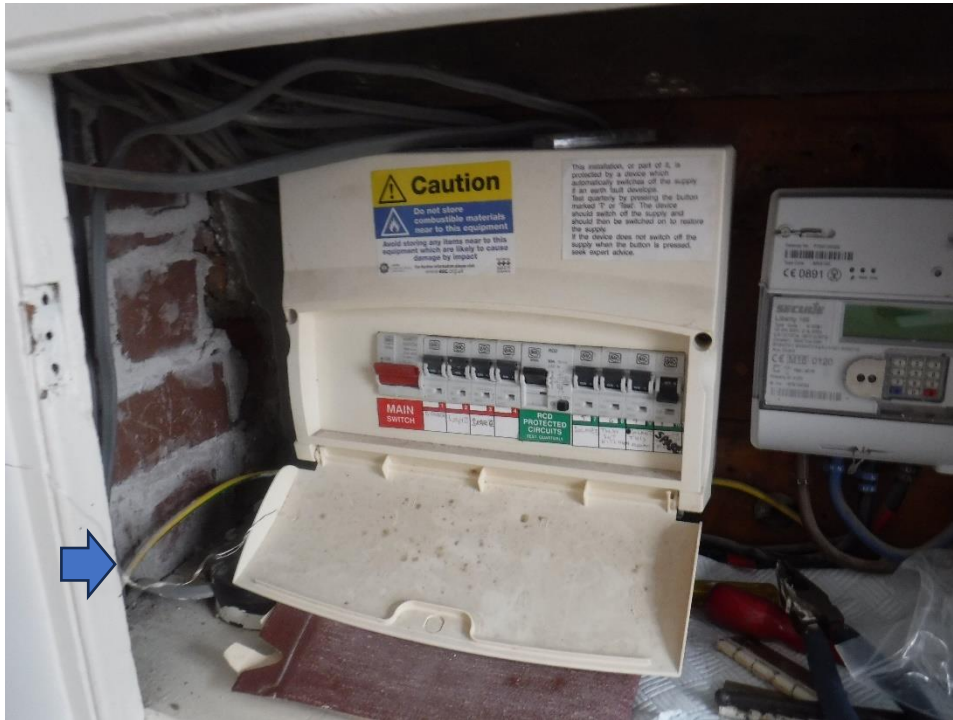
**Photograph 49: Consumer unit (note stray wire)**

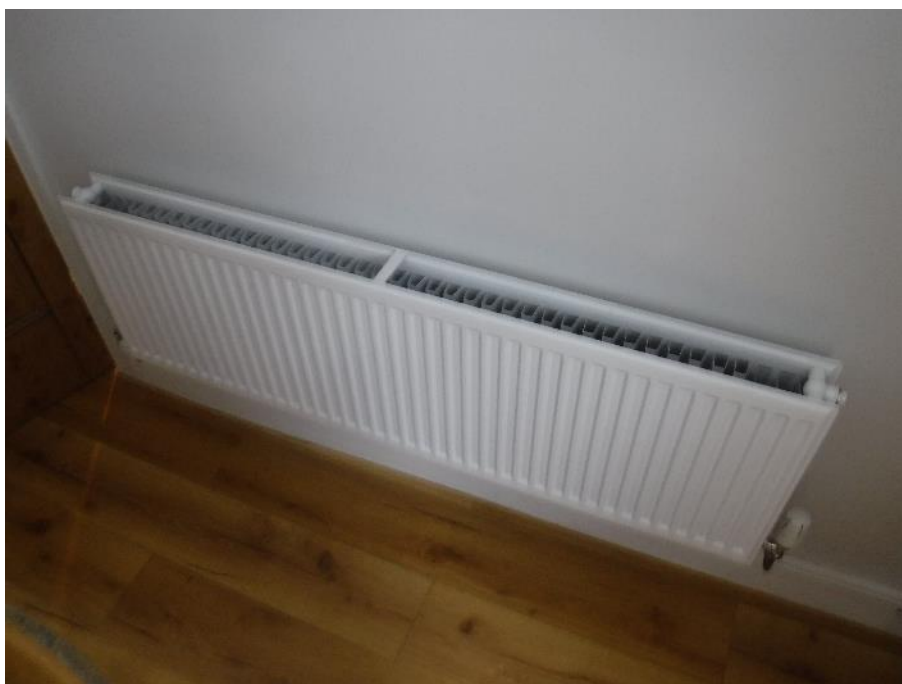
**Photograph 52:** Radiators - no evidence of any active leaks

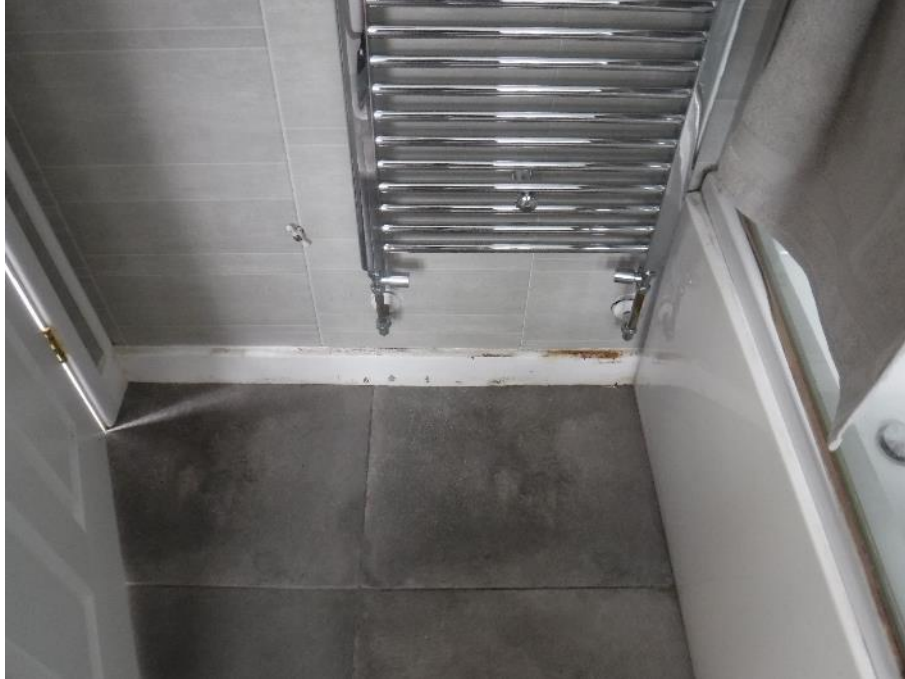
**Photograph 53:** Bathroom radiator – staining/rot to skirting board

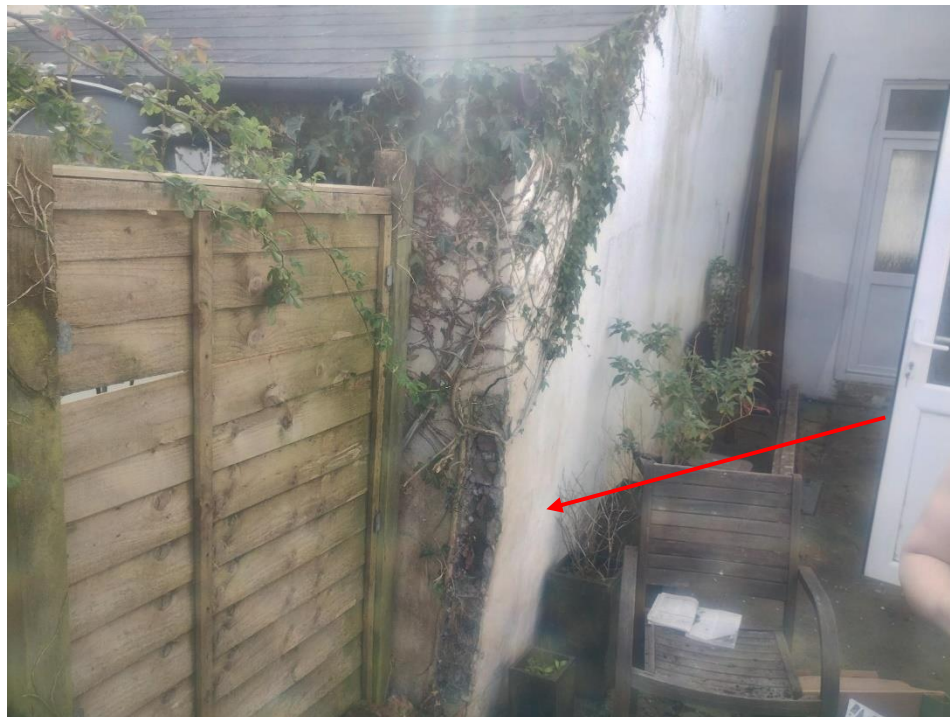
**Photograph 60:** Garden south boundary wall – extension bulge

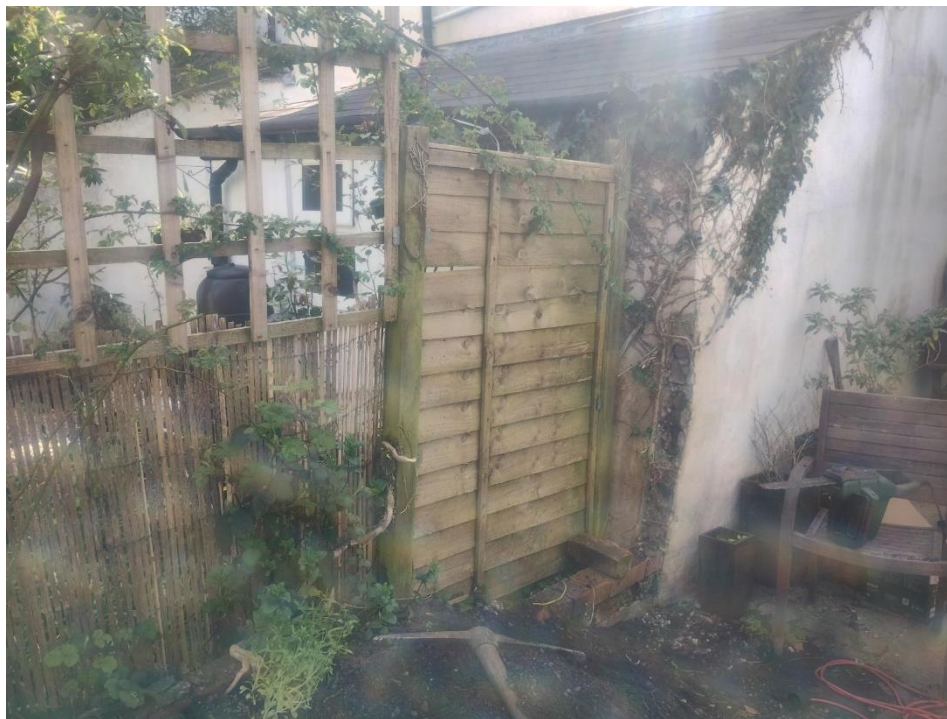
**Photograph 61:** Garden south boundary wall – extension bulge

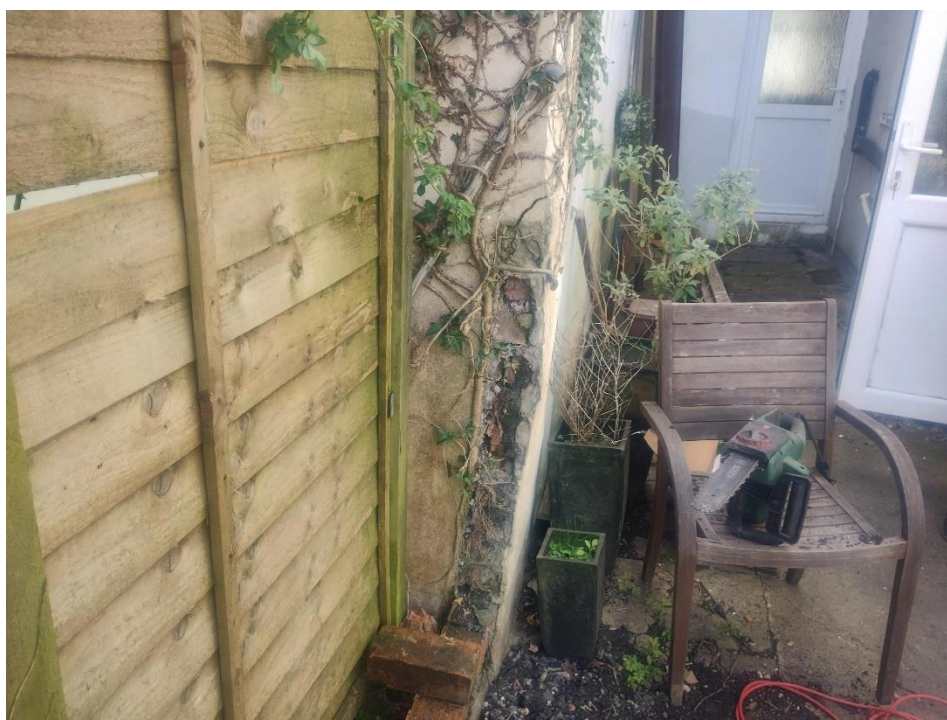
**Photograph 62:** Garden south boundary wall – extension bulge
