BUILDING SURVEY REPORT

PROPERTY: Pencerrig St,
Pontypridd,
CF37 2HS

**SURVEY
DATE:** 02 June 2025

REF: TN0878

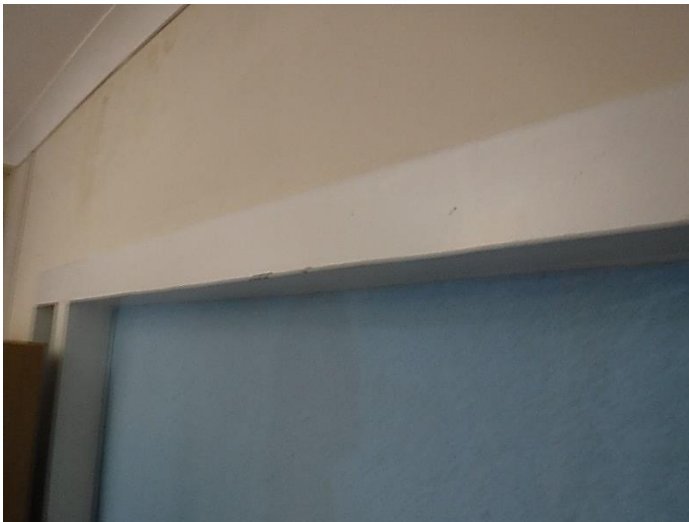
<p>There was a knock through and installation of an RSJ in the sitting/dining room. Detection confirmed this was a metal I-beam. It was noted as level. You should request if this has been signed off by building control and has the associated paperwork.</p>
Access & Rights of way	No issues were noted by the Surveyor.

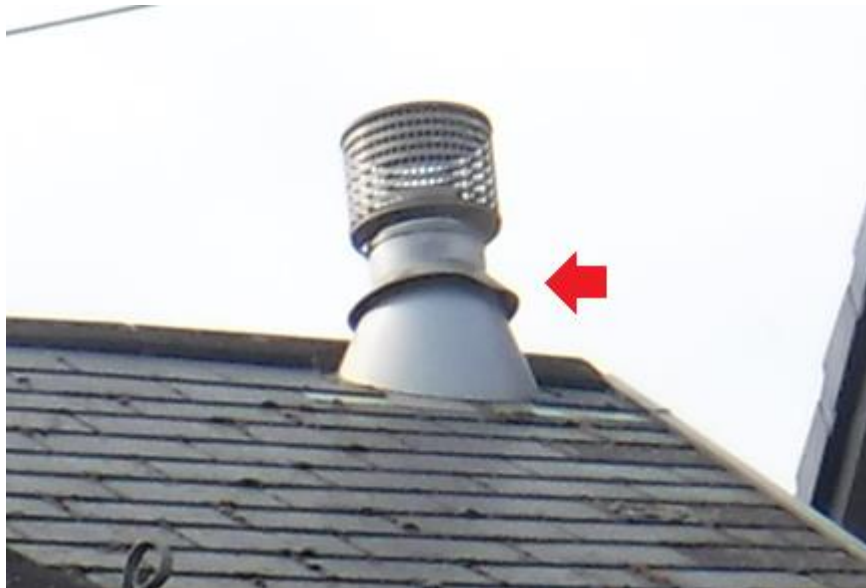
Photograph 4: Front chimney – minor dent observed

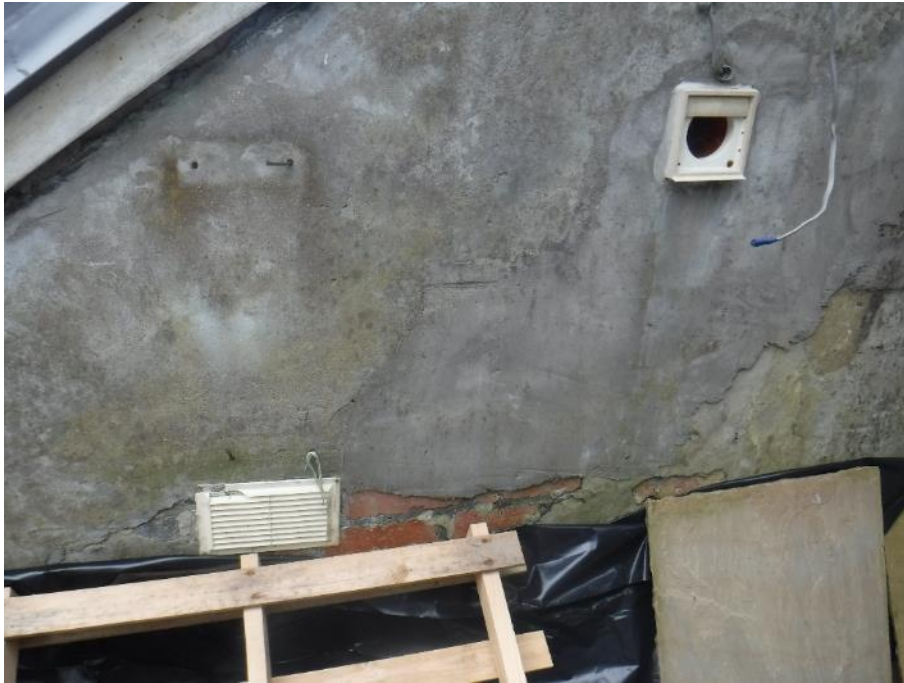
Photograph 7: The gable end in this location requires re-rendering/repairing. There is some ventilation in this area (for the roof) however the fan is not operational.

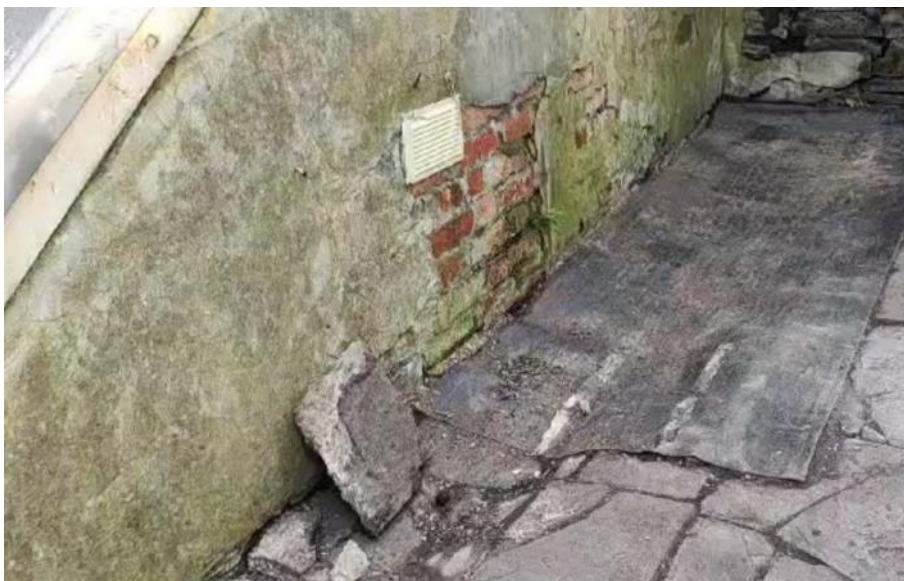
Photograph 8: approximately 1.5m² of render was missing to this location and would require a patch repair

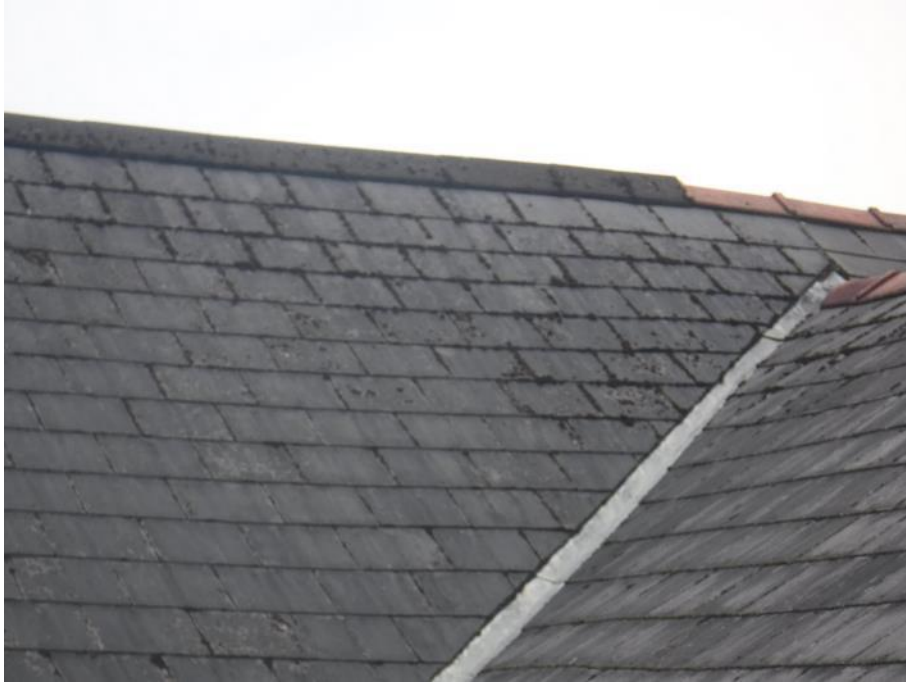
Photograph 9: Valleys noted in fair condition, also please noted 3m2 moss growth (presumed to be unreachable area without increased access)

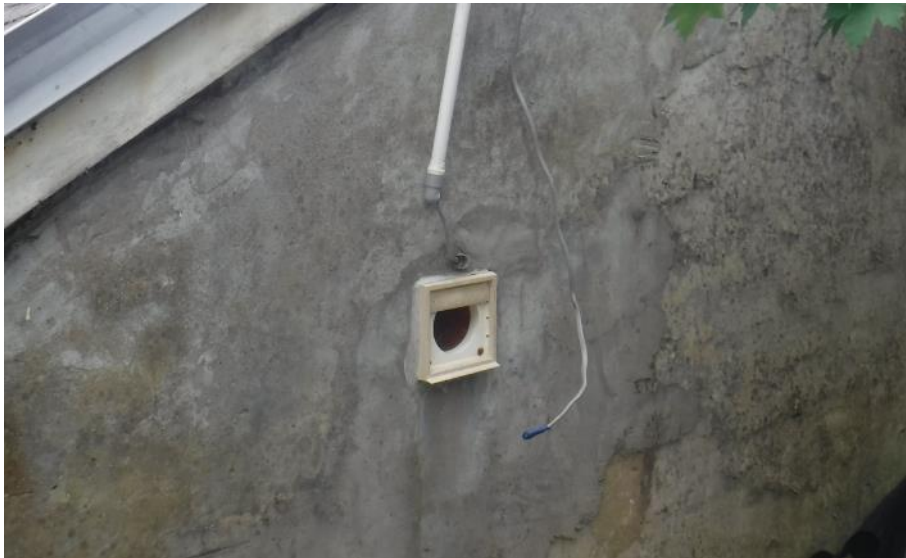
Photograph 10: Unknown electrical cable in this location, the homeowner has assured ourselves that it is redundant given the recent re-wire.

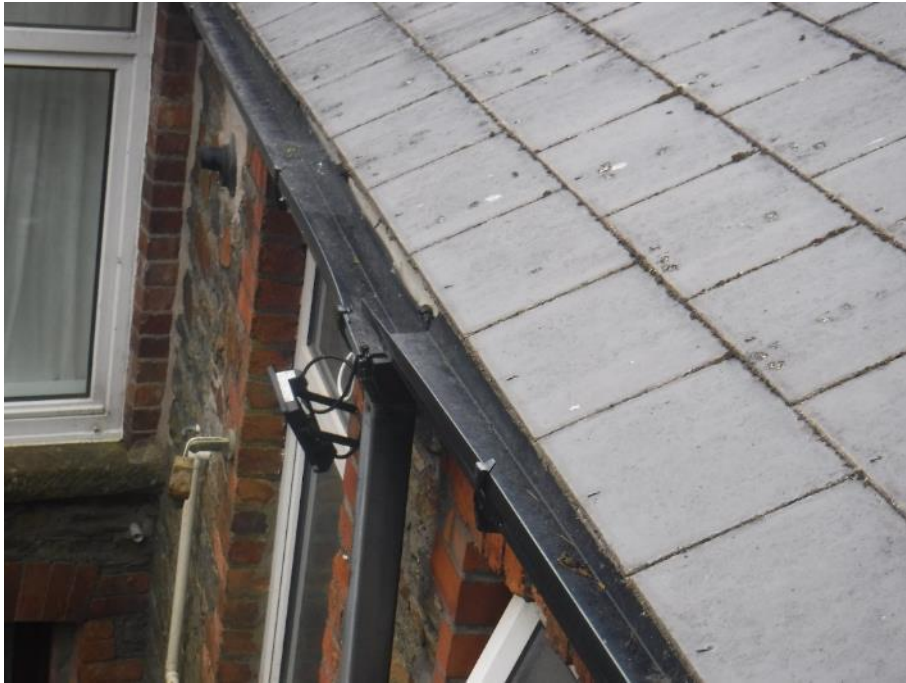
Photograph 11: A another temporary fix was noted at the NE corner:

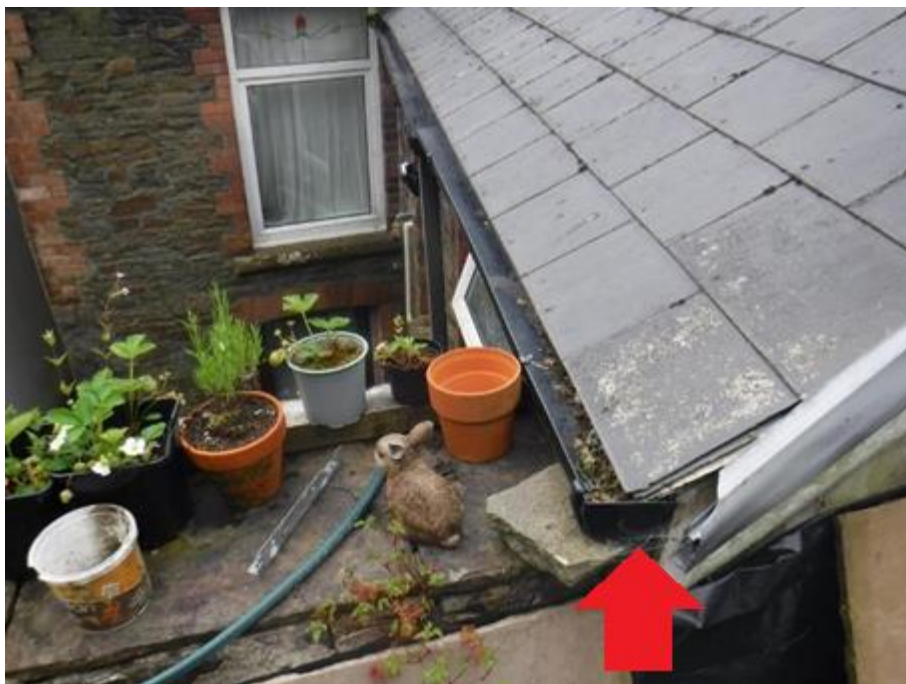
Photograph 12: Further temporary fix to the stop-end

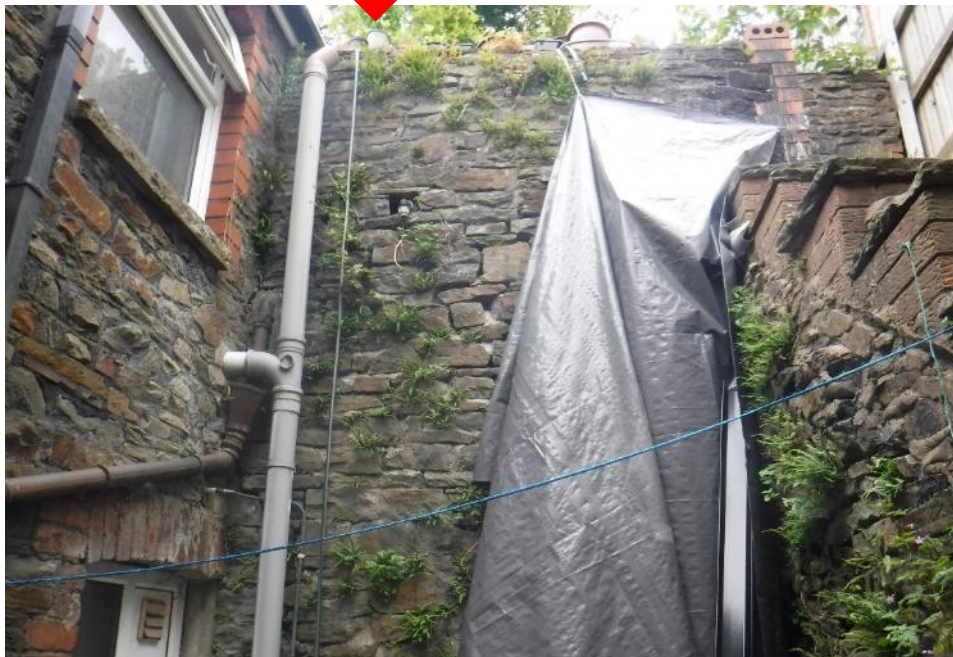
Photograph 14: Soil pipe missing cap/close too window

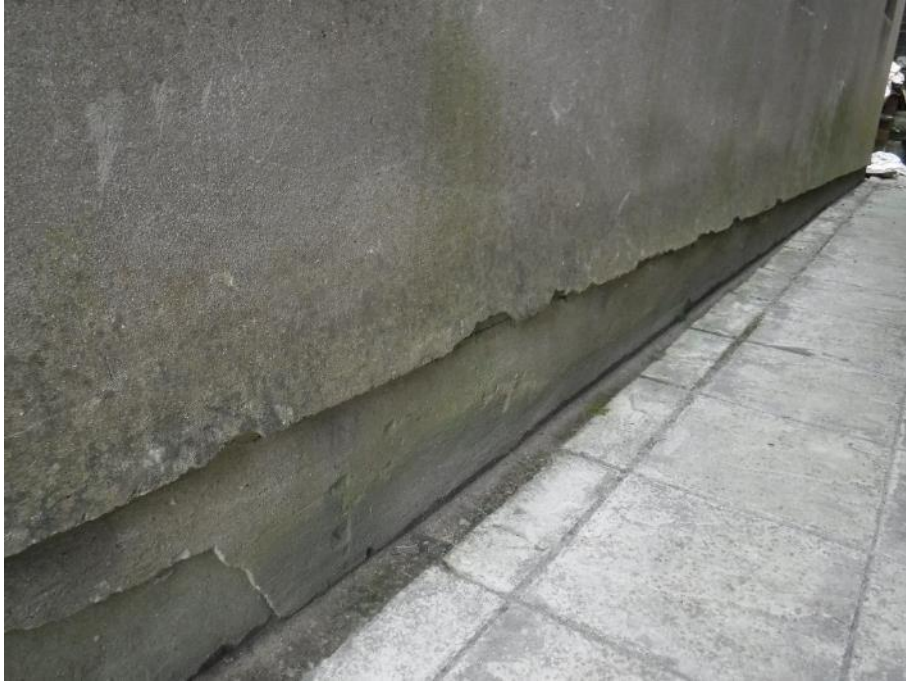
Photograph 15: Cement render to the bottom of the east elevation (we would recommend 150-200mm removal)

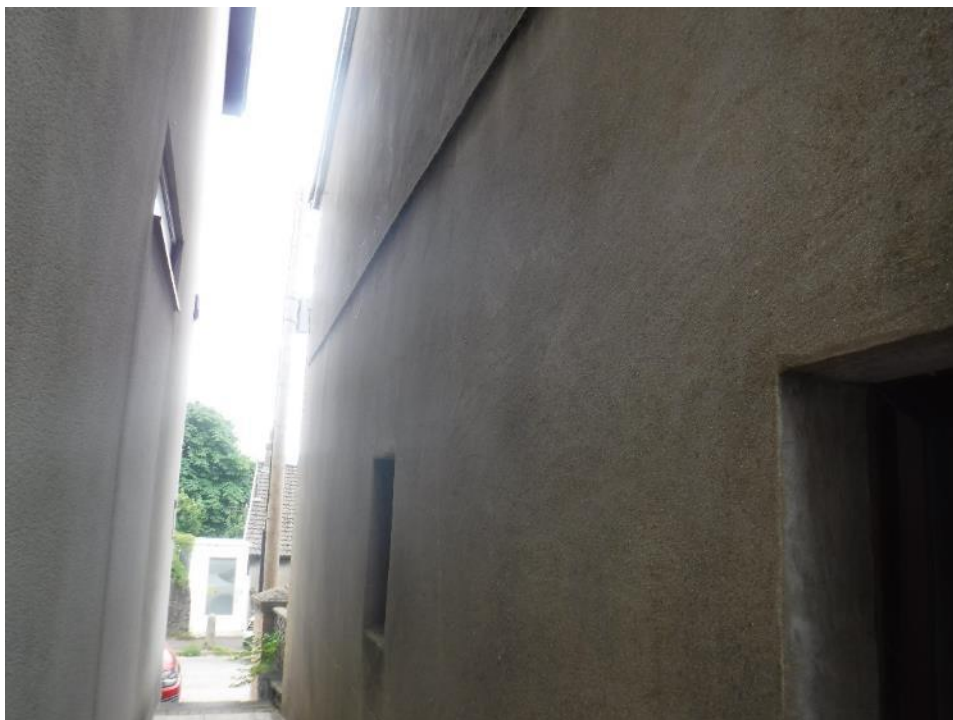
Photograph 16: Cementitious render to east elevation

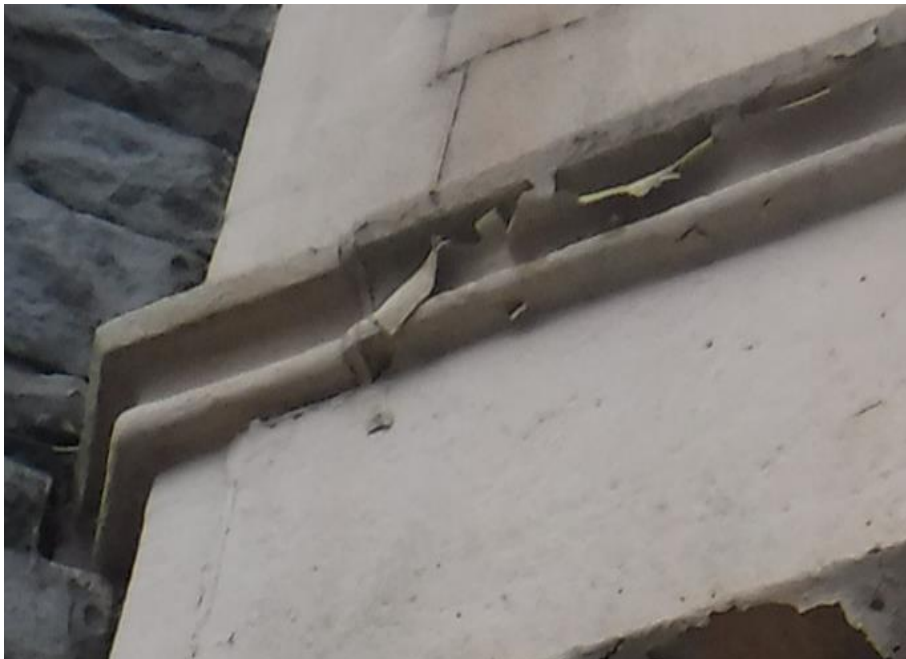
Photograph 18: Alignment defect to bay window jambs/lintels at west (also noted paint condition)

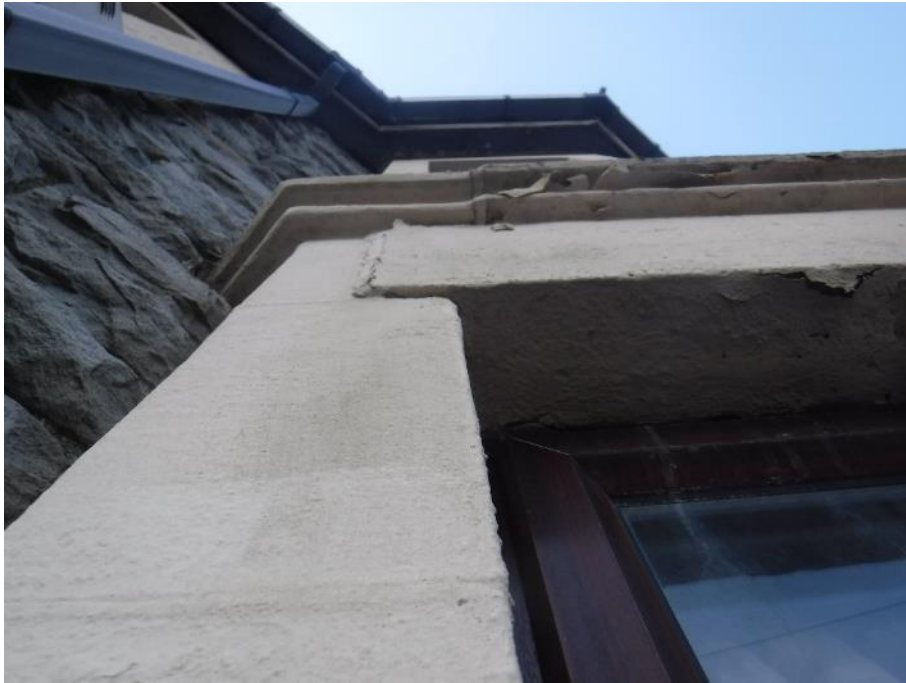
Photograph 19: Alignment defect to bay window jambs/lintels at west

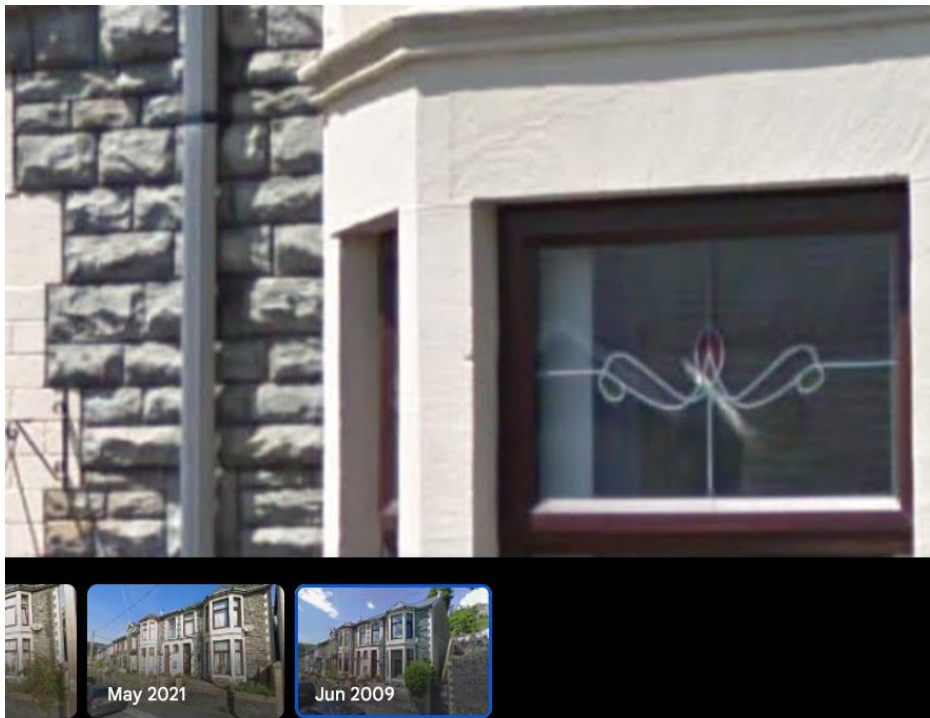
Photograph 20: Google streetview image capture of bay window defect from 2009

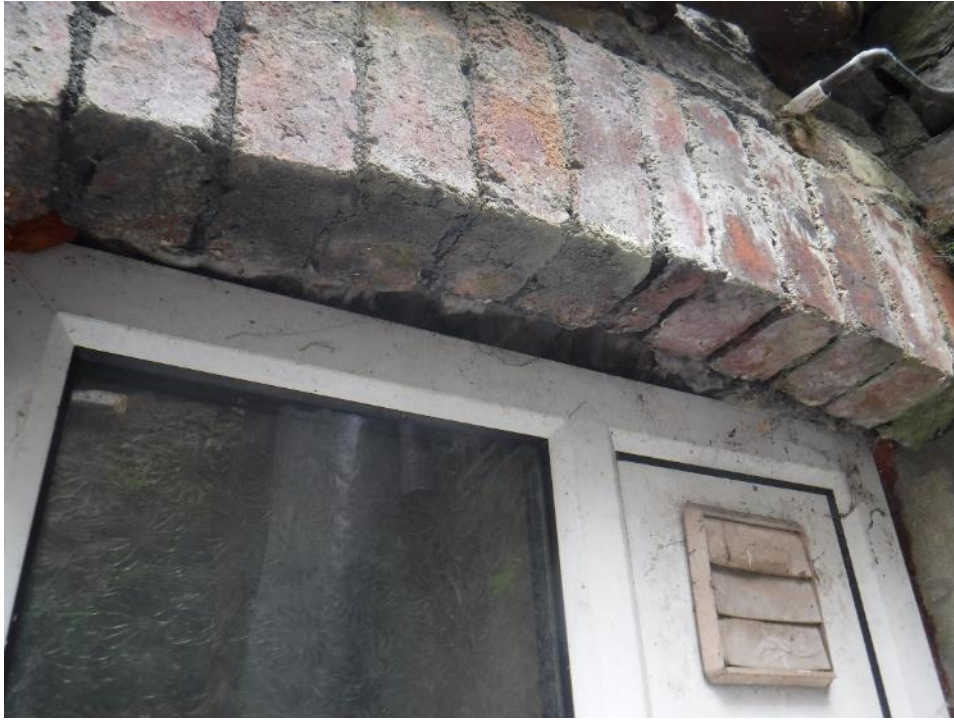
Photograph 21: Spalling and heavy efflorescence to rear lower lintel arch

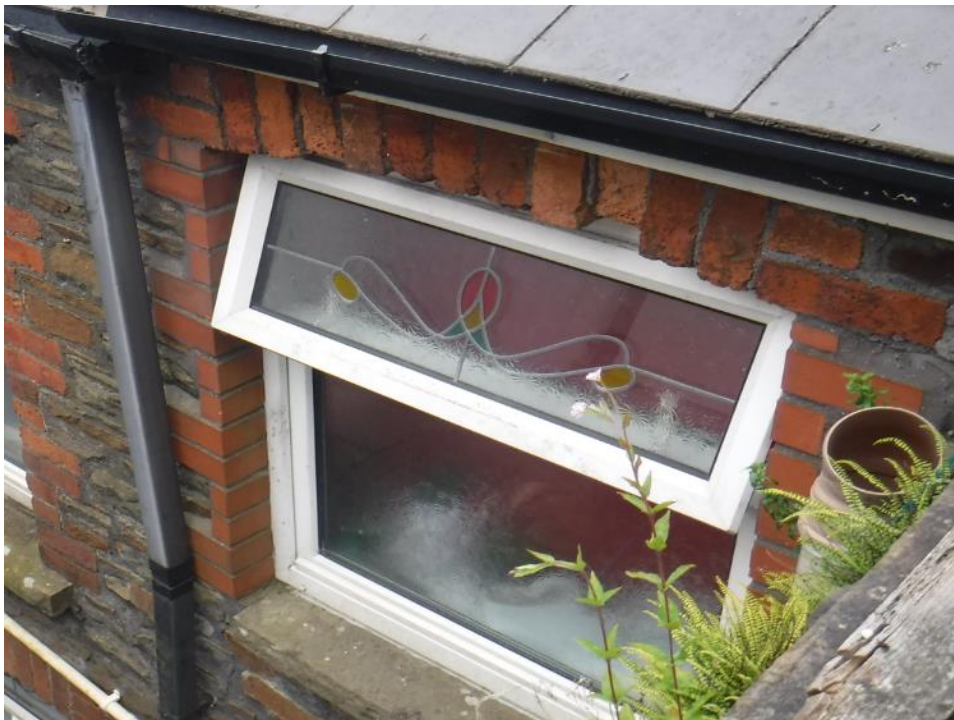
Photograph 22: Spalling to rear upper lintel arch

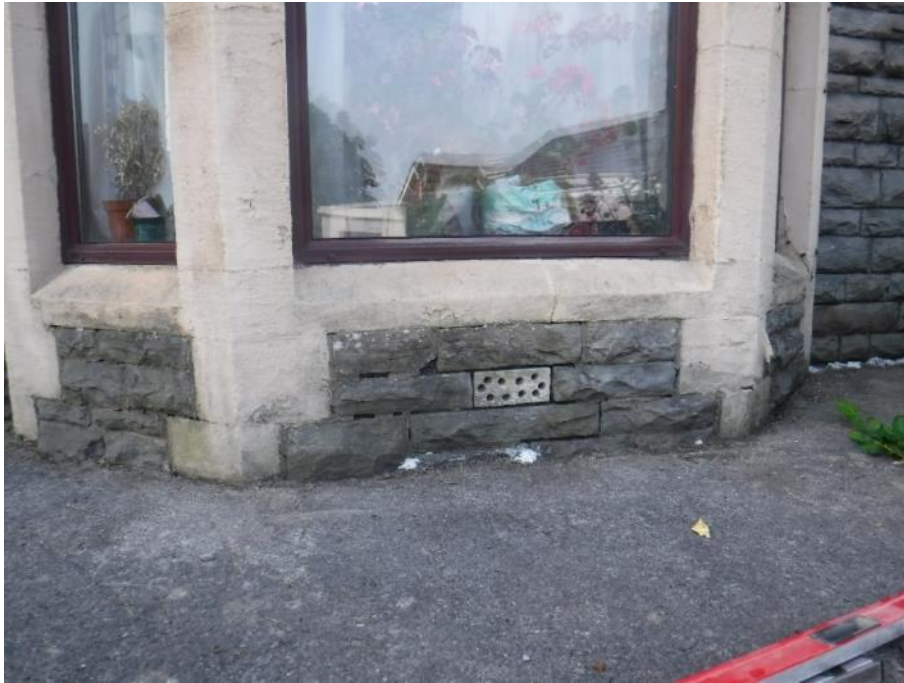
Photograph 23: External ground infilled with concrete to the front elevation, also note single air brick we would recommend installation of more air bricks to this elevation

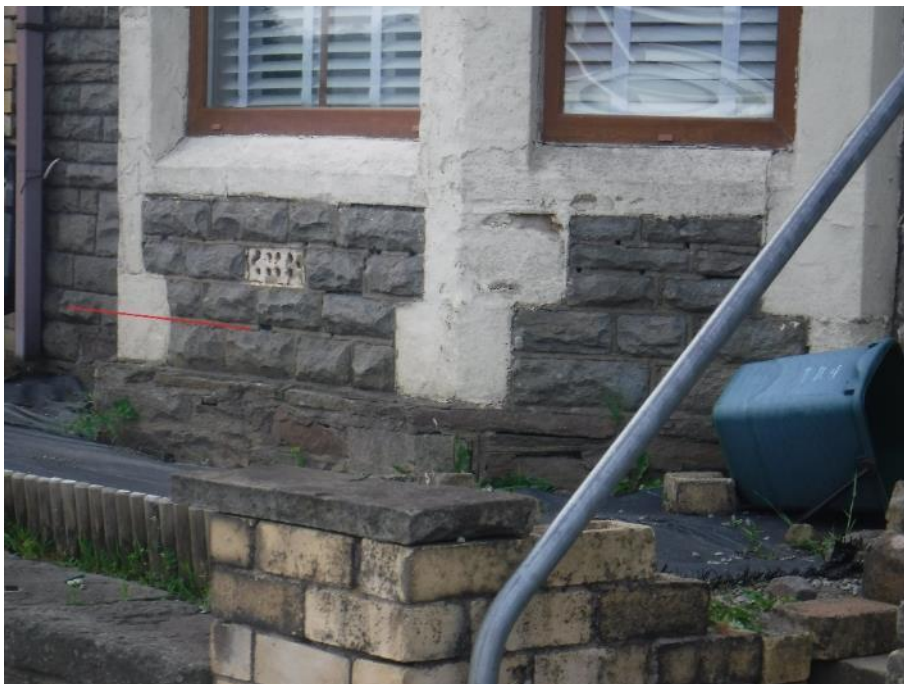
Photograph 24: When compared to the neighbouring property where the plinth course is still visible (line added):

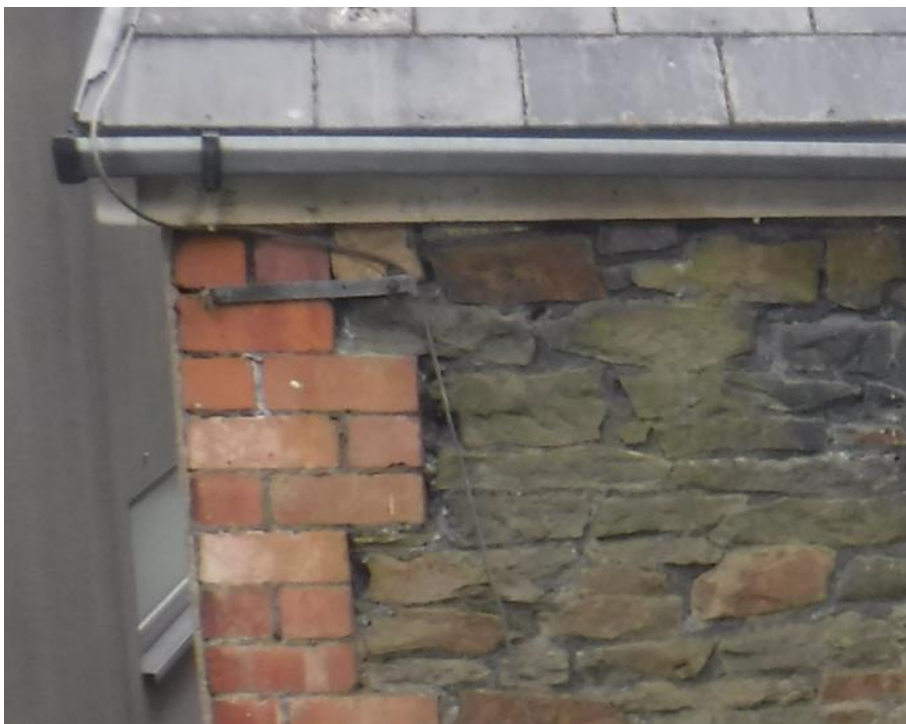
Photograph 26: Areas of mortar loss noted

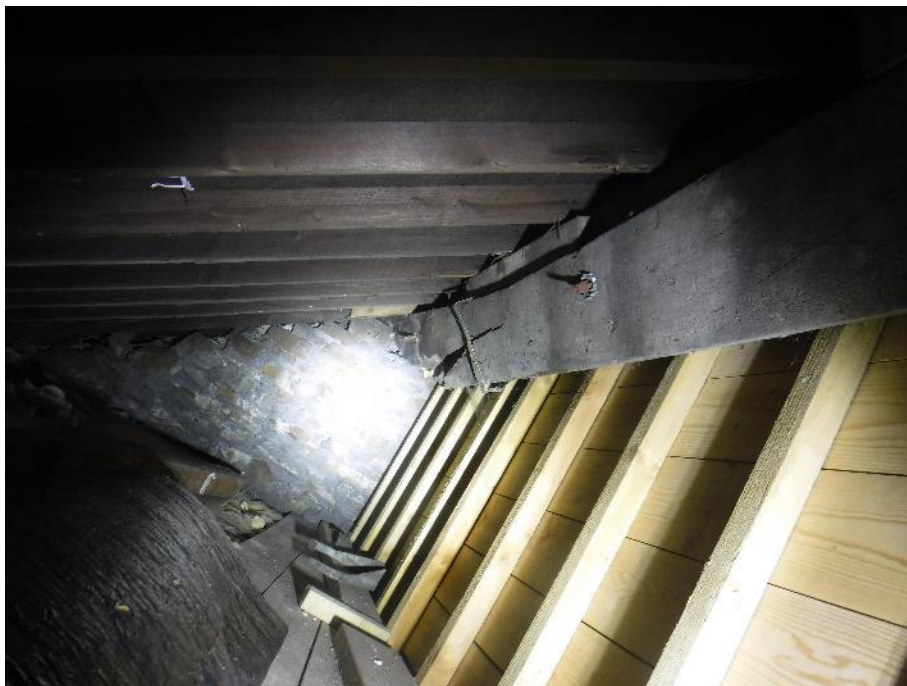
Photograph 32: A significant crack was noted to one of the purlins

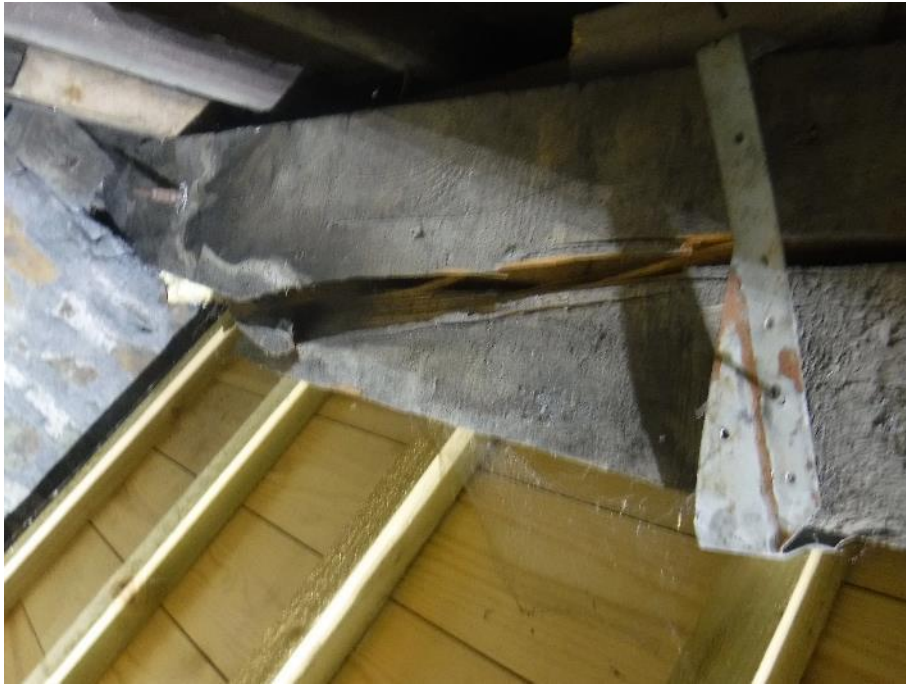
Photograph 33: Further view of crack to purlin

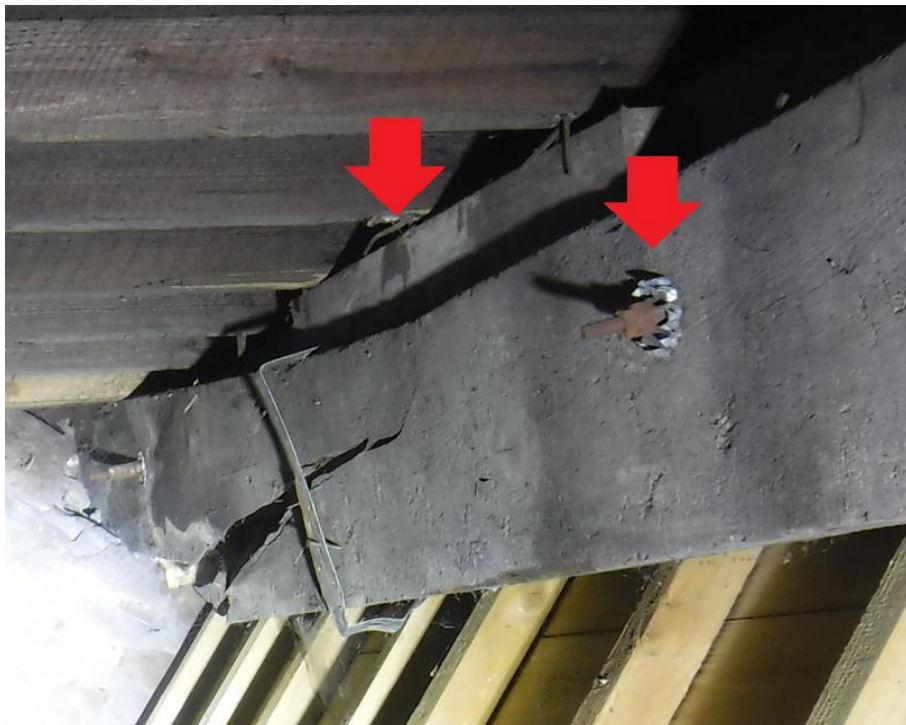
Photograph 34: Purlins sistered up (reinforced) to new supporting member (note dogtooth bolt)

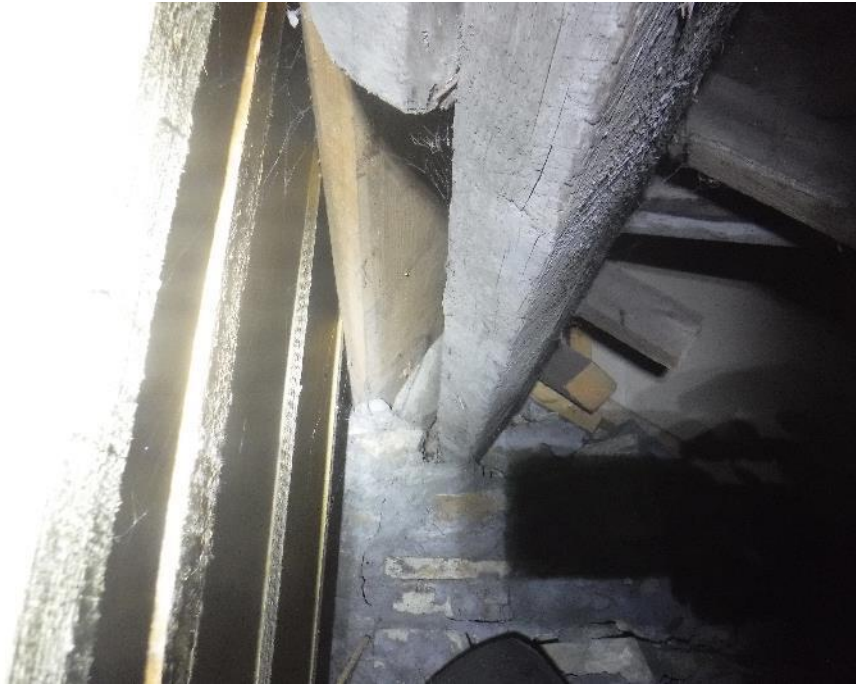
Photograph 37: Roof space - external view of cracked purlin location (no sagging noted)

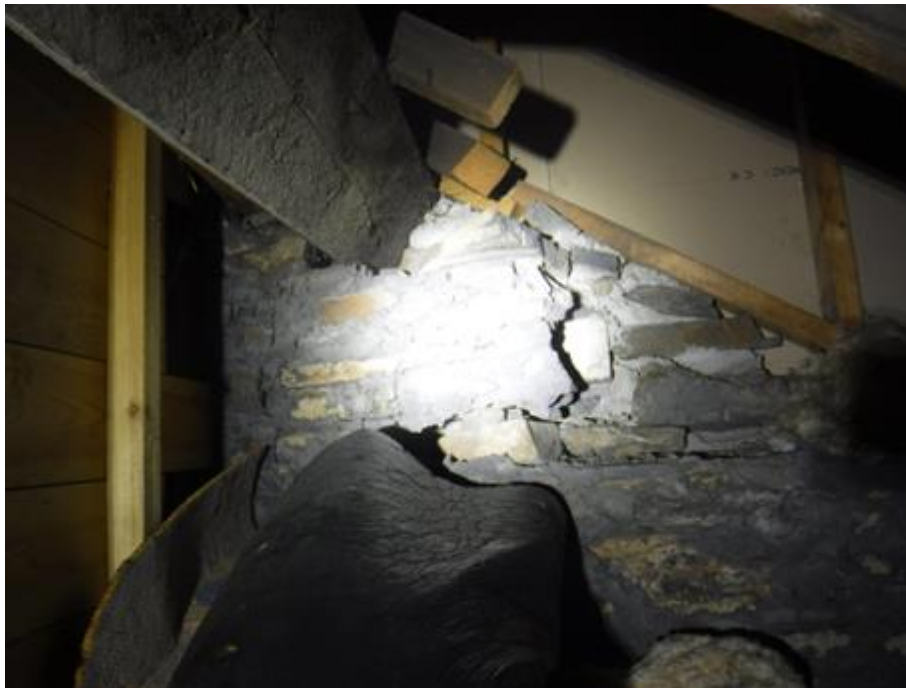
Photograph 38: Roof space - gap/un-mortared section of wall (note proximity to purlin) at the NW

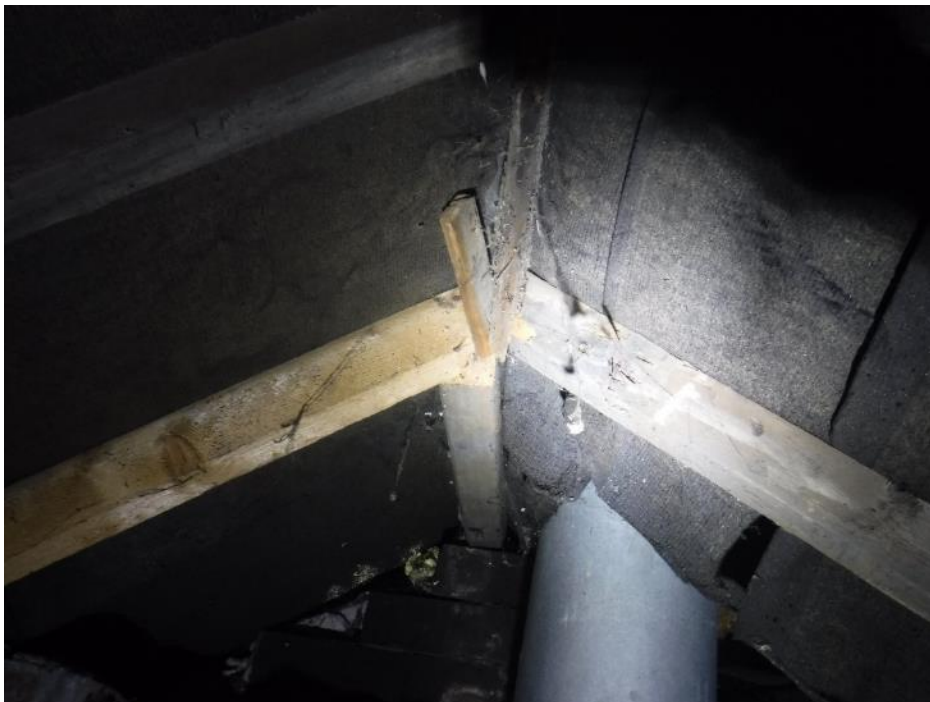
Photograph 40: Roof space – the newly added ridgeboard extension is off centre

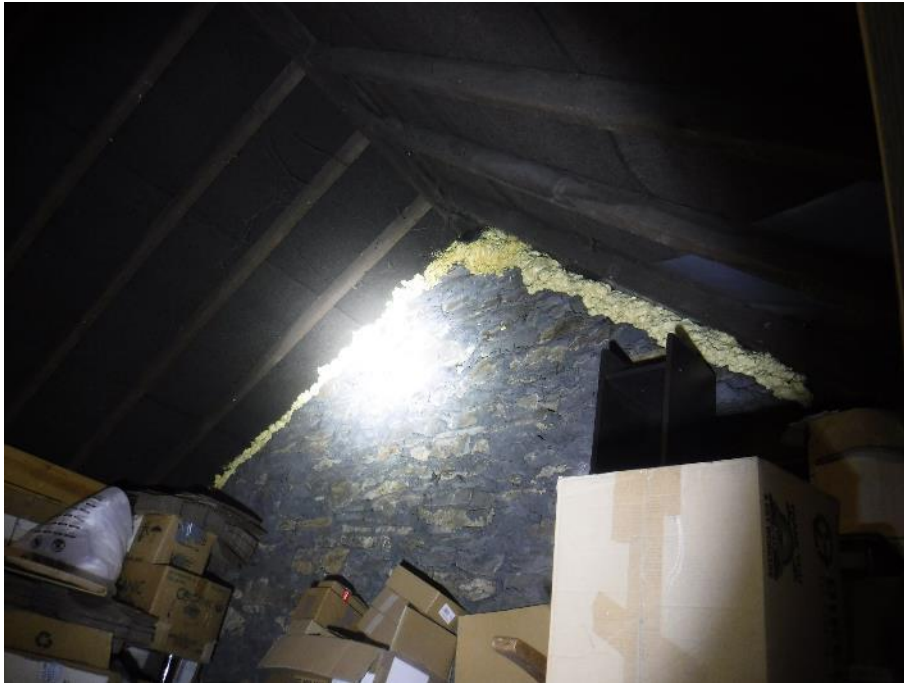
Photograph 43: Roof space - Expanding foam was found up to the rafters in both walls. Not believed to be fireproof expanding foam (which has pink colourants)

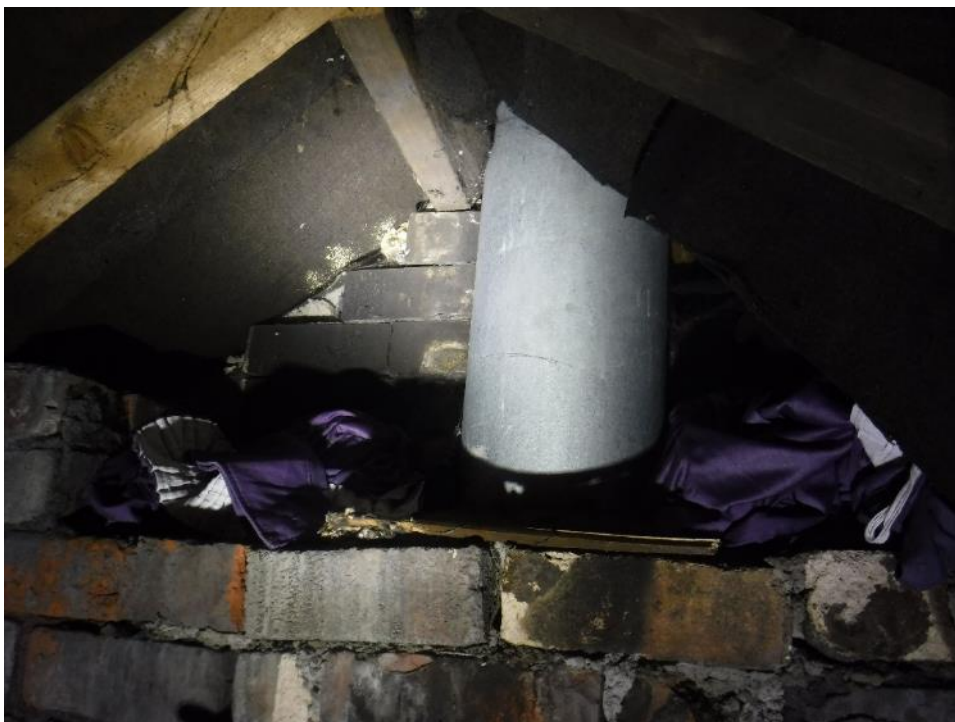
Photograph 44: Roof space – flue/chimney – not compartmentalised with combustibles around it

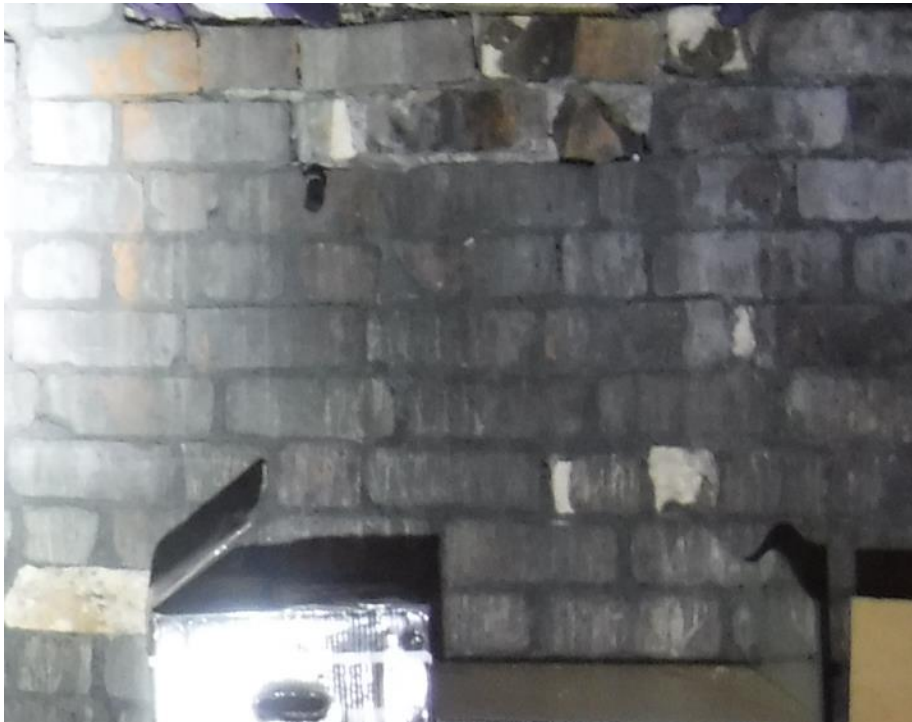
Photograph 45: Roof space - areas of mortar repairs noted

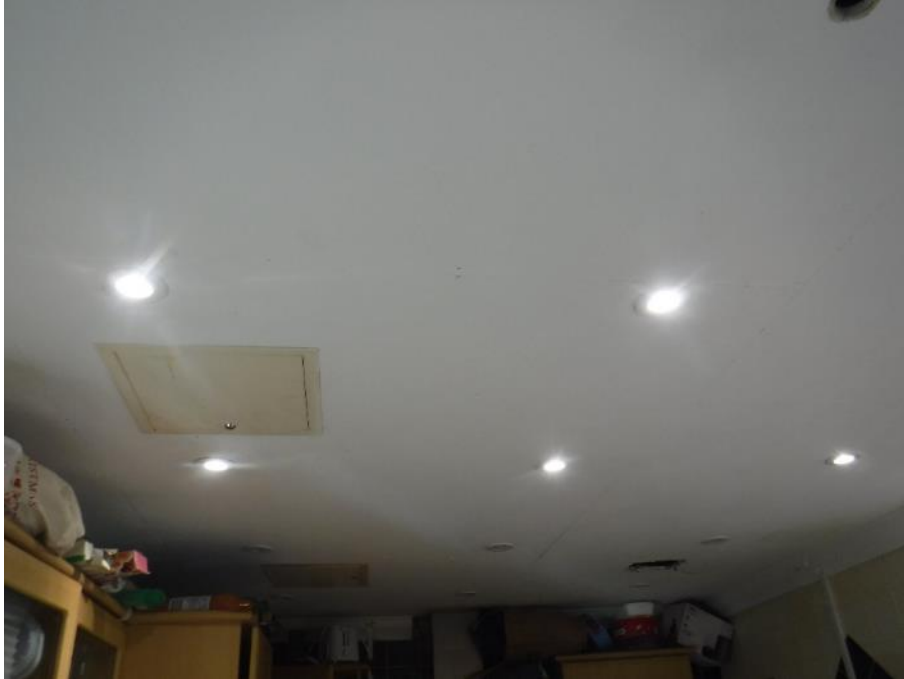
Photograph 49: Kitchen ceiling - requires patch repairs

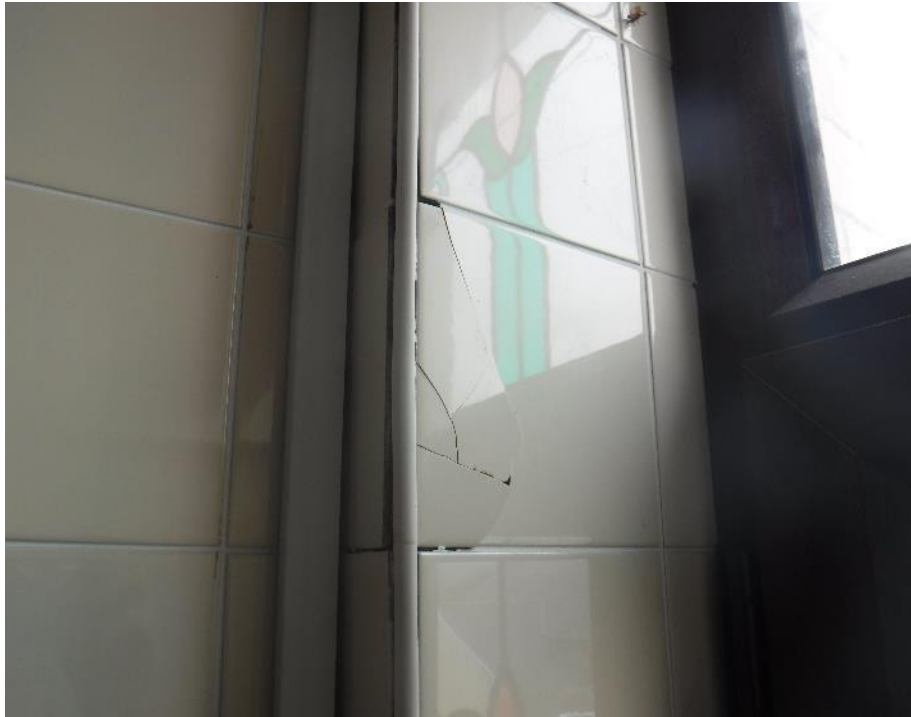
Photograph 53: Cracked tiles and grout failure to porch

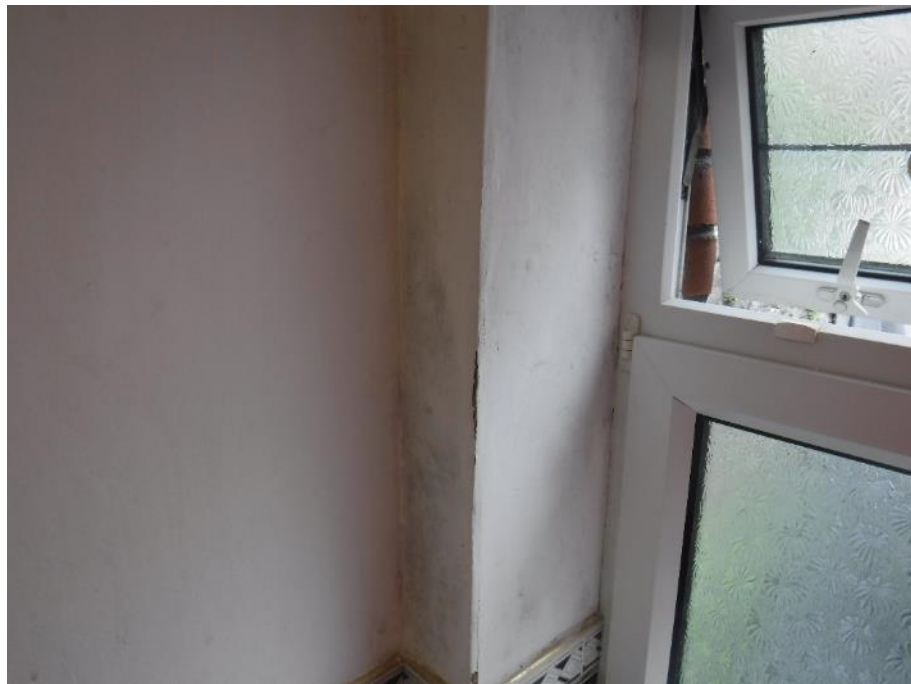
Photograph 54: Corroded angle bead to bathroom

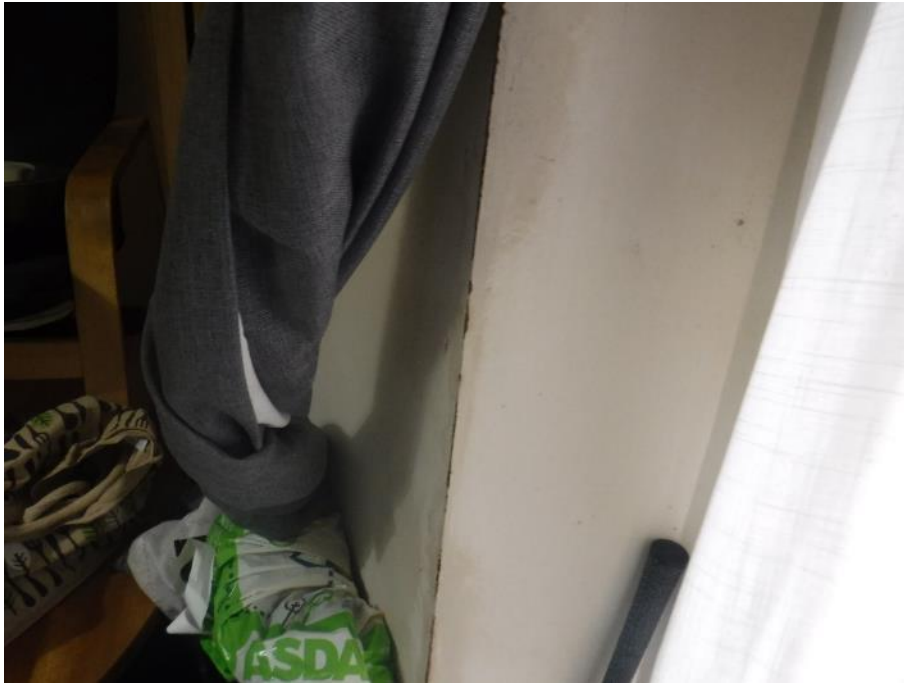
Photograph 55: Corroded angle bead to the dining room, indicative of damp inside the property

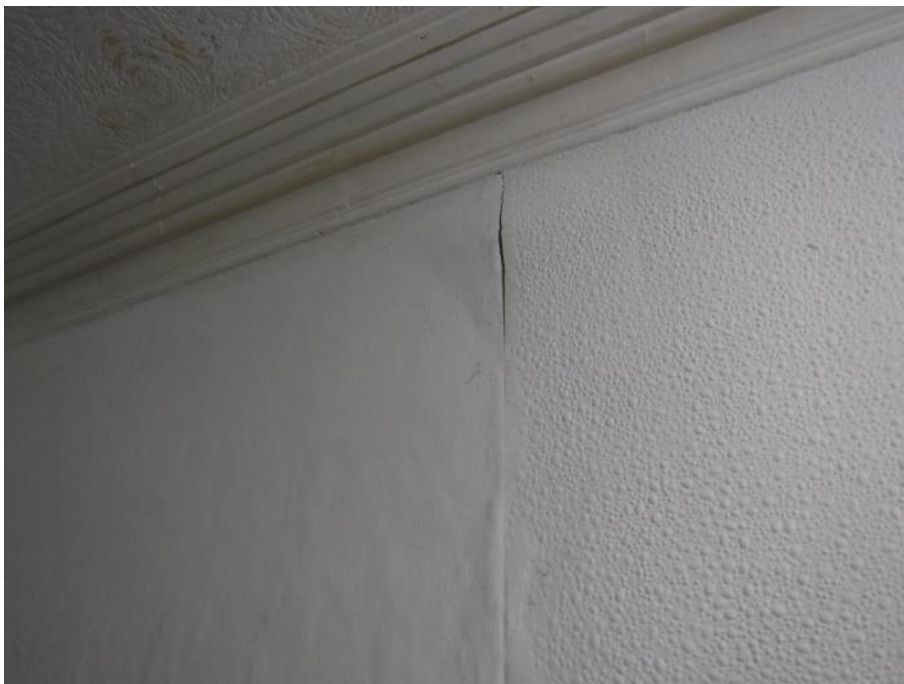
Photograph 56: Sitting room— The wallpaper had failed in the sitting room

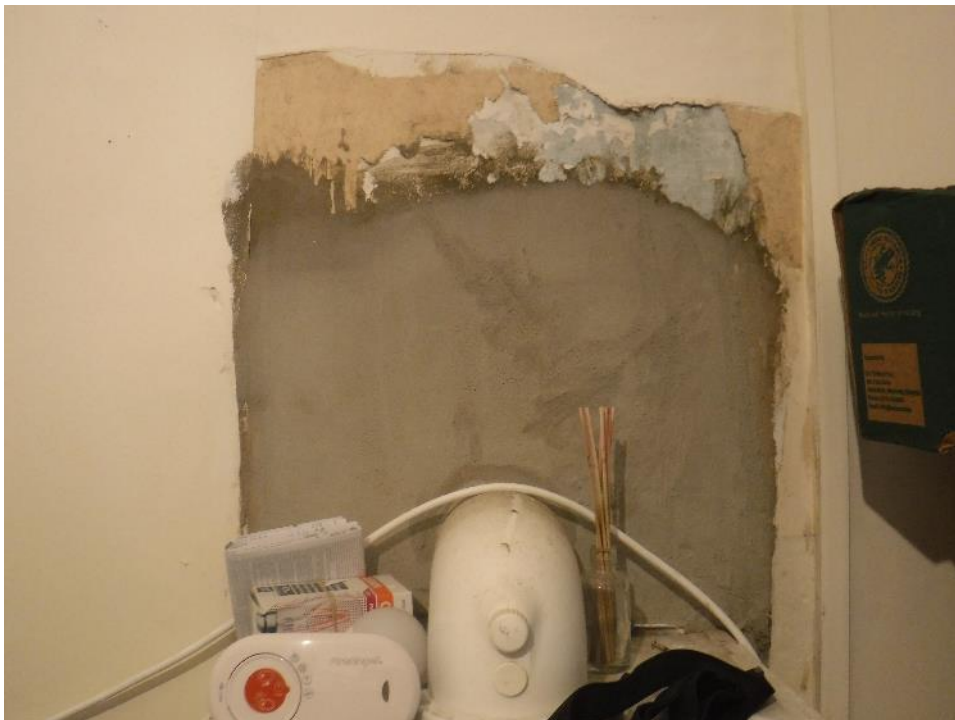
Photograph 58: Walls – boiler installation plaster repair

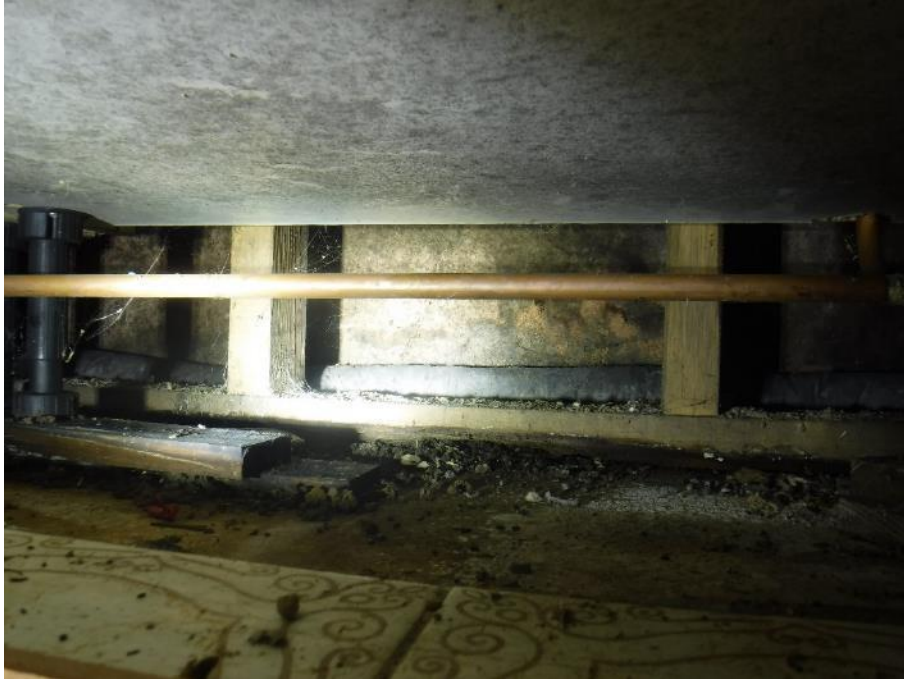
Photograph 59: Kitchen - damp was noted to the kitchen rear wall, note damp proof membrane (presumed) laid above concrete subfloor.

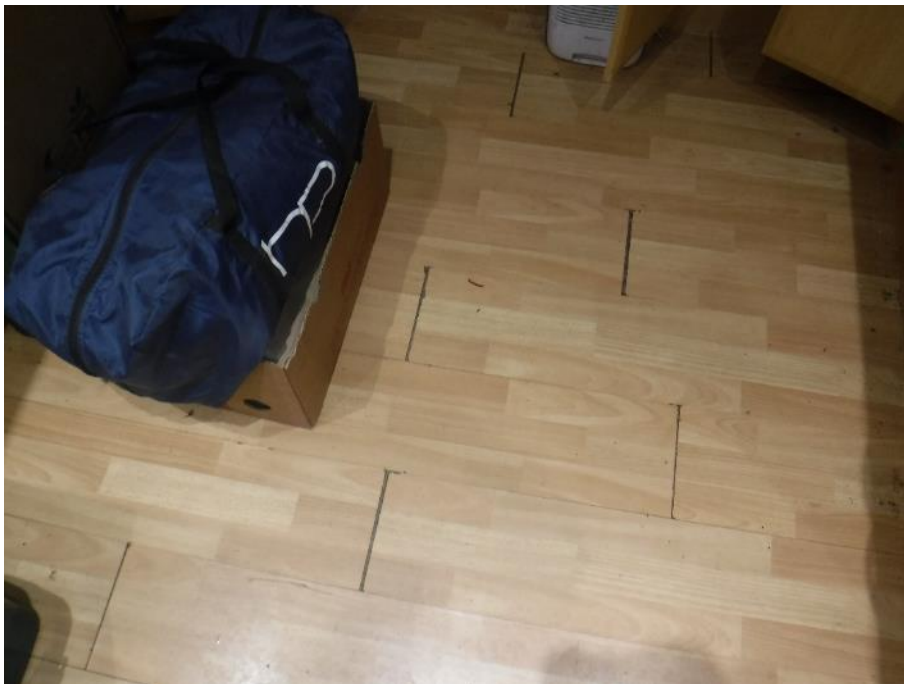
Photograph 60: Kitchen - the laminate flooring was degrading and would require replacement in the short-medium term
