BUILDING SURVEY REPORT

PROPERTY: Pencerrig St,
Pontypridd,
CF37 2HS

**SURVEY
DATE:** 02 June 2025

REF: TN0878

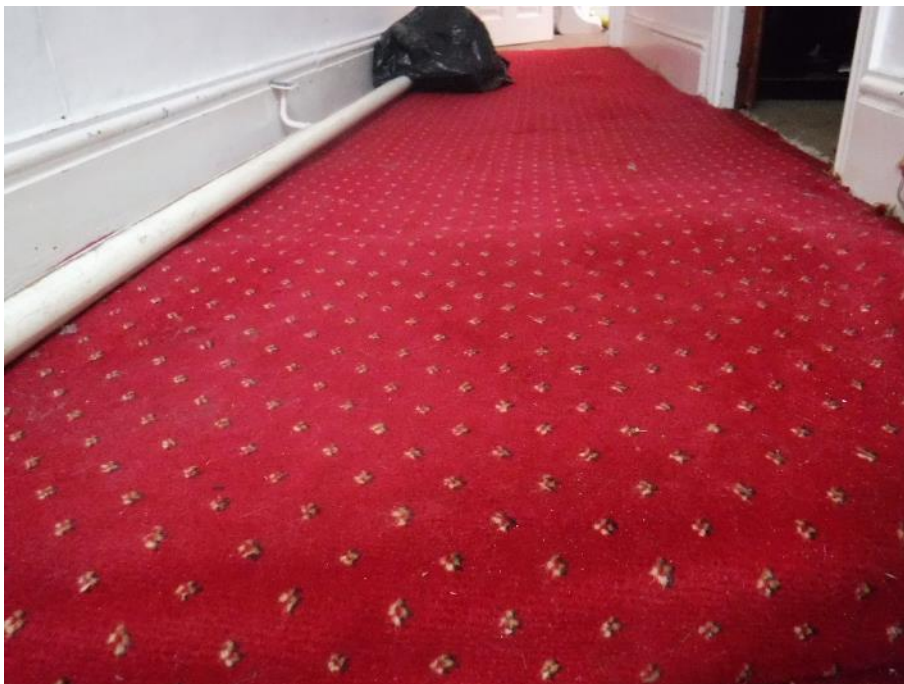
Photograph 62: Landing - repair noted to hallway landing. Presumed to be quick repair (wooden plank laid across broken floorboard instead of replacing the board)

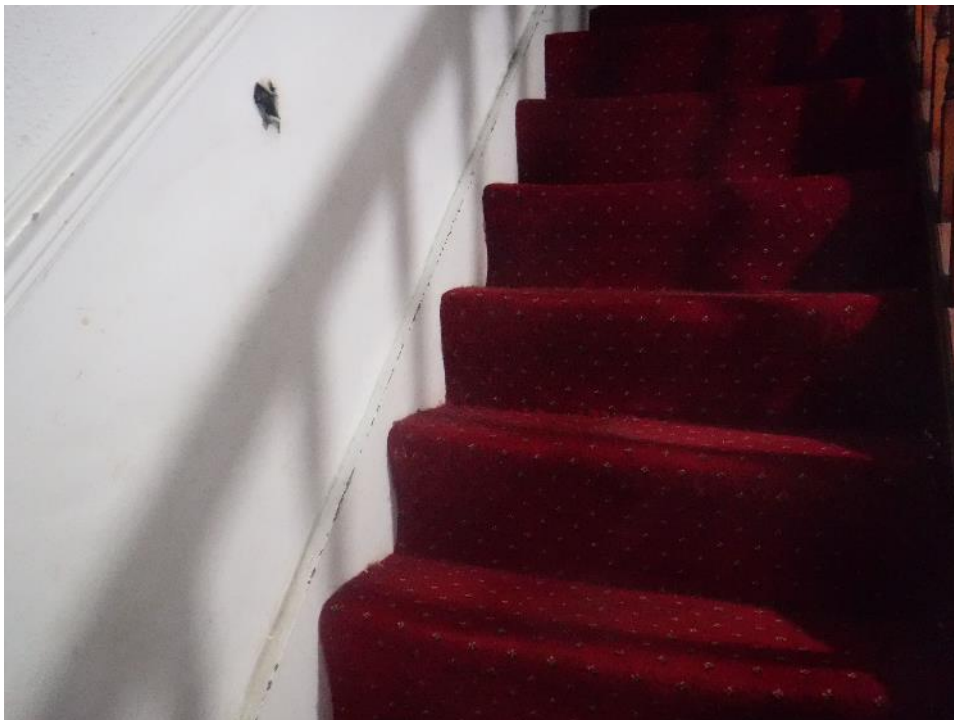
Photograph 68: View of staircase – note patch repair to wall (discussed previously)

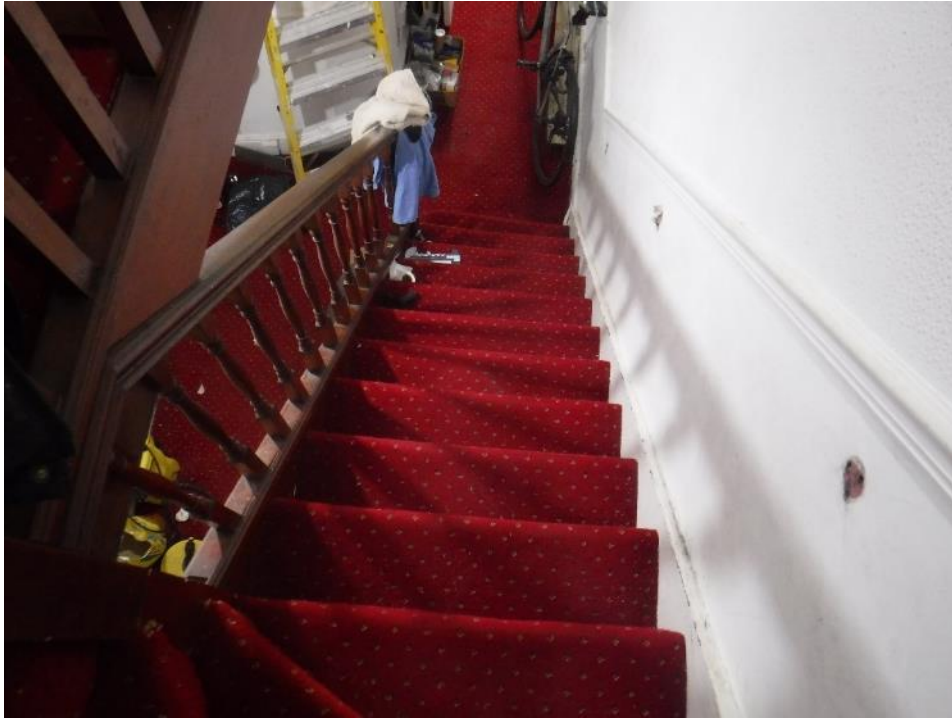
Photograph 69: The staircase was covered (restricting examination) however it was noted as level, no significant creaking on heel tests and the stringer was in good order (note patch repairs to wall)

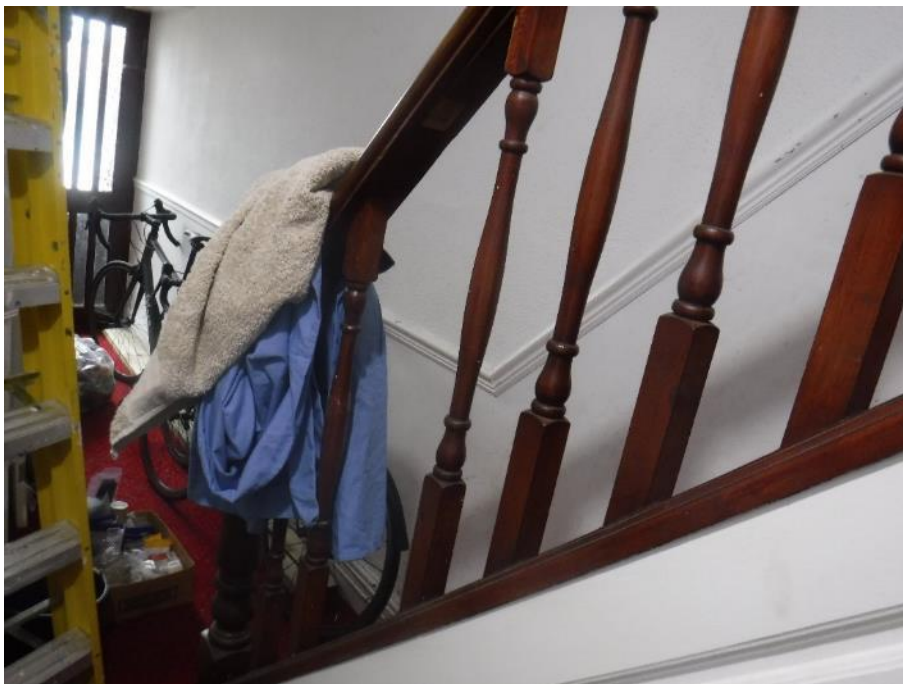
Photograph 70: Spindle missing to staircase (remainder of staircase in fair condition)

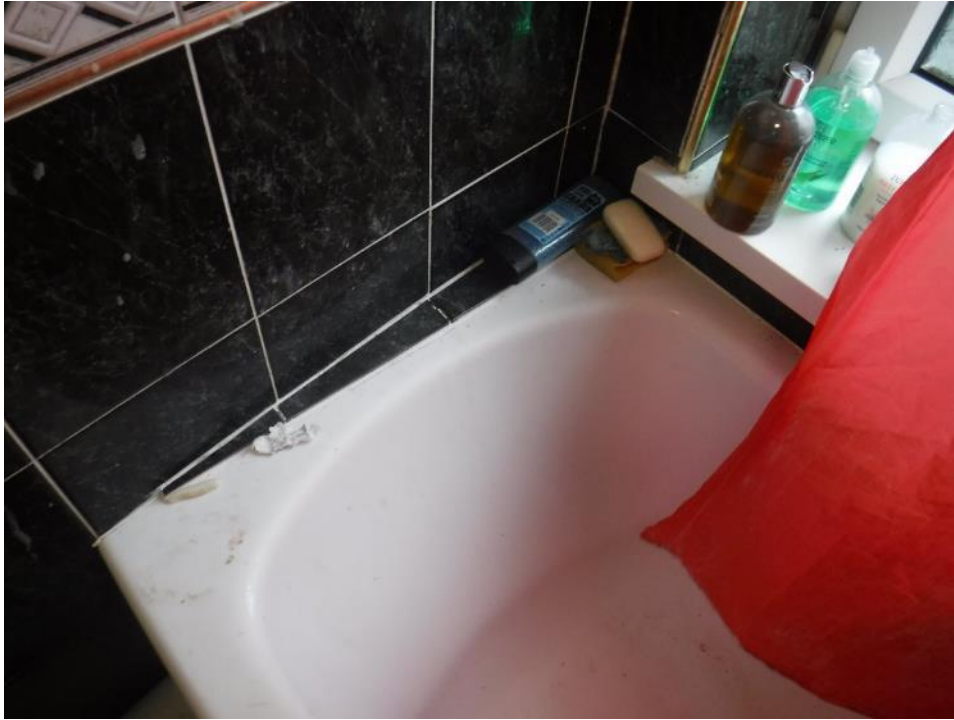
Photograph 71: Bathroom – sealant degraded

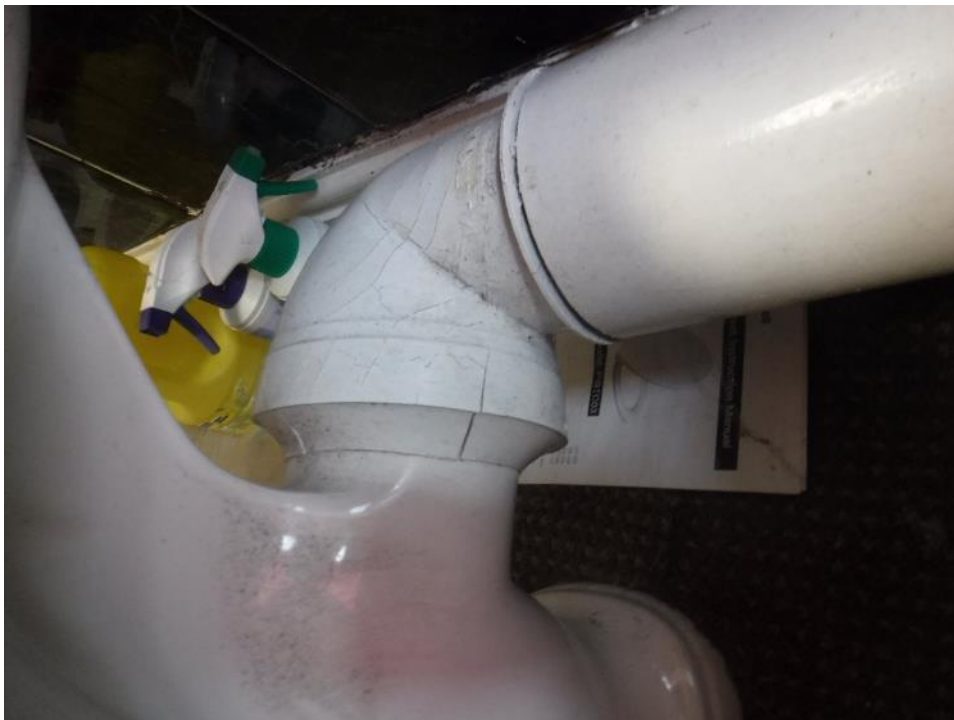
Photograph 72: Bathroom – crack in soil pipe collar

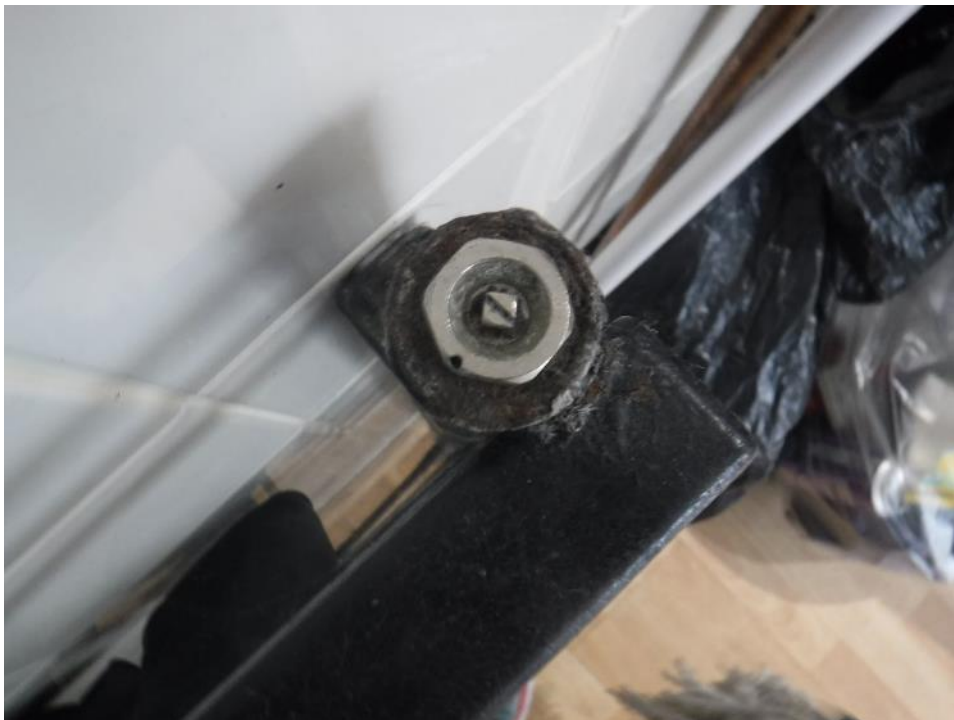
Photograph 74: Bathroom – corrosion to radiator
