BUILDING SURVEY REPORT

PROPERTY: Farmville Road,
Splott,
CF24 2JN

REF: TN_0602

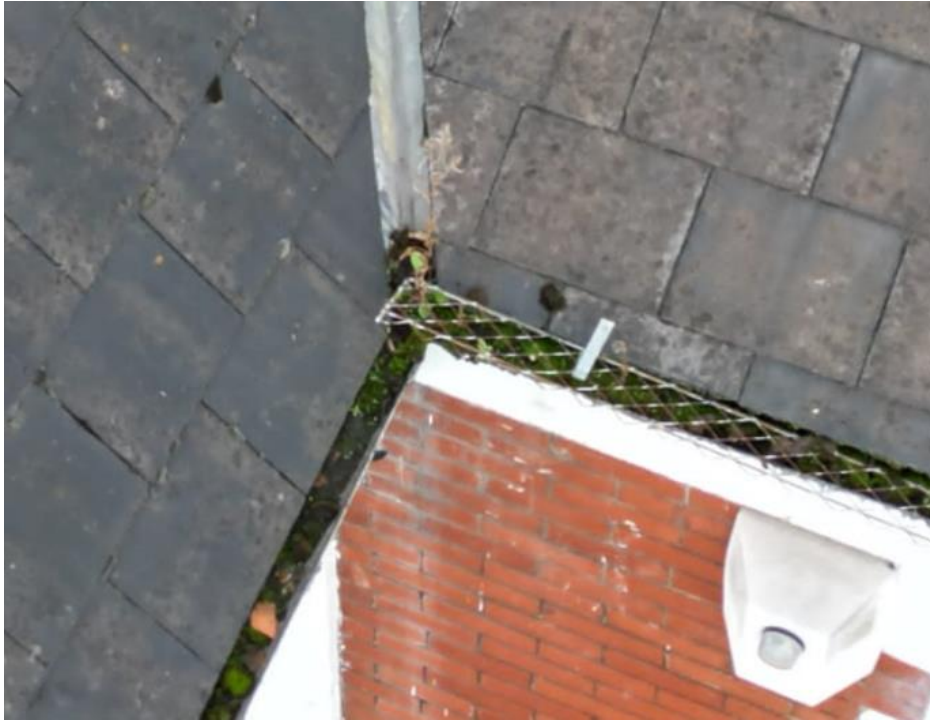
Photograph 9: Gutters – moss/blockages

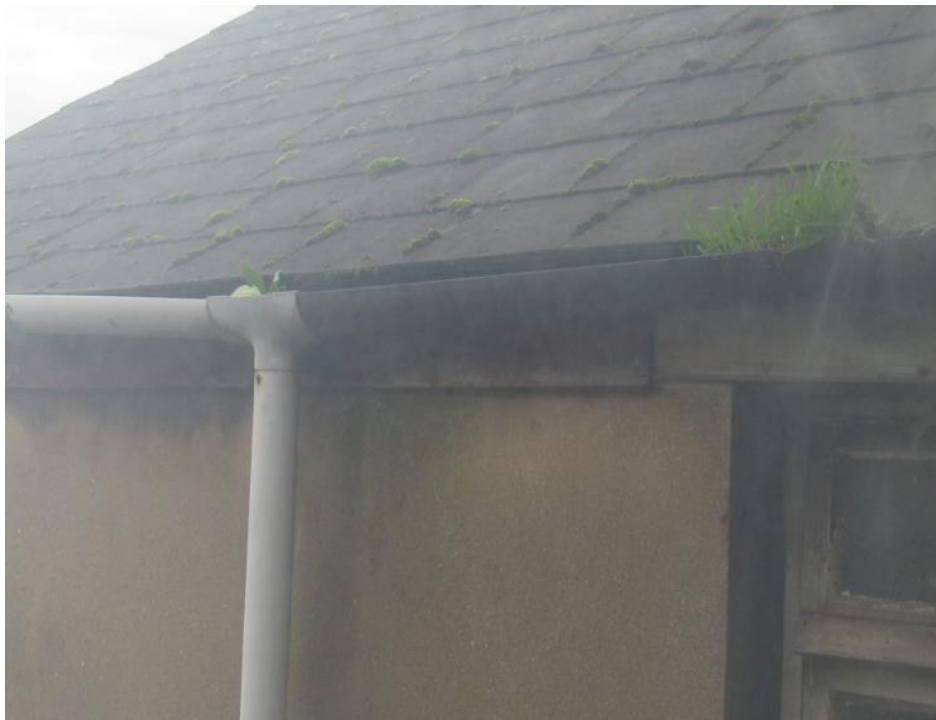
Photograph 10: Gutters – moss/blockages

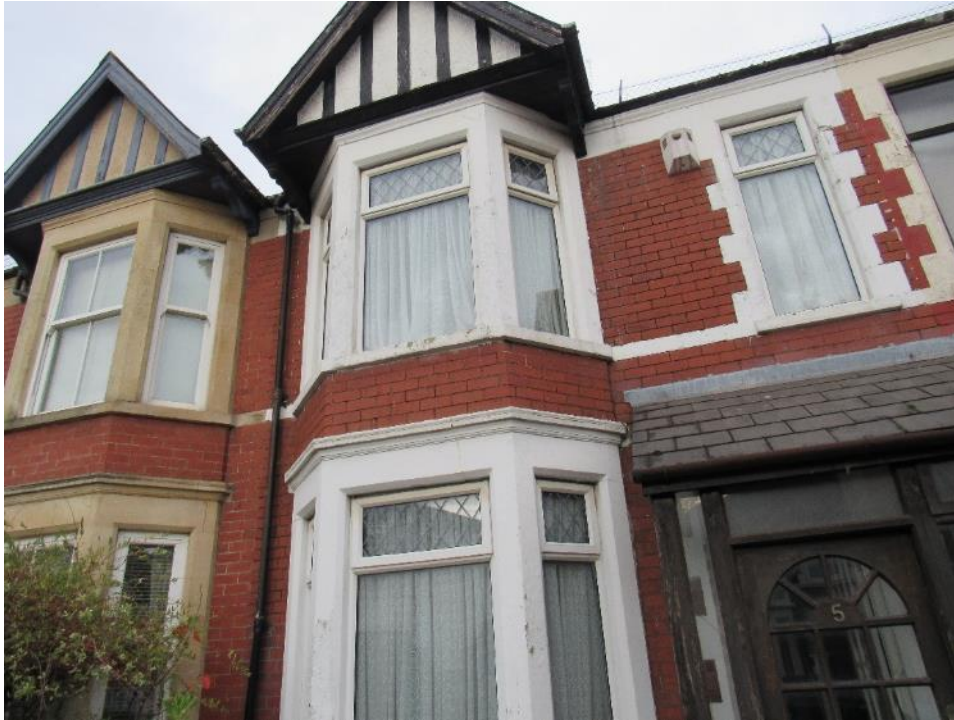
Photograph 17: Bay window - overview

The most likely remedial treatment would be providing restraint ties (helical bars) through the main walls into the jambs. Further helical bars providing lateral restraint through the joists and into the lintel.

Further to this either underpinning the main bay windows area or installing a number of Heli-piles which in turn tie into the brickwork at the foundation:

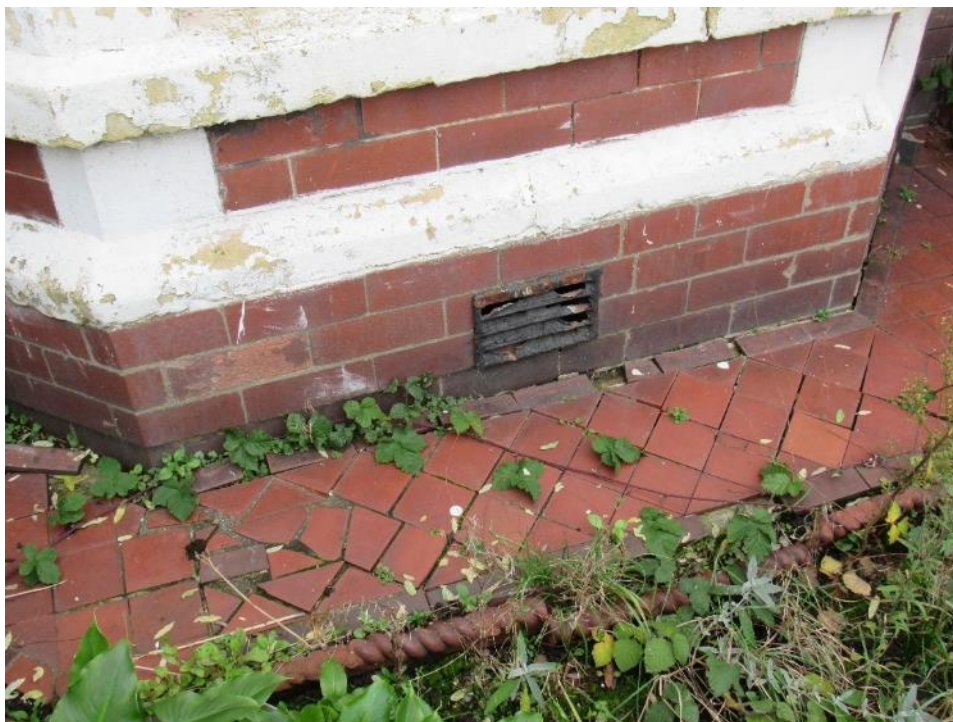
Photograph 20: Bay window – view of ground to bay

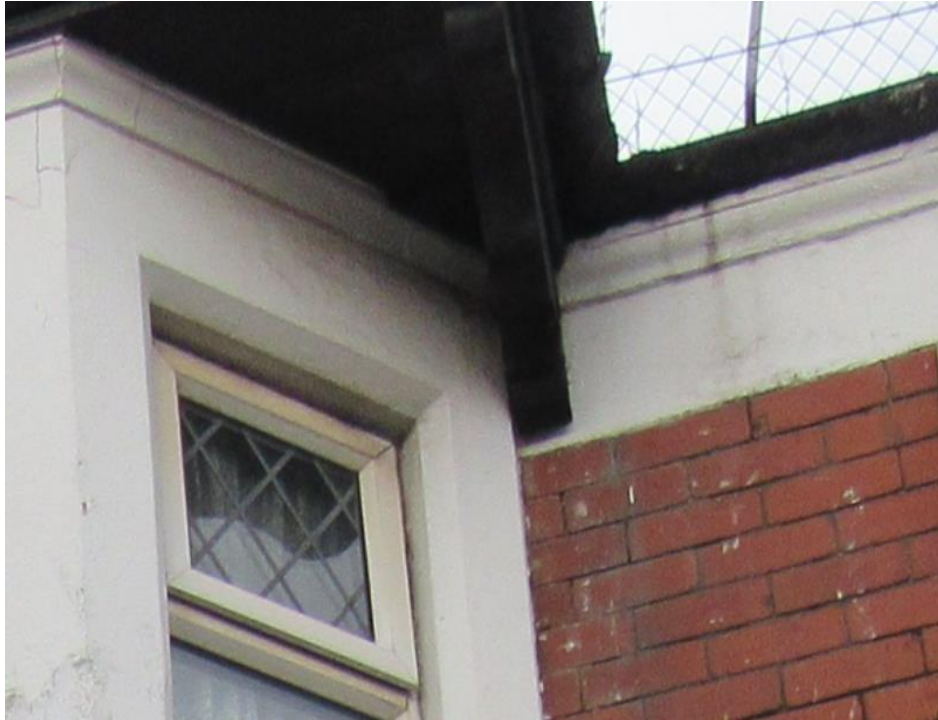
There is a corbel to the front elevation (by 30mm) which is believed to be detached and would require reattachment (**Photo.23**).

Photograph 23: External walls – corbel displaced (note shadow)

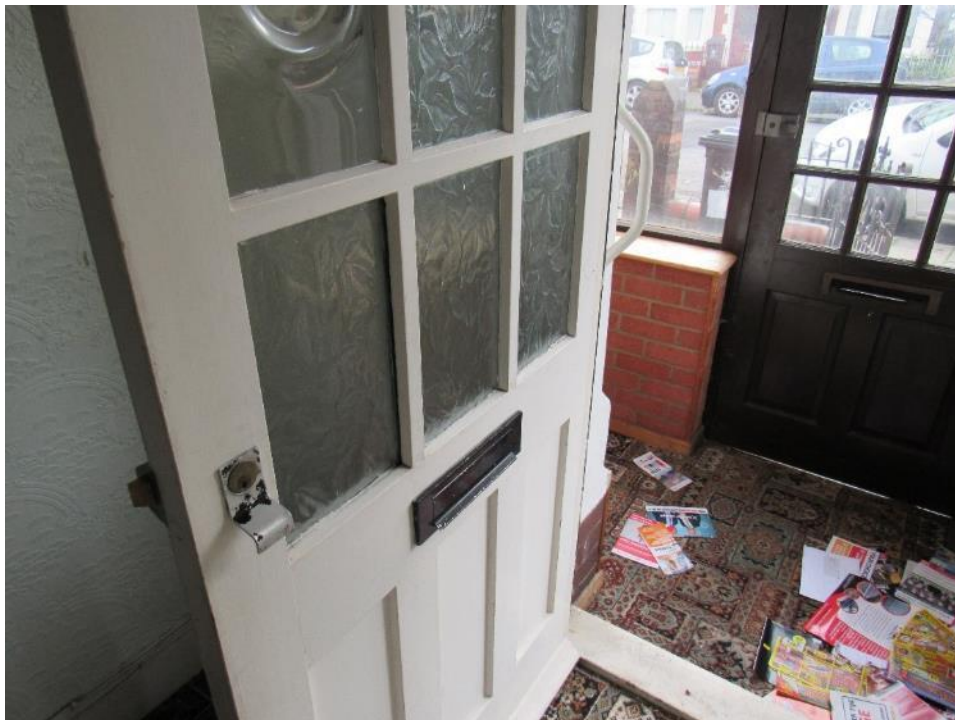
Photograph 32: Windows/doors – single pane door

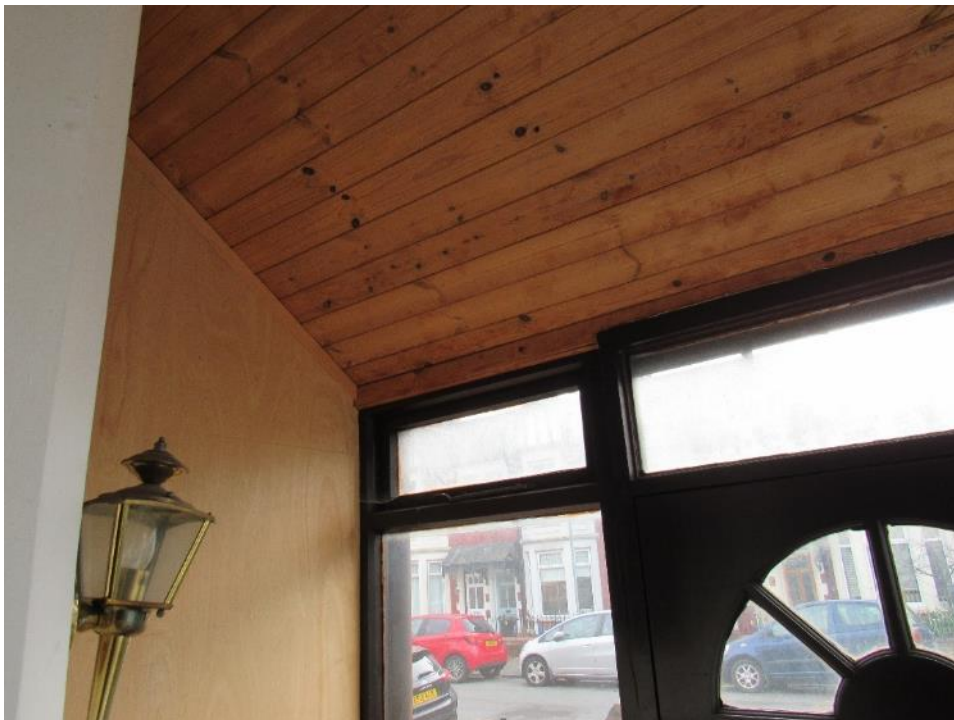
4.7 Conservatories and Porches	Condition Rating	2
Construction & Type and Limitations	There is an integral porch to the front of the property with a wooden/single pane door.		
Condition	<p>Poor condition (Photo.35) please see above comments about treating woodwork and considering replacement. There were no leaks to the inside noting suggesting the roof is in a fair condition (Photo.36).</p> <p>The flashing and guttering were found to be in satisfactory condition.</p>

Photograph 36: Porch – roof in fair condition

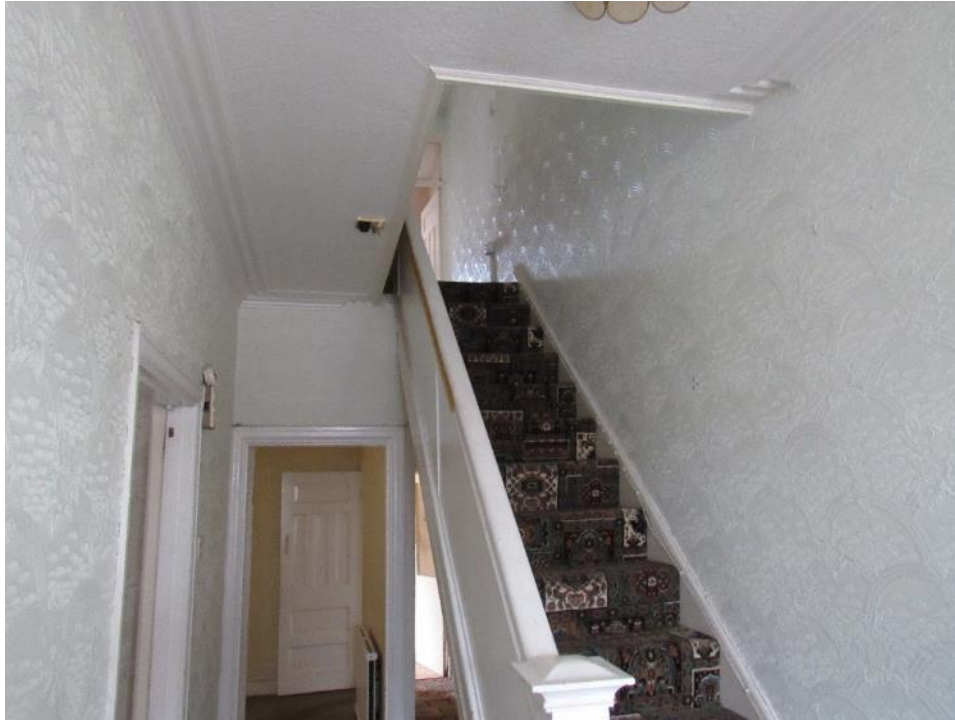
Photograph 43: Ceilings – textured ceiling to hallway

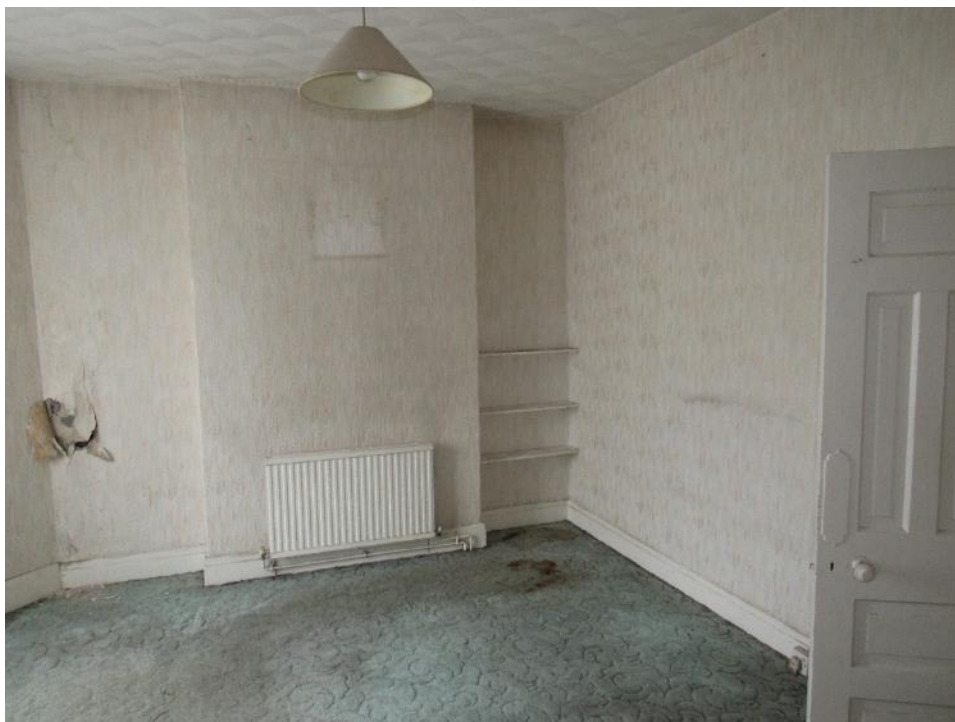
Condition	<p><i>Some of the internal walls were hidden by heavily textured paper and ceramic tiles</i></p> <p>Full update required (Photo.44-48) The interior of the property is in poor decorative condition, with wallpaper sloughing off the walls, particularly in areas prone to dampness or previous redecoration failures. Many surfaces show peeling paint, damaged plaster, and outdated finishes, indicating that the property has not been refurbished for some time. General wear and tear, combined with moisture issues, have contributed to wall coverings lifting and detaching, giving the interior a neglected and tired appearance. A full cosmetic update will be required to restore the property to a good modern standard. Please note – this is most likely beyond the scope for patch repairs, a full replastering will be required.</p> <p>Textured wallpaper may contain asbestos as noted previously. Beyond the wallpaper itself, there may be other asbestos-containing materials (ACMs) within the wall structure, such as plaster, Artex coatings, or adhesives. Testing should be carried out before any work begins to confirm whether asbestos is present. If found, professional removal will be required to ensure safety.</p> <p>Kitchen (Photo.49) A number of cracked tiles and isolated missing grout was noted. Overall, the kitchen requires an update.</p> <p>Damp readings High damp readings were taken throughout the property. The kitchen was tiled meaning no wall readings could be taken. Please see our incremental approach to damp section towards the end of this document for suggested remedial treatments.</p> <p>Black mould Small areas of black mould were noted to the interior of the property. Black mould is more commonly associated with internal moisture issues. This is most likely due to the house remaining uninhabited for a long period of time. Please consider a combination of air bricks, roof vents, extraction fans (bathroom and kitchen), trickle vents to windows, ensuring discharge from tumble driers is directed outside. Anything that may cause condensation to be directed outside.</p>

Photograph 44: Internal walls – master bedroom

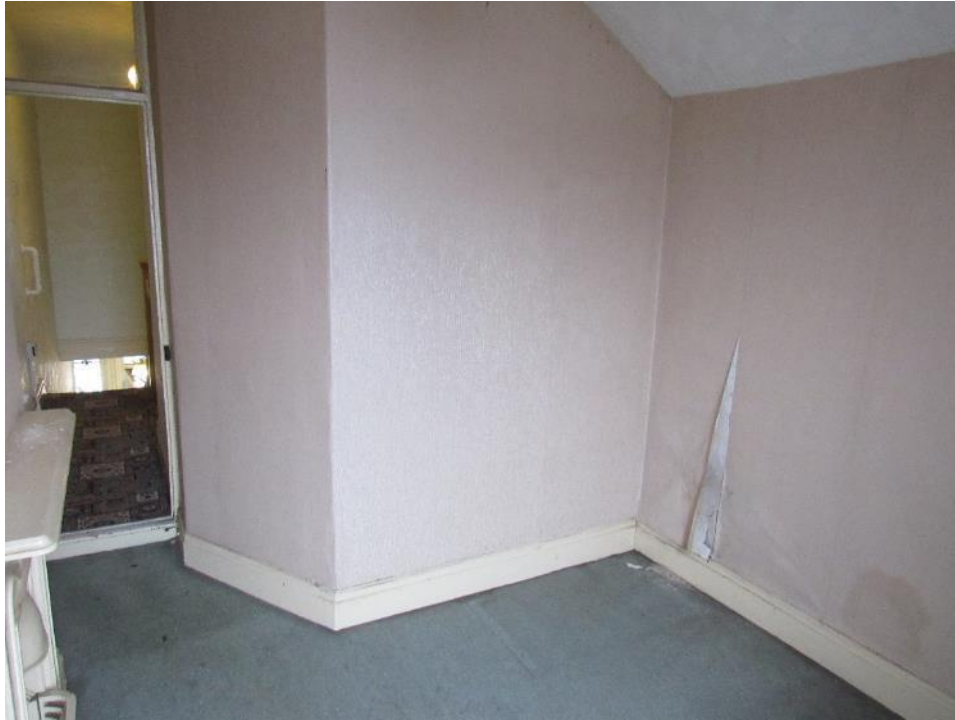
Photograph 45: Internal walls – third bedroom

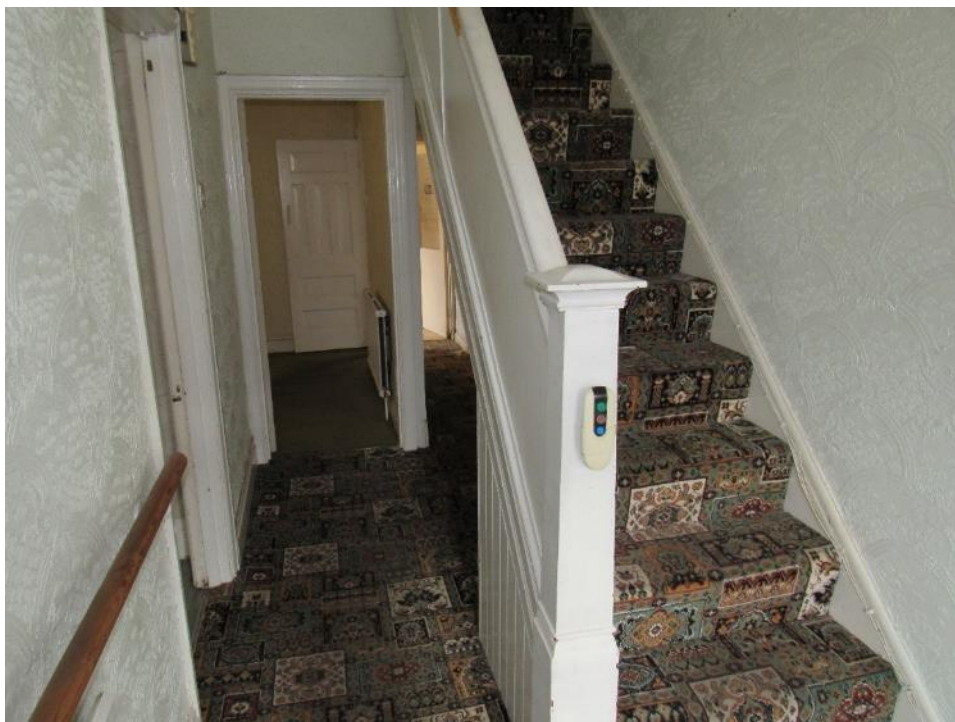
Photograph 46: Internal walls - hallway

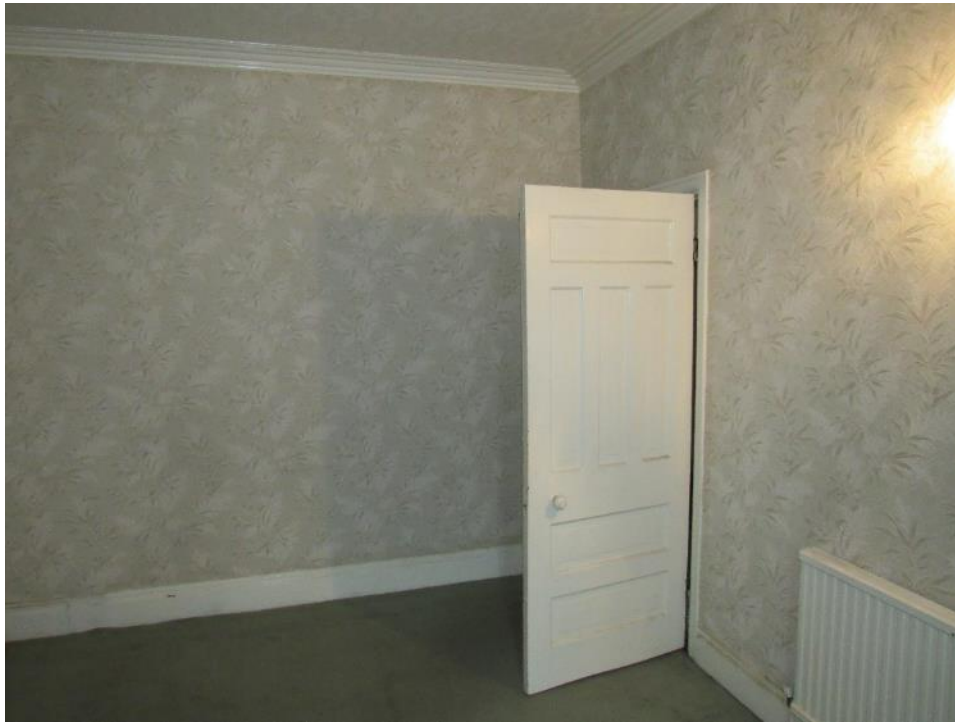
Photograph 47: Internal walls – second bedroom

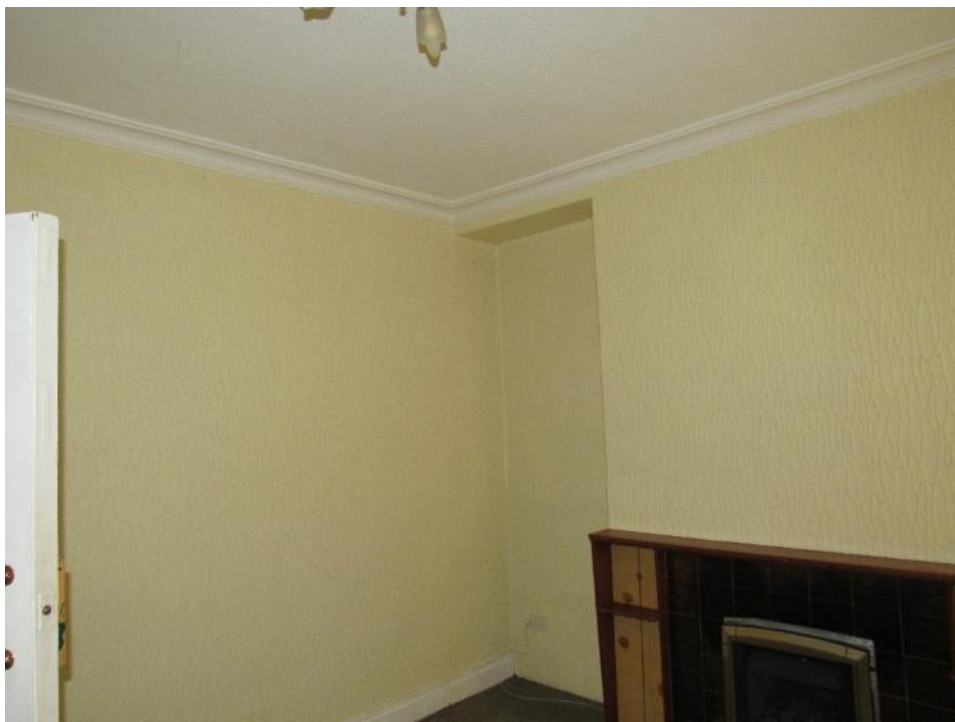
Photograph 48: Internal walls – dining room

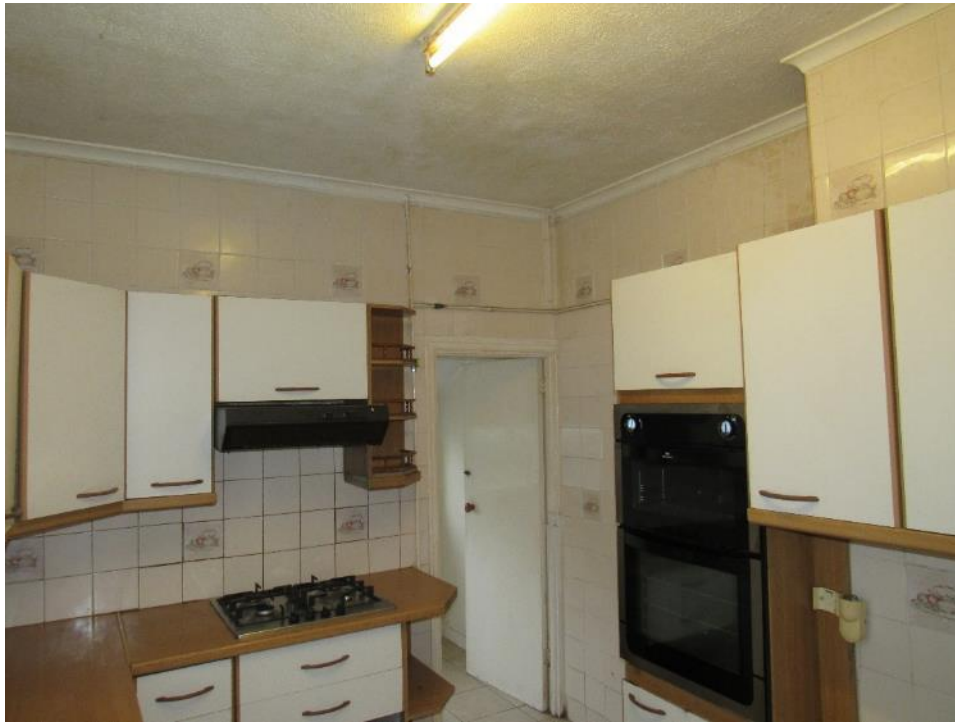
Photograph 49: Internal walls – kitchen

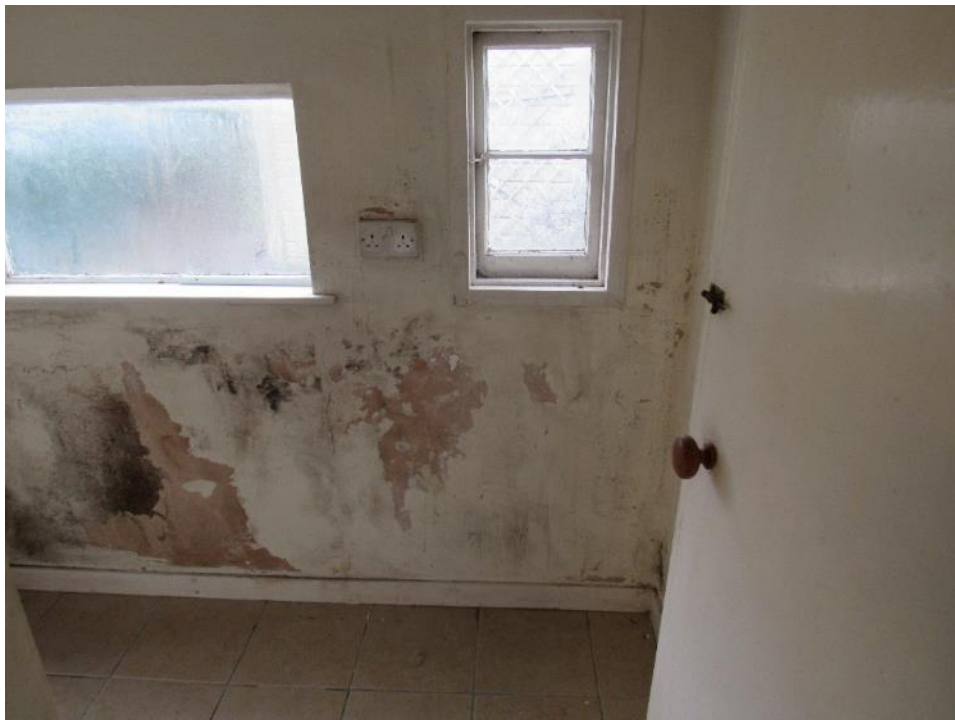
Photograph 50: Internal walls – downstairs toilet/utility room

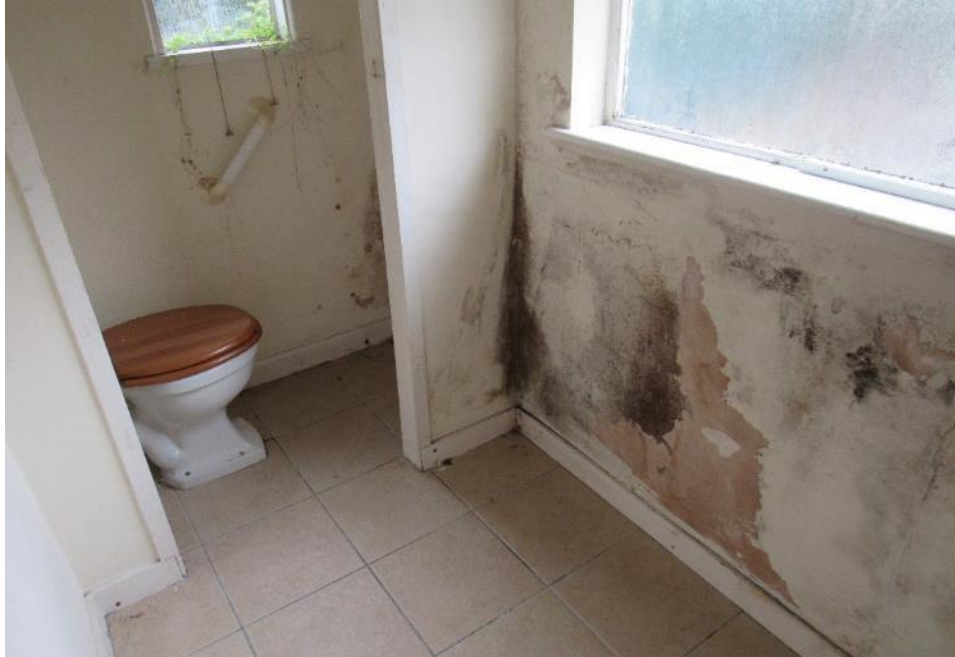
Photograph 51: Internal walls – downstairs toilet/utility room

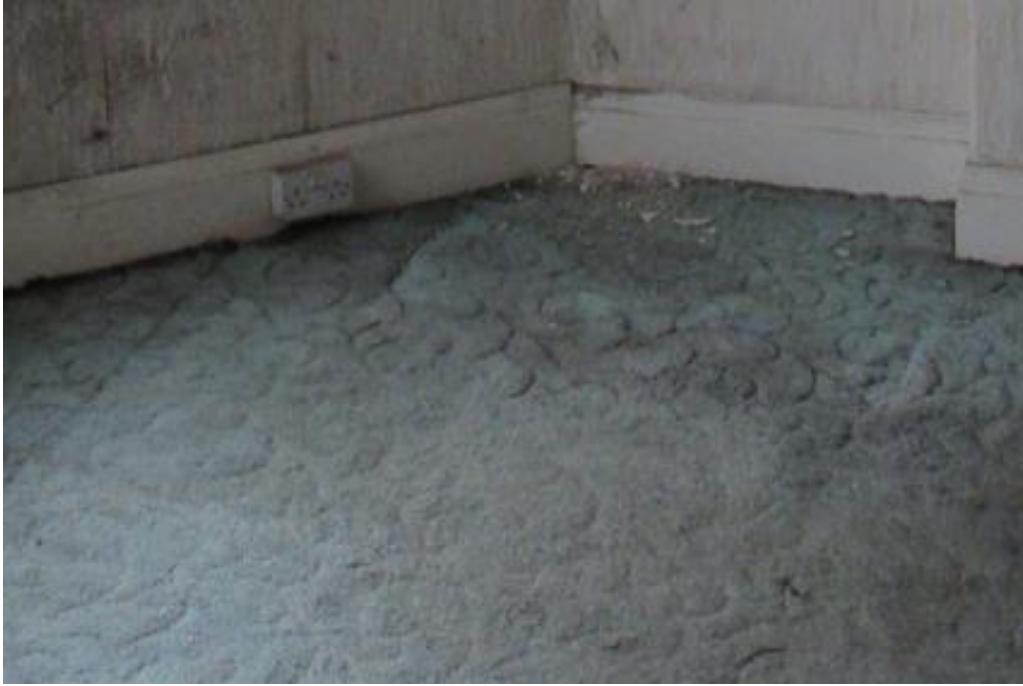
Photograph 53: Floors – master bedroom

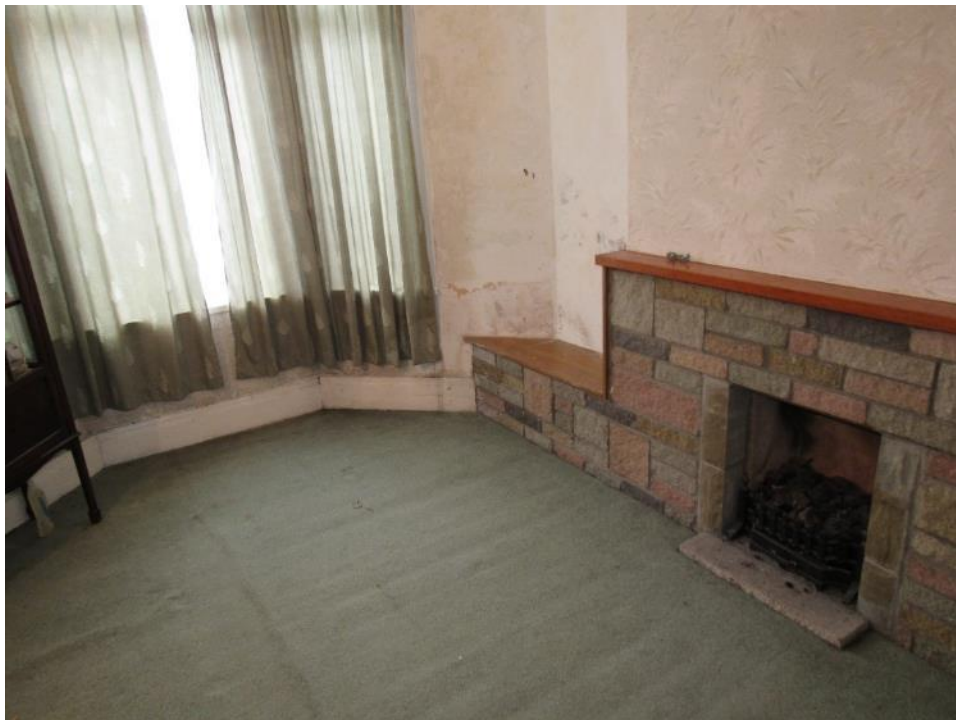
Photograph 54: Floors – sitting room

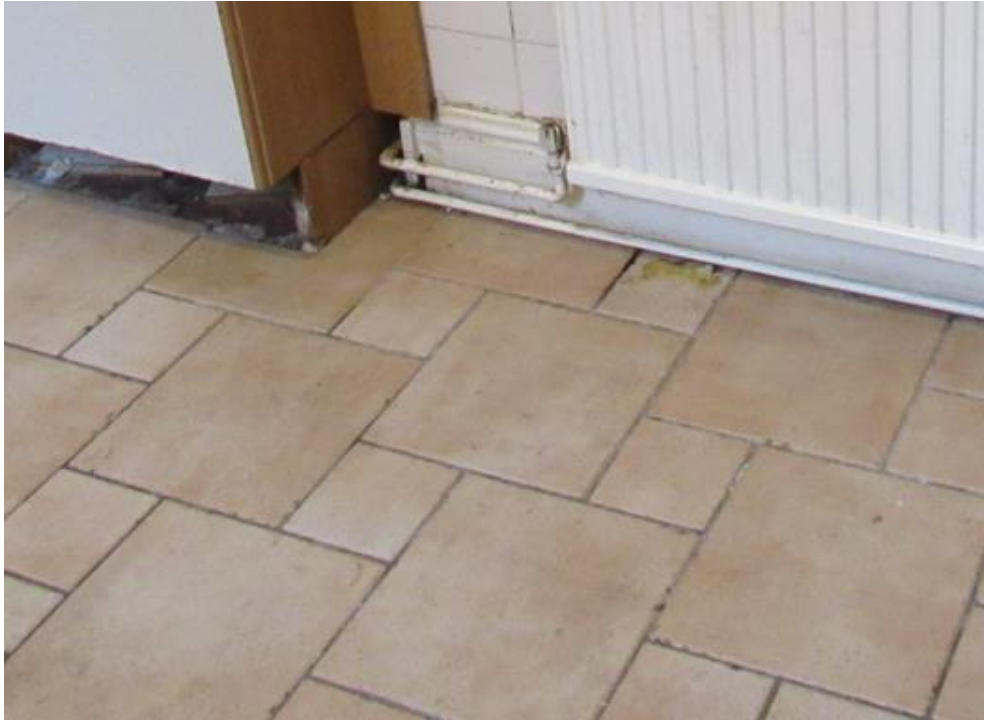
Photograph 55: Floors – kitchen

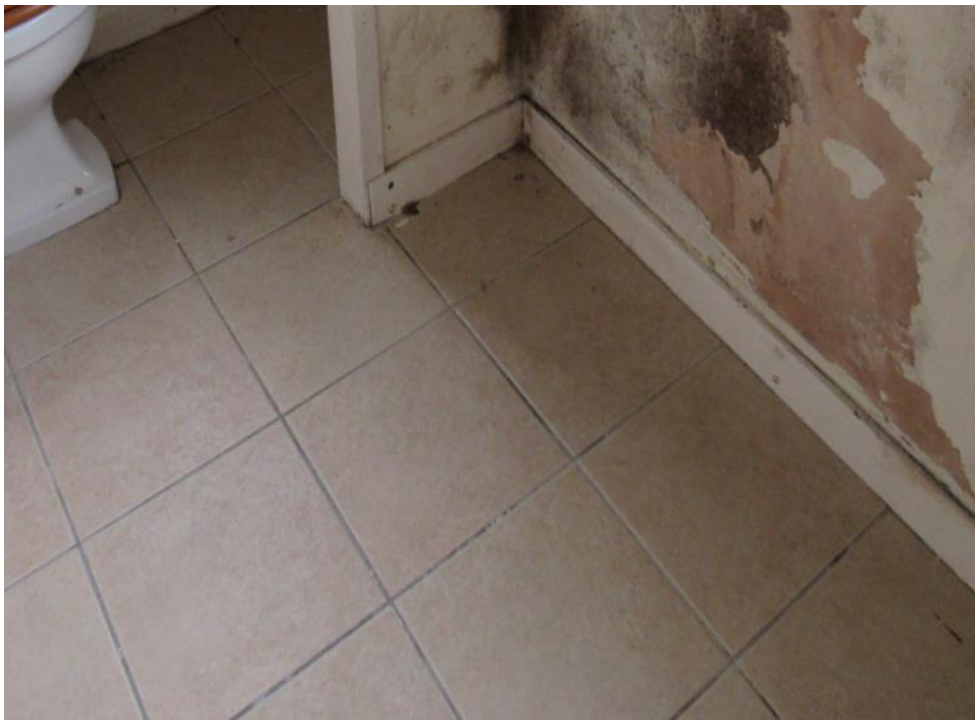
Photograph 56: Floors – utility room

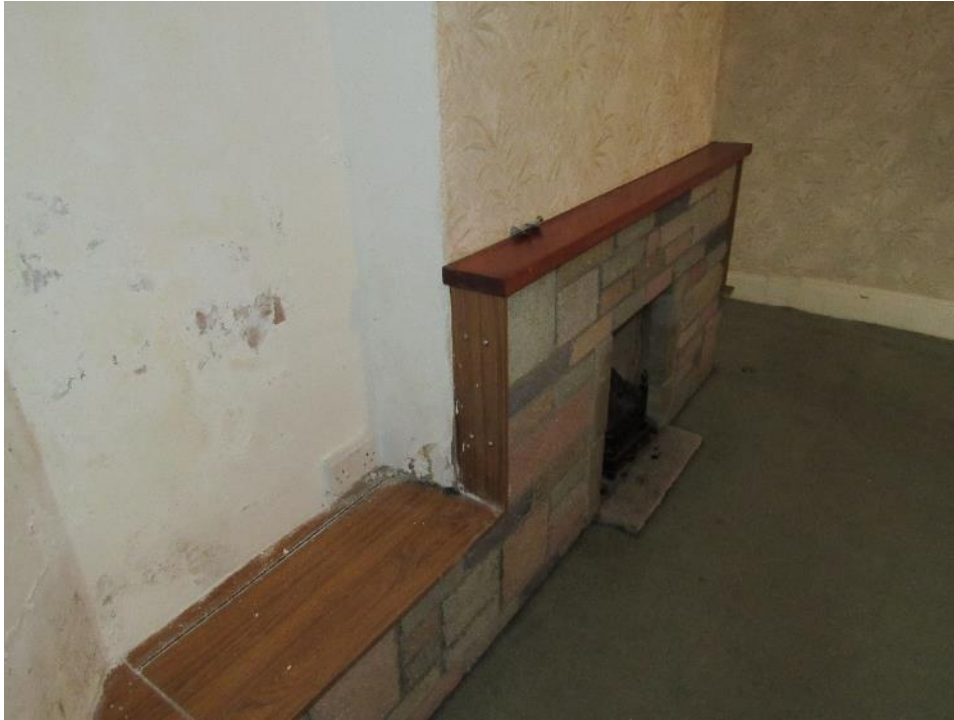
Photograph 57: Downstairs front chimney breast

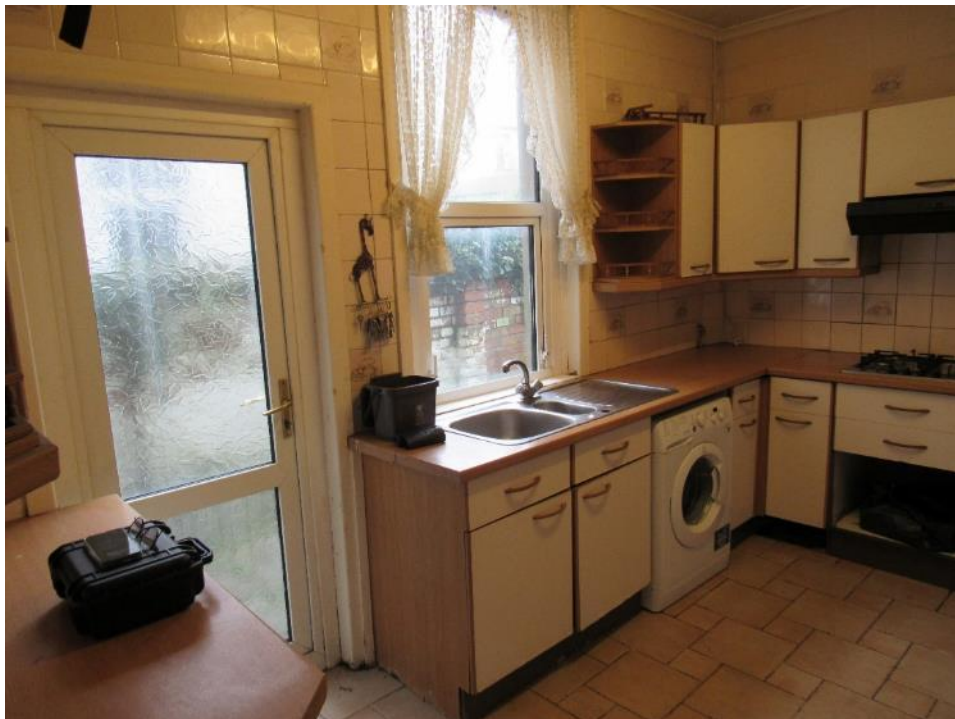
Photograph 60: Built in units – kitchen

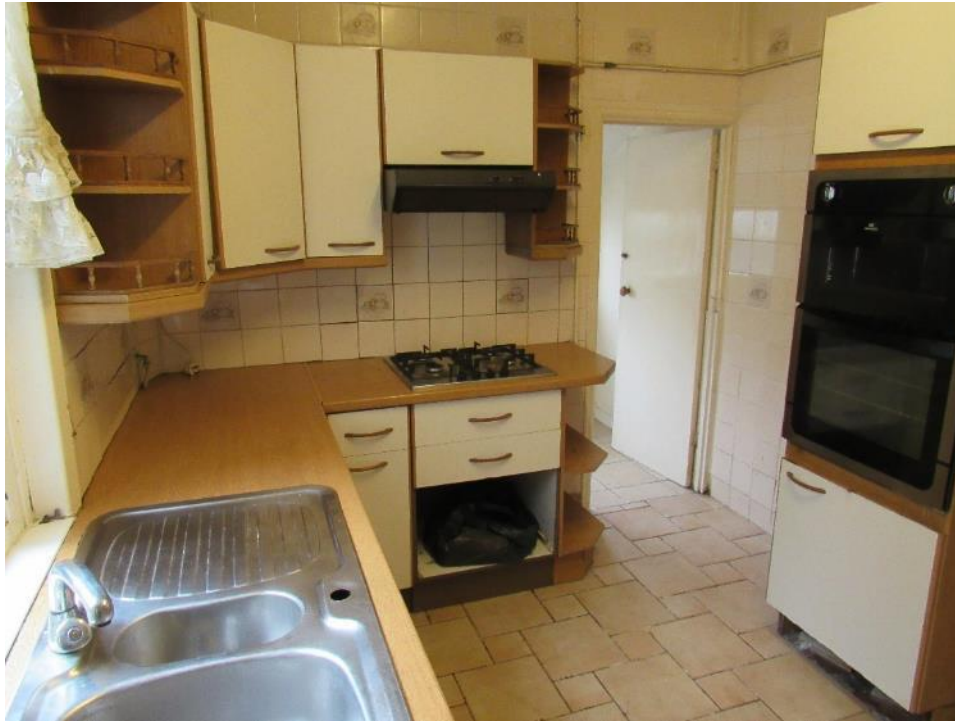
Photograph 61: Built in units – kitchen

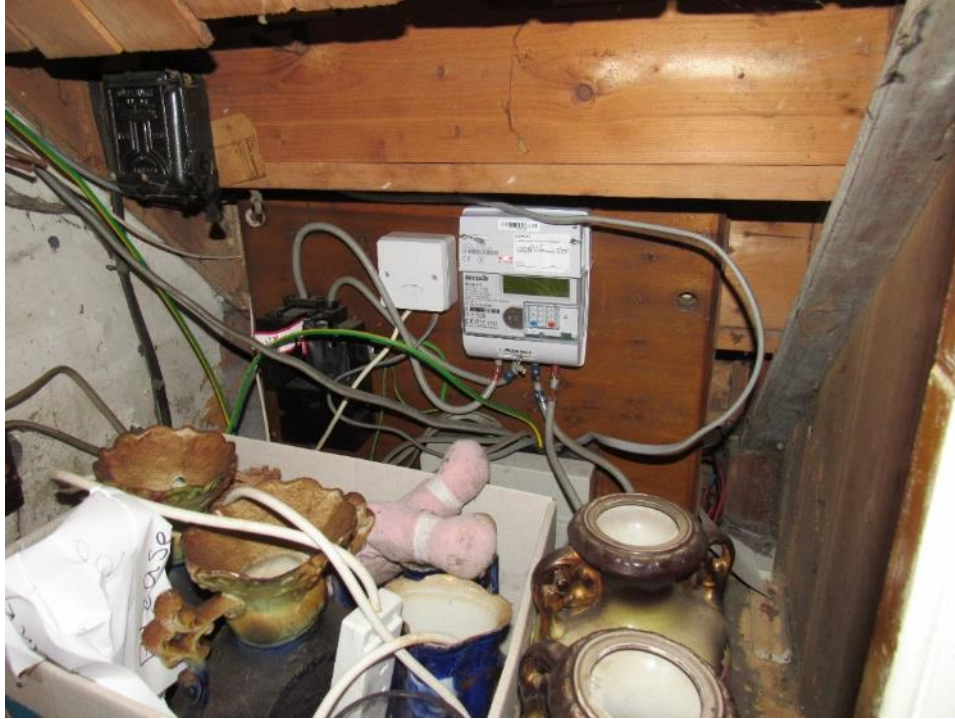
Section 6 – Services			
6.1 Electricity		Condition Rating	HS
Construction & Type and Limitations	<p><i>There is a mains electrical supply and the meter and consumer unit (fuse box) are located under the stairs. An EICR is also recommended in all domestic homes every 10 years or upon change of occupancy to check the condition of the electrical installation and ensure there is no deterioration. This report should cover all the fixed wiring and equipment within the property boundaries, including outbuildings.</i></p>		
Condition	<p>No Electrical Installation Condition Report (EICR) certificate noted (Photo.67) It is recommended that you get an Electrical Installation Condition Report (EICR) carried out in a domestic property every ten years. The EICR identifies potential hazards, outdated wiring, and safety concerns, such as lack of earthing, deteriorated cables, or overloaded circuits. In rental properties, an EICR is legally required every five years, and failure to comply can result in fines. A qualified electrician should be consulted to carry out an EICR and recommend necessary upgrades to ensure compliance and safety. Your conveyancer will be able to assist in this.</p> <p>Equipotential bonding was noted around the house, which would be a more modern addition.</p> <p>Outdated consumer unit (Photo.68) The property has a legacy consumer unit (fuse board) installed, it may not comply with current UK wiring regulations (BS 7671, 18th Edition), particularly regarding Residual Current Device (RCD) protection. Modern consumer units use MCBs (Miniature Circuit Breakers) and RCBOs (Residual Current Breaker with Overcurrent protection) to provide better safety against electric shocks and fire hazards. The latest units are also designed with fire-resistant enclosures, usually made of metal, to reduce the risk of electrical fires spreading.</p> <p>We would recommend that the house receive an Electrical Installation Condition Reports and suspect either a full rewire or a consumer unit replacement may be required.</p> <p>Red and black wiring noted The presence of red and black twin and earth wiring indicates that the electrical installation predates the wiring regulation changes that were introduced between 2004 and 2006 in the UK. This suggests that the electrical system may be outdated and potentially in need of a rewire to comply with current standards. It is recommended that your conveyancer makes further inquiries and, if necessary, arranges for an EICR to assess the safety and condition of the installation.</p>

Photograph 67: Electrical – meter under the stairs

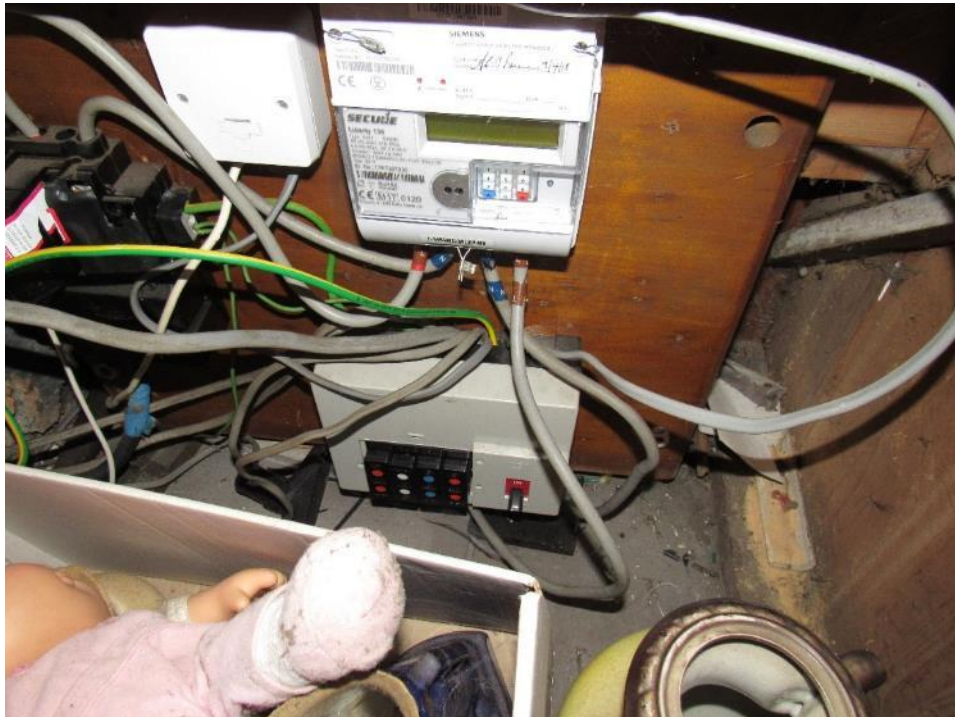
Photograph 68: Electrical – consumer unit (fuse board) under the stairs

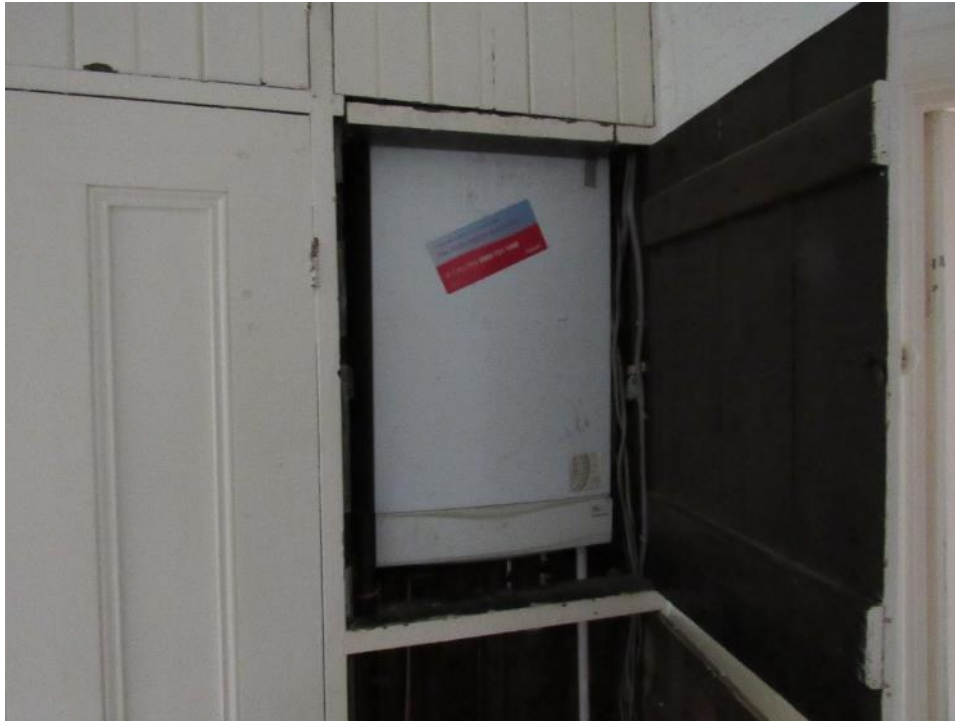
6.4 Heating & Cooling	Condition Rating	HS
Construction & Type and Limitations	<p>Central heating and domestic hot water are provided by the gas fired boiler (Photo.69). Given the age of the appliance I have assumed that the boiler was serviced recently and regularly. It is connected to hot water radiators. Your Legal Advisers will inquire about the boiler service records and obtain copies of these prior to exchange of contracts.</p> <p><u>Gas Safe recommends that all gas appliances and boilers are inspected and serviced according to manufacturer's guidance, but at least once a year. A gas installation can look to be in a safe condition, but serious defects may be hidden, some of which can kill. It is therefore considered to be essential that you commission an inspection of the gas/heating installation prior to purchase of the property.</u></p>		
Condition	<p>Container below boiler There was a bucket located under the boiler (Photo.70), although the central heating was off this would still be suggestive of active leaks to the boiler. Please raise this with your vendor for clarification.</p> <p>Radiators (Photo. 71) The radiators were observed to be in fair condition. There was no evidence of any active leaks on the pipework's or areas surrounding the radiators, except for the bathroom radiator (discussed below). Please note the radiators were rather small for a property of this size, typically larger radiators will deliver a greater BTU output.</p> <p>Inhibitor Please note: the most common cause of corrosion in your radiator system is sludge, a black, mud-like substance which if untreated, will build up over time. From the inside of your radiators, it will cause rust which ends up eating tiny holes in the radiator resulting in leaks.</p> <p>Typically, it is recommended to flush the system every 6 years.</p> <p>An inhibitor is a chemical solution that prevents corrosion and limescale formation in central heating systems and provides protection against microbiological contamination and installation debris. Heating systems will require an inhibitor adding typically every year for extra protection. Although it will not prevent corrosion happening completely, it will certainly slow it down.</p> <p>You could also install a magnetic filter. Any iron oxide that develops in the system will be attracted to the magnet. After the filter is fixed, water will flow through it and any iron oxide crystals that have begun to form will be collected in it before they have a chance to do any harm.</p>

Photograph 69: Boiler – downstairs kitchen

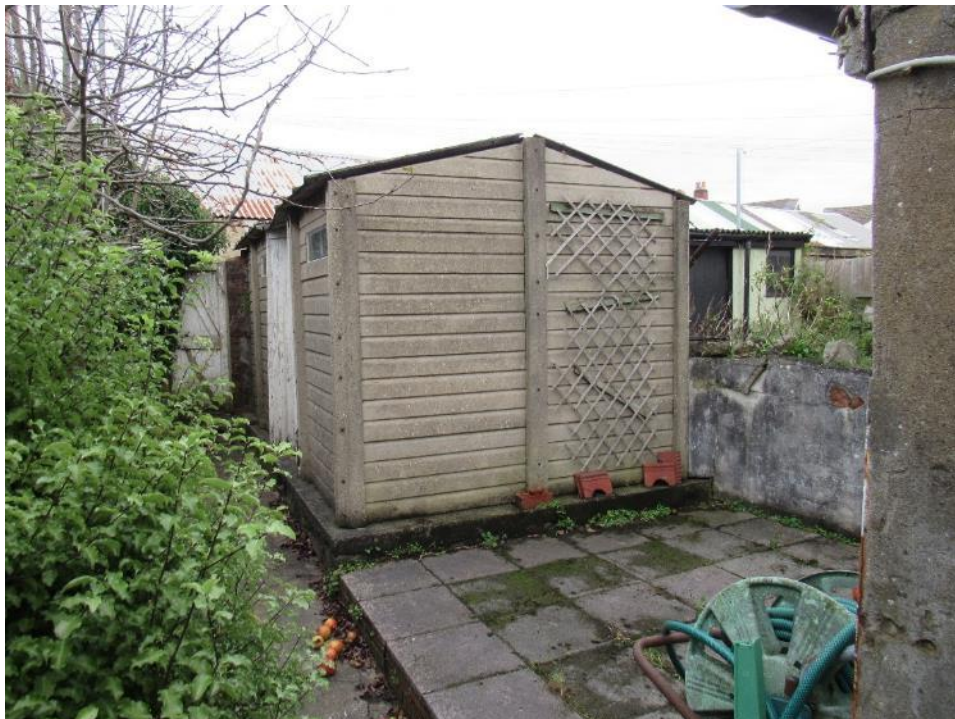
Photograph 72: Outbuildings – shed overview

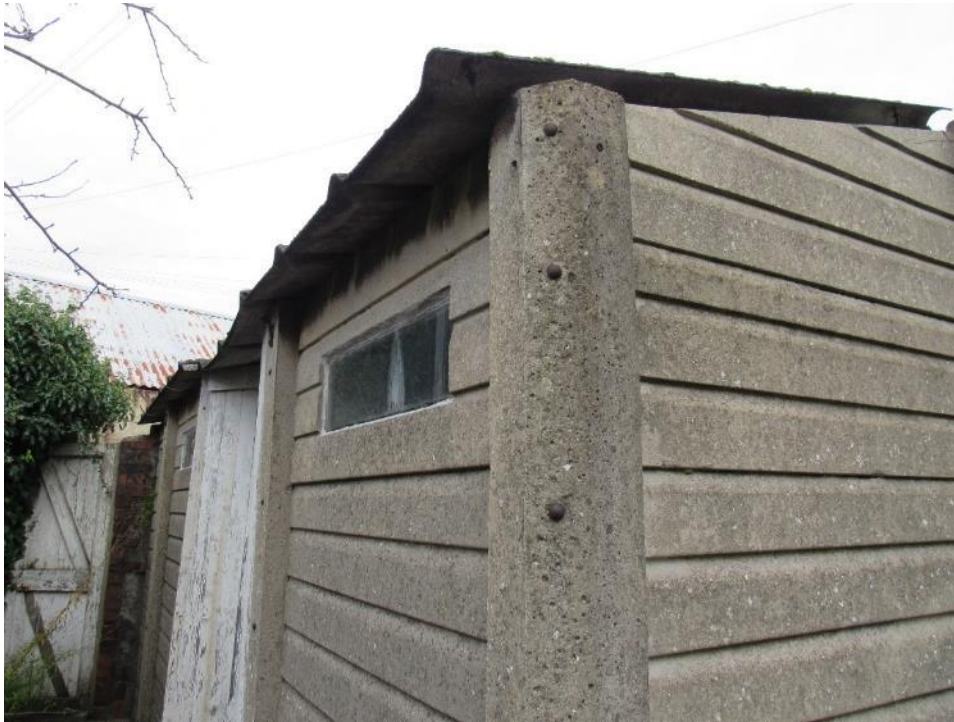
Photograph 73: Outbuildings - shed

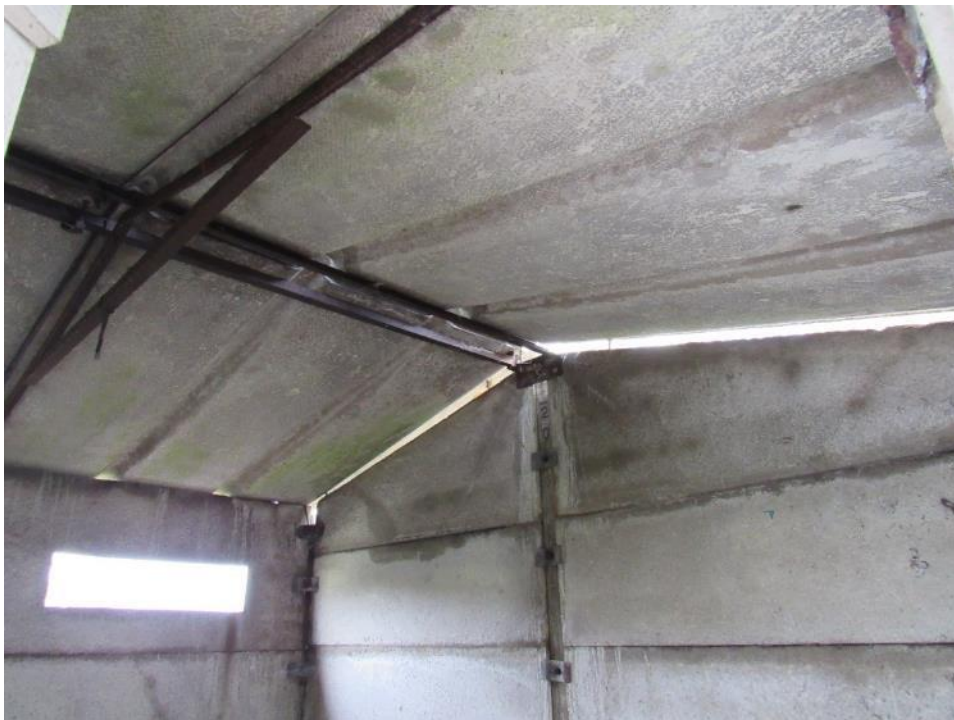
Photograph 74: Outbuildings – shed roof
