BUILDING SURVEY REPORT

PROPERTY: Farmville Road,
Splott,
CF24 2JN

REF: TN_0602

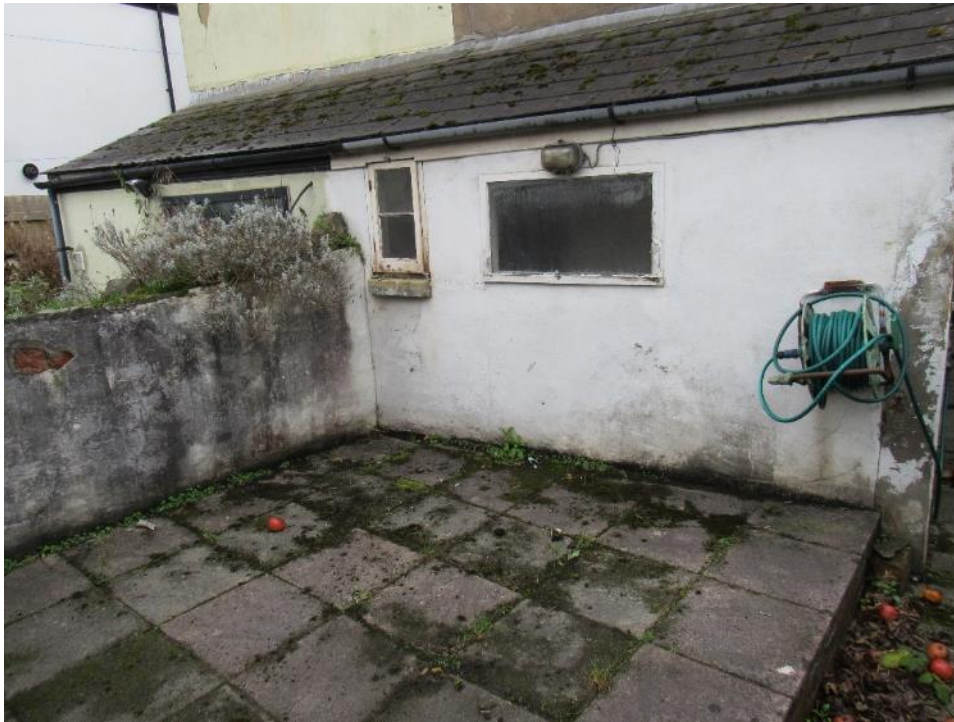
Photograph 75: Garden – rear patio

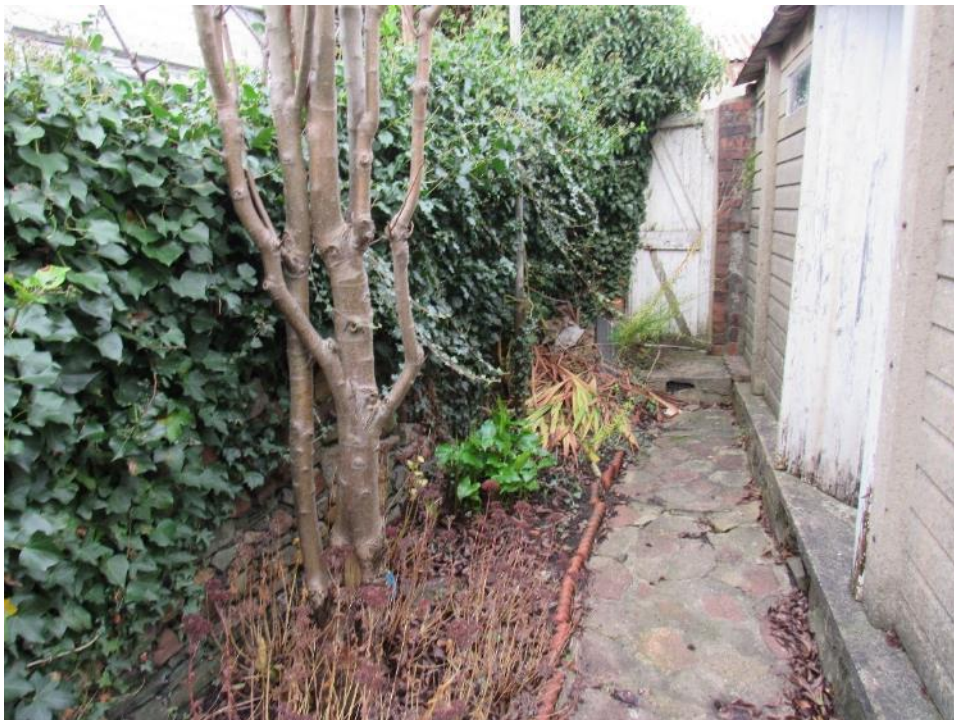
Photograph 76: Garden – further view
