# BUILDING SURVEY REPORT

**PROPERTY:** Blanche Street,  
Splott,  
CF24 1QS

**SURVEY  
DATE:** 30 May 2025

**REF:** TN\_0691

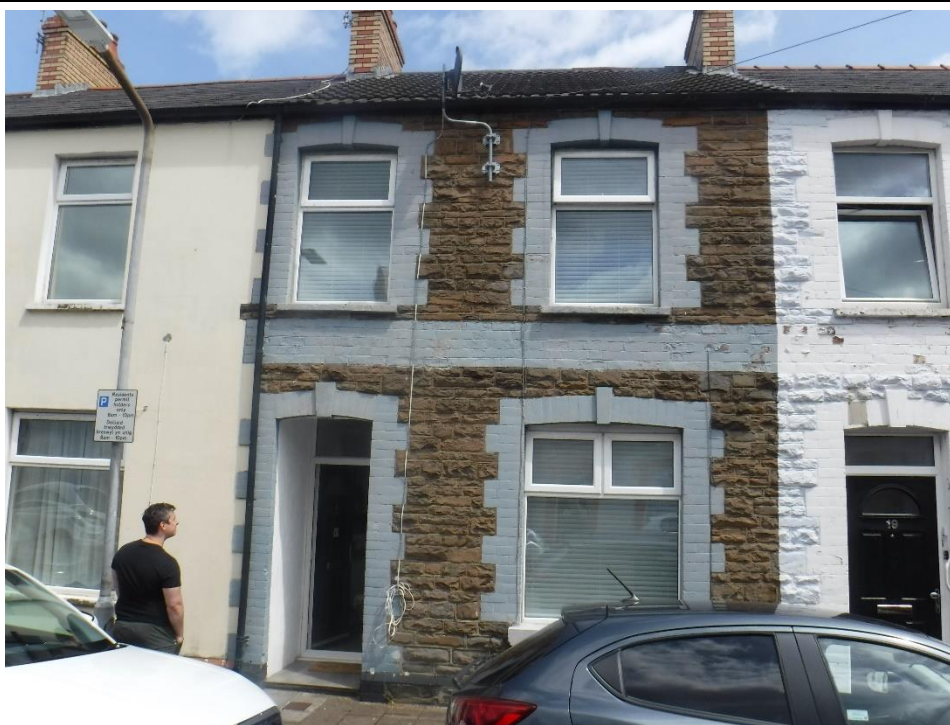
**General Photograph 1:** Front elevation

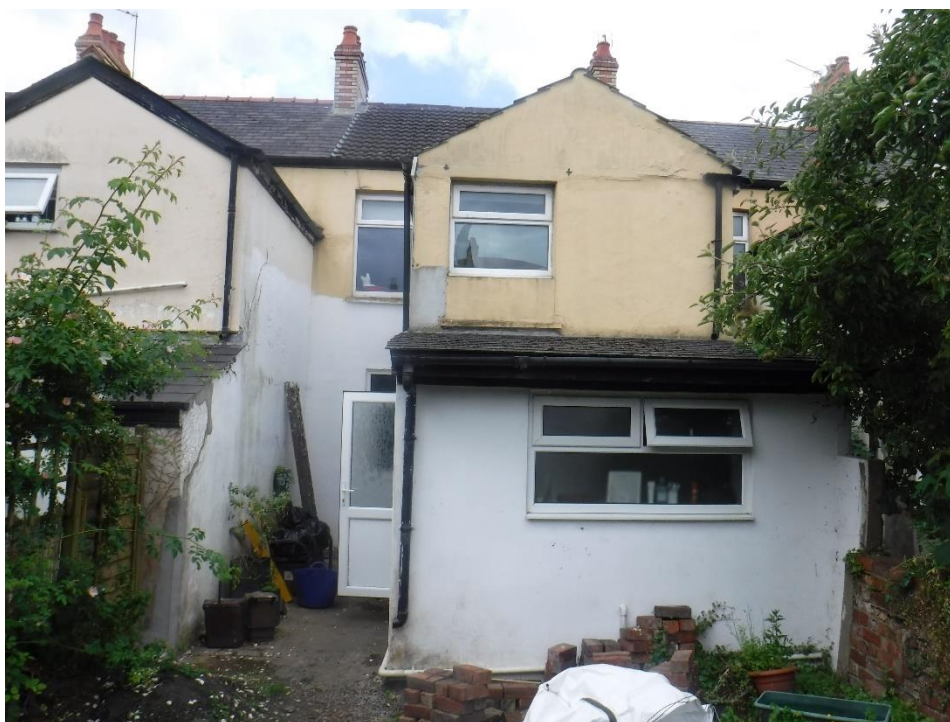
**General Photograph 2:** Rear elevation

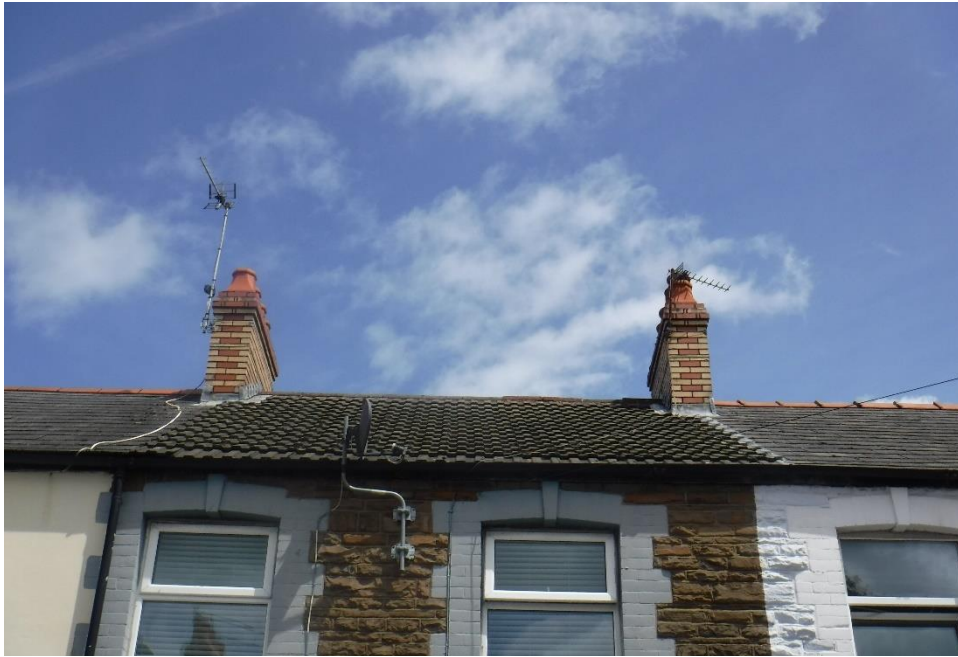
**Photograph 5:** Roof - overview

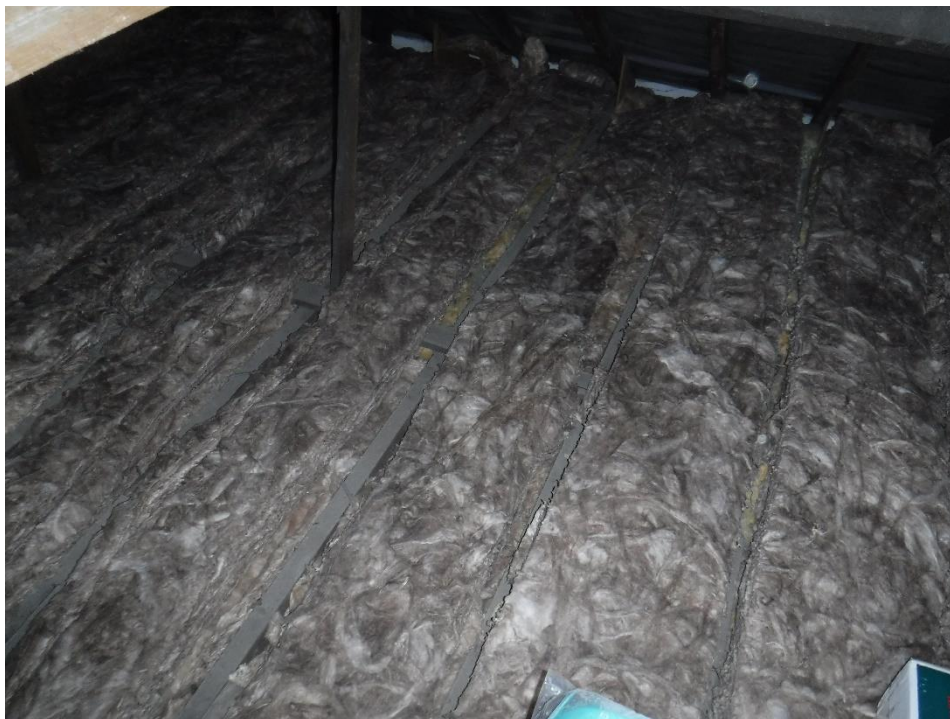
**Photograph 21:** Roof space - Insulation view

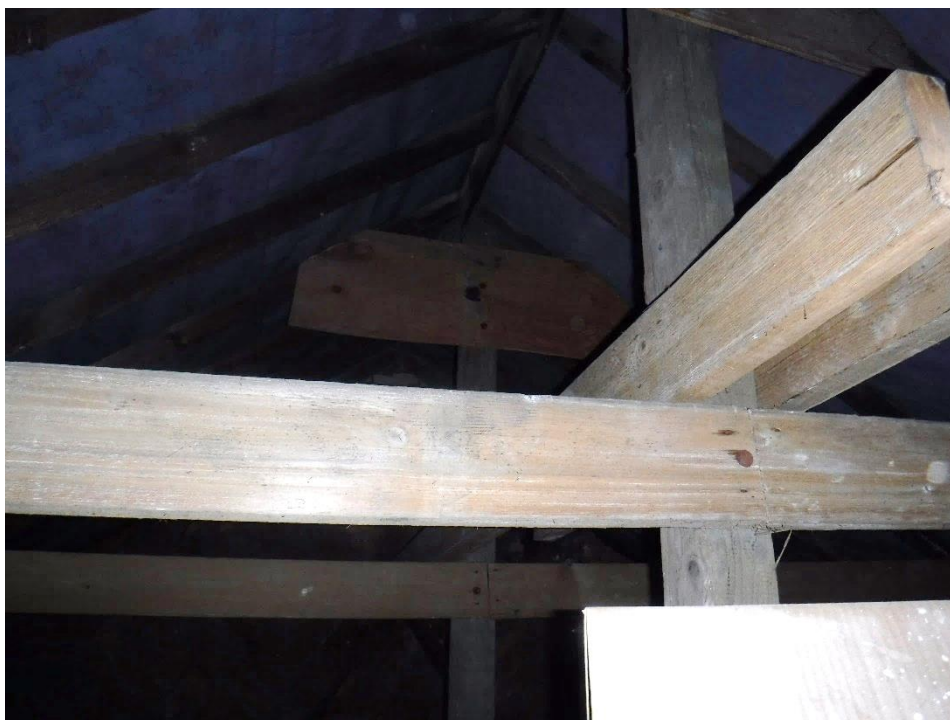
**Photograph 22:** Roof space - Kingpost located centrally

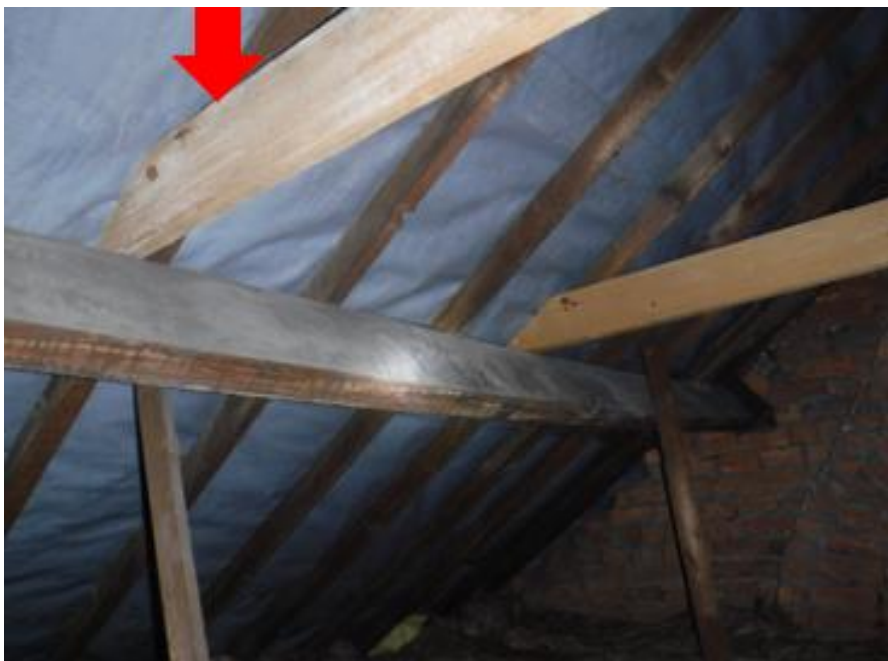
**Photograph 23:** Roof space - Kingpost horizontal members

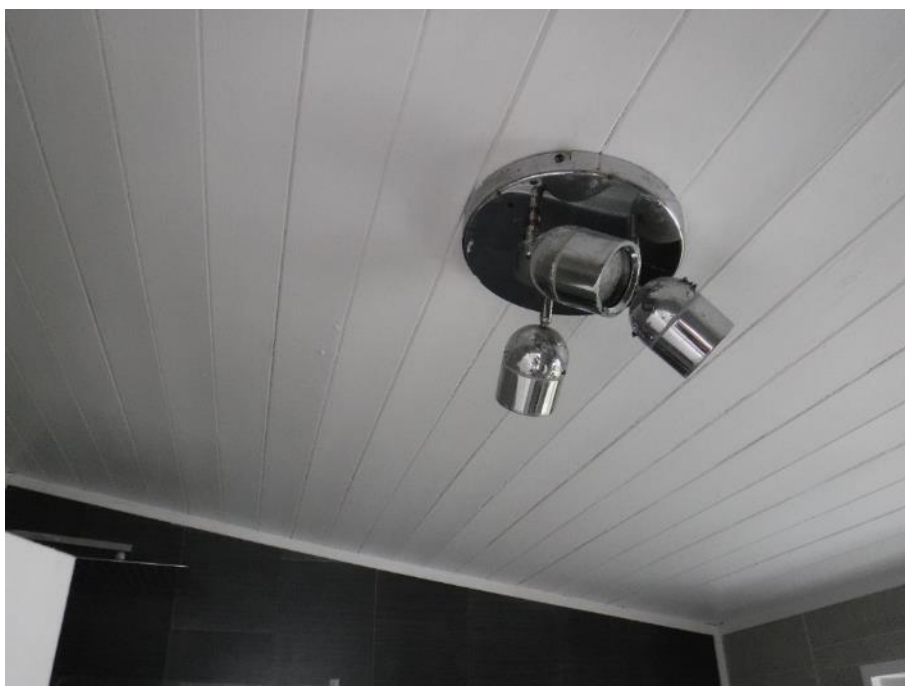
**Photograph 28:** Bathroom - wooden ceiling in bathroom

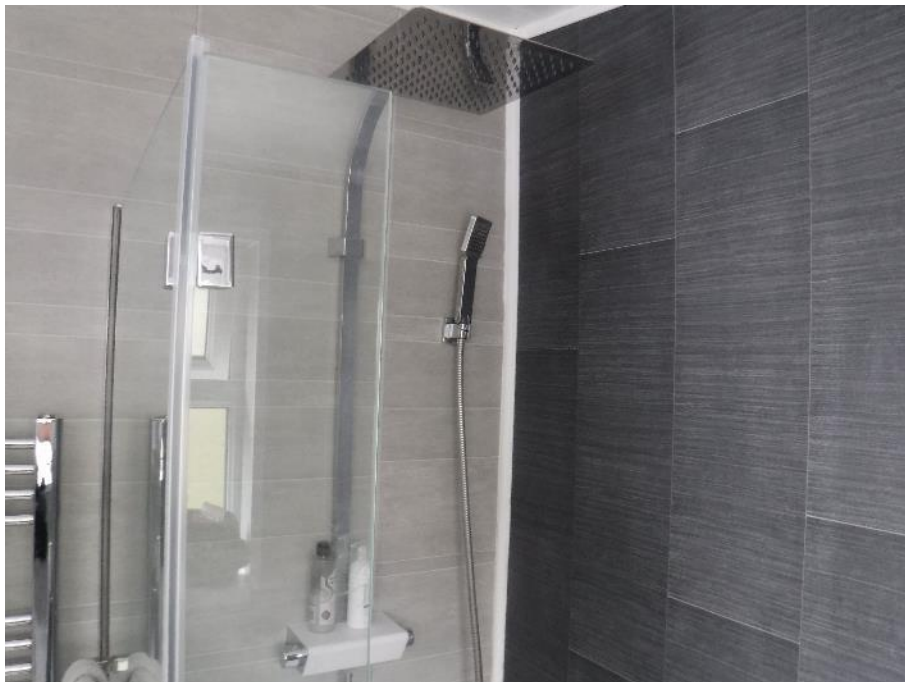
**Photograph 34:** PVC bathroom panels to bathroom

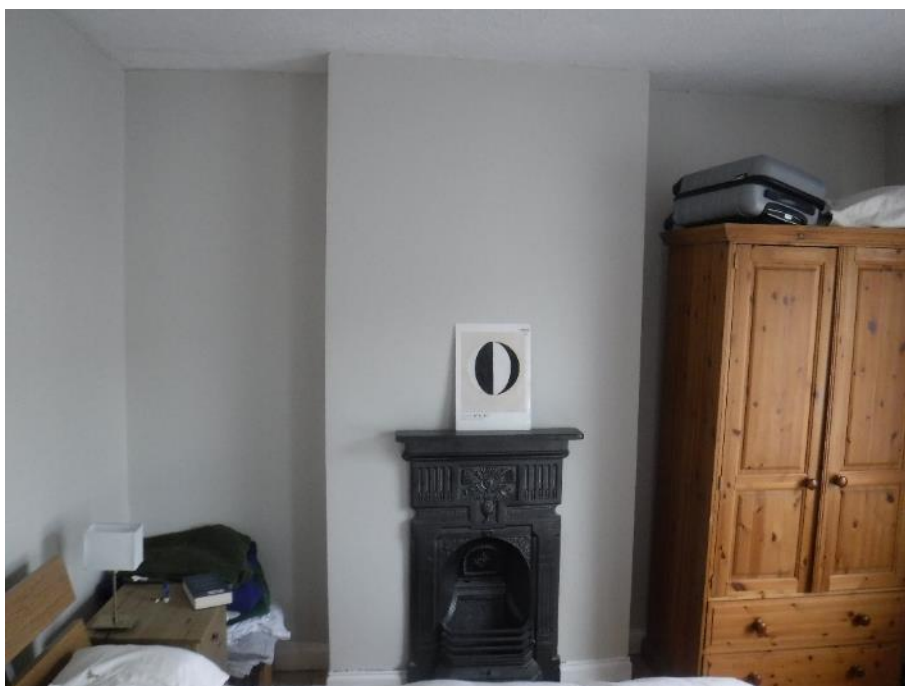
Condition	<p>The chimney breasts were found to be in sound condition. <b>(Photos.40-41)</b></p> <p>It is important to ensure that unused chimneys are <b>vented</b> at both the top and bottom to allow a constant flow of air. At the top, a cowl attached to the chimney pot is sufficient, as it prevents rain ingress while still allowing airflow.</p> <p>At the bottom, removing a single brick and installing a decorative vent would provide adequate ventilation to prevent damp buildup. In this case, a vent in the plasterboard could be installed to allow air to circulate. <b>(Photo.42)</b></p>

**Photograph 40:** Chimney breast in master bedroom

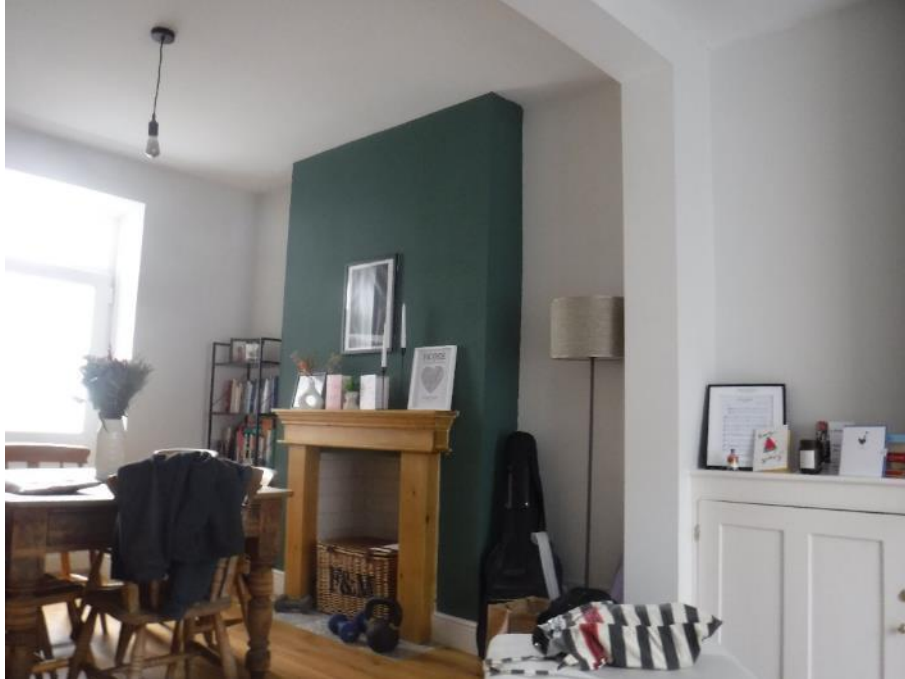
**Photograph 41:** Chimney breast downstairs

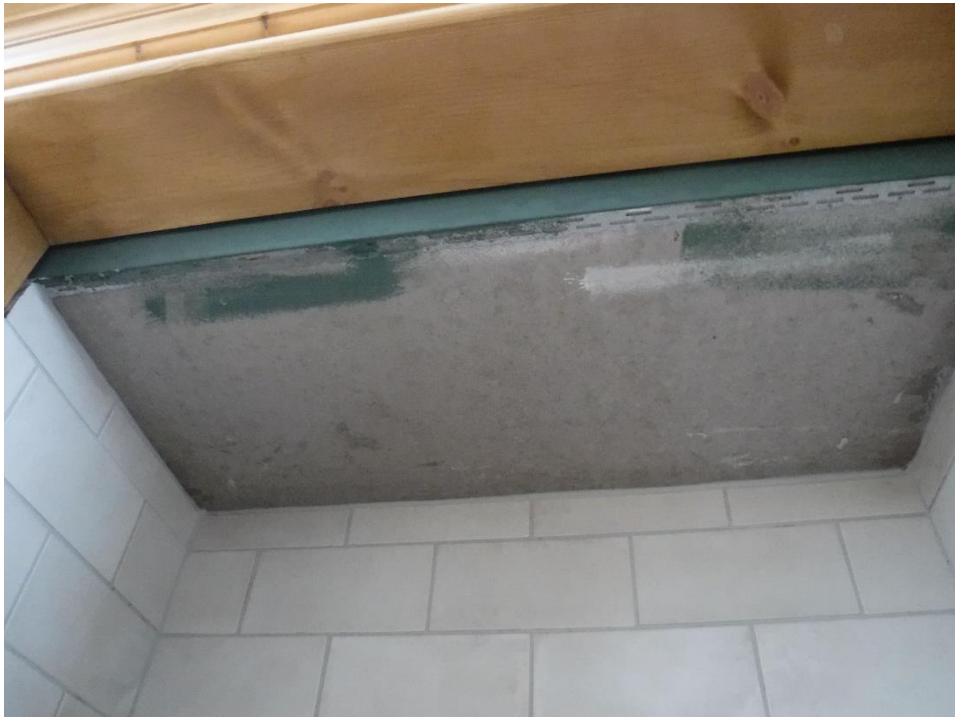
**Photograph 42:** Chimney breast boxed off

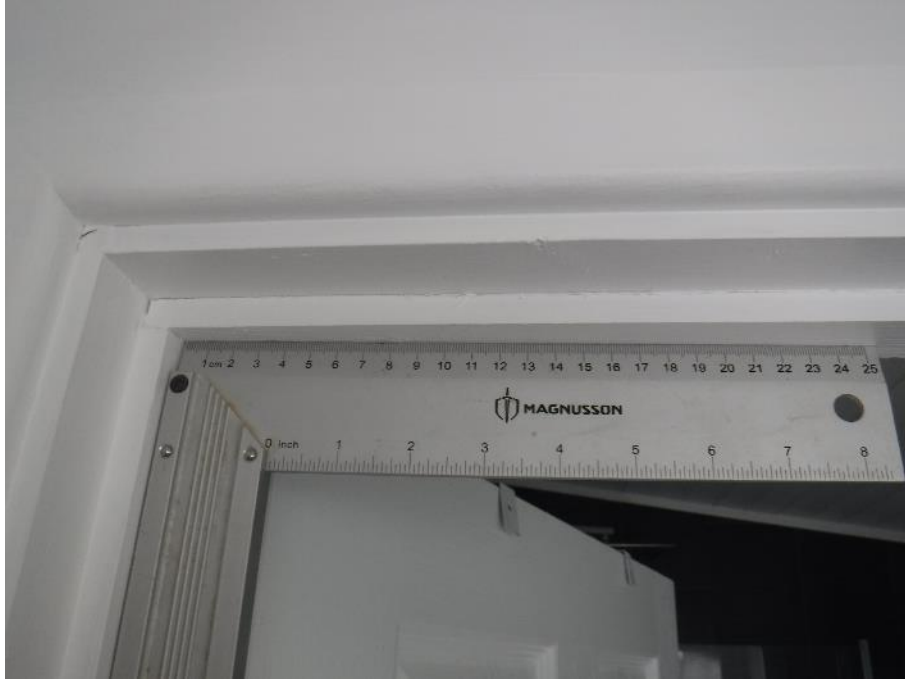
**Photograph 45:** Doors noted as square throughout the house

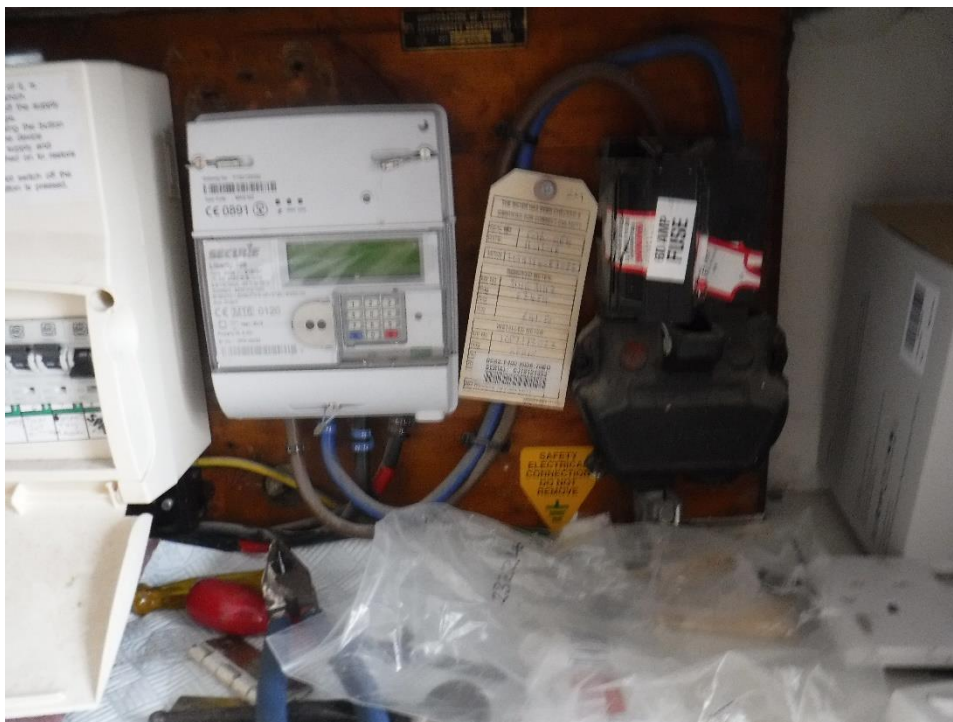
**Photograph 50: Meter and service head**

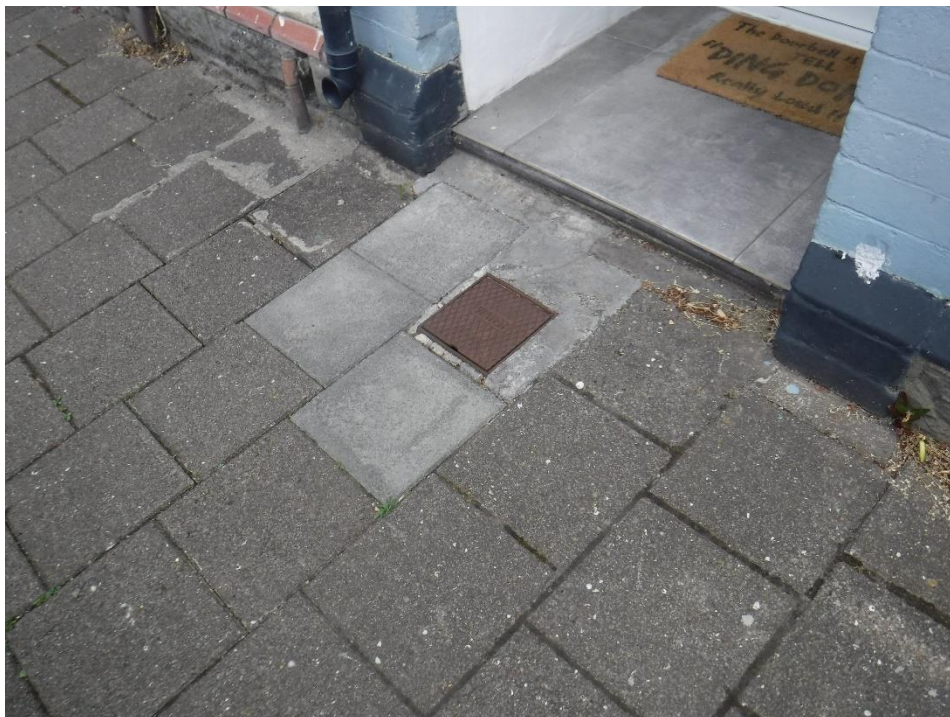
**Photograph 51:** Location of external stop tap

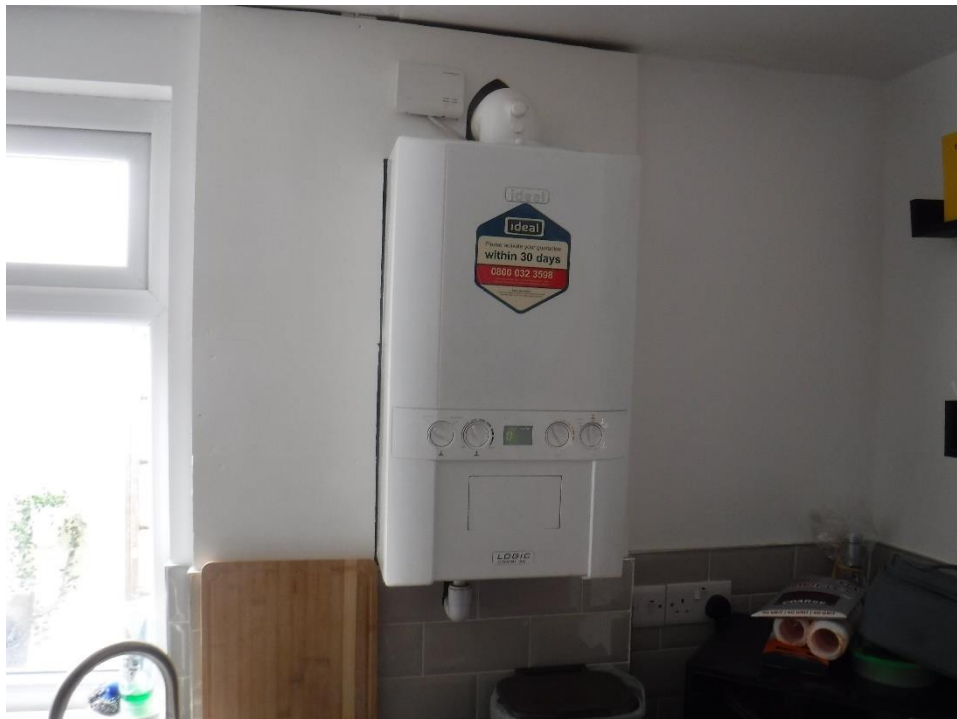
6.4 Heating & Cooling	Condition Rating	HS
<b>Construction &amp; Type and Limitations</b>	<p>The heating and hot water is provided by a gas-fired combi-boiler which is located in the kitchen (<b>Photo.54</b>). The boiler is an Ideal Logic Combi 30. It is believed that this model was manufactured between 2009 and 2015. A condition rating of HS is applied when there is no evidence of recent certification.</p> <p><i>As a guide, most modern combi-boilers have an efficiency of around 85-90%. Under normal circumstances a modern boiler will last for 15-20 years before requiring replacement.</i></p> <p><i>It is not possible to fully assess the condition and safety of a gas installation on the basis of a visual inspection only. A visual inspection was carried out of the radiators, pipework and boiler to detect leaks, corrosion and other common defects. None were found.</i></p> <p><i>Gas Safe recommends that all gas appliances and boilers are inspected and serviced according to manufacturer's guidance, but at least once a year. A gas installation can look to be in a safe condition, but serious defects may be hidden, some of which can kill. It is therefore considered to be <u>essential</u> that you commission an inspection of the gas/heating installation prior to purchase of the property.</i></p>

**Photograph 54:** Boiler – located in kitchen

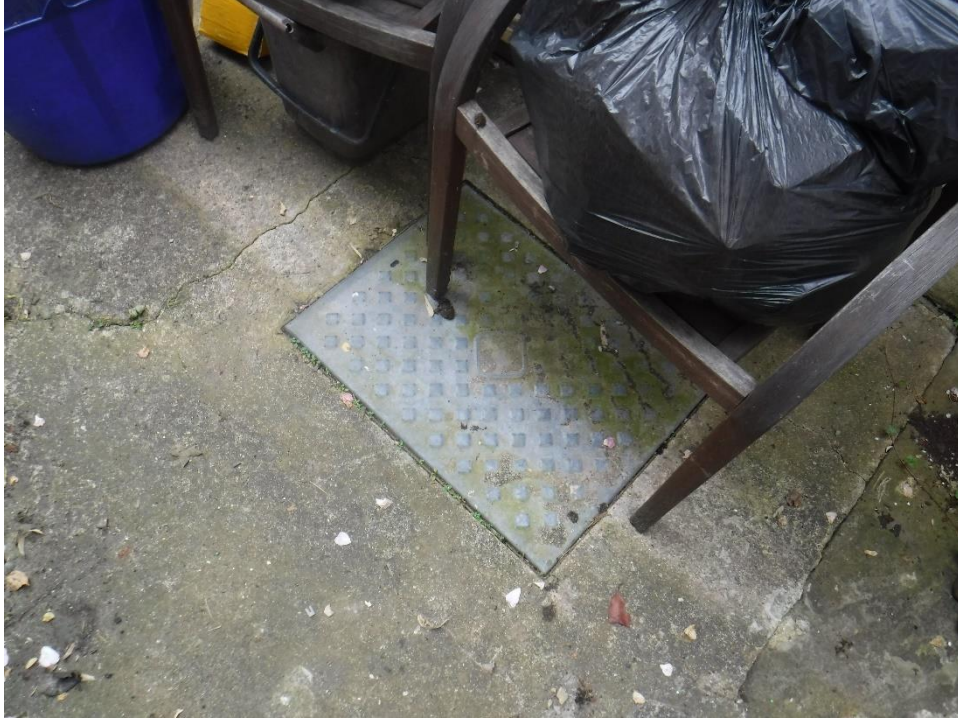
**Photograph 55:** Drainage chamber

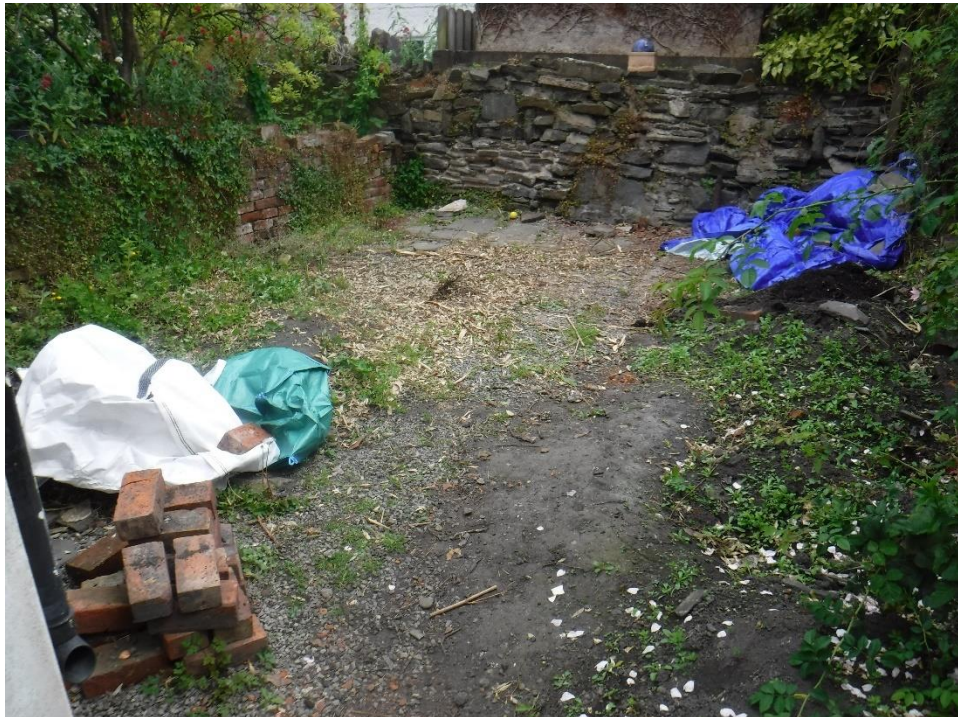
**Photograph 56:** Garden overview

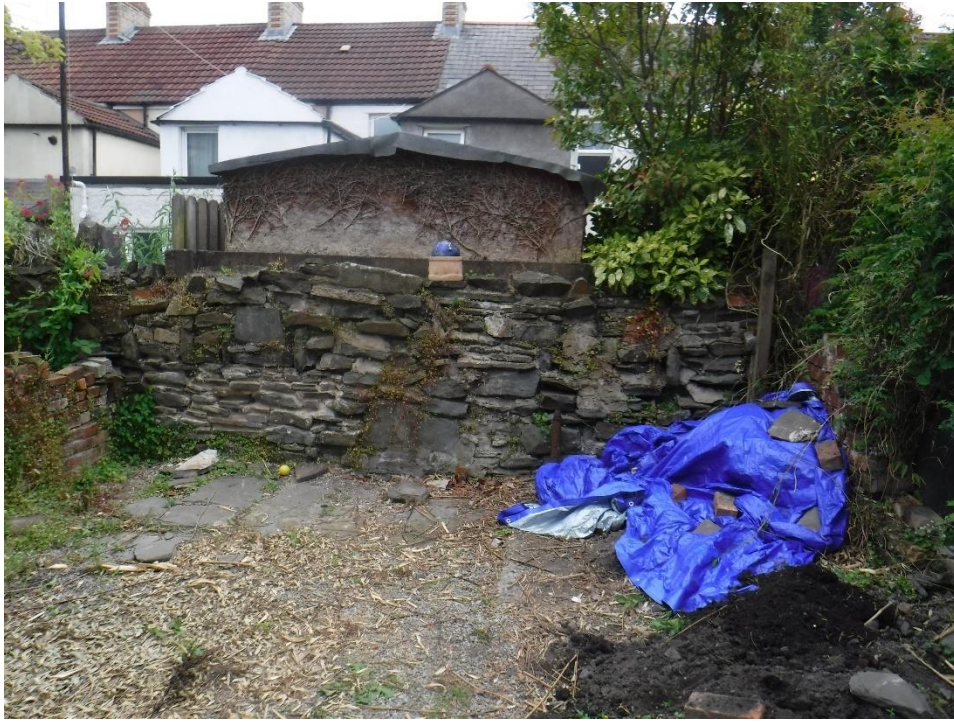
**Photograph 57:** Garden rear wall

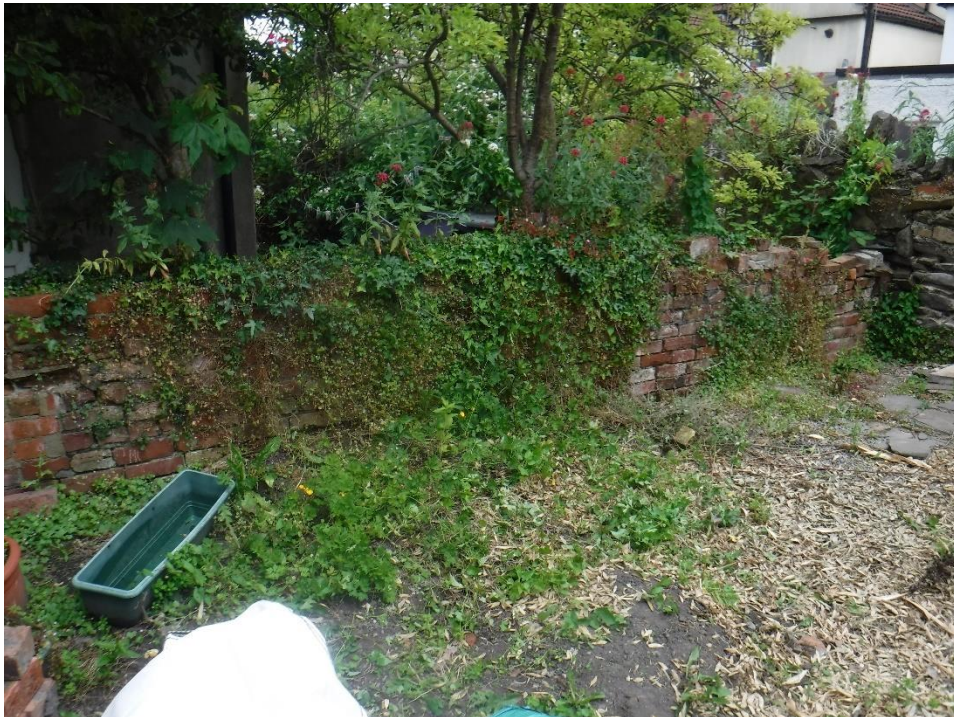
**Photograph 58:** Garden north boundary

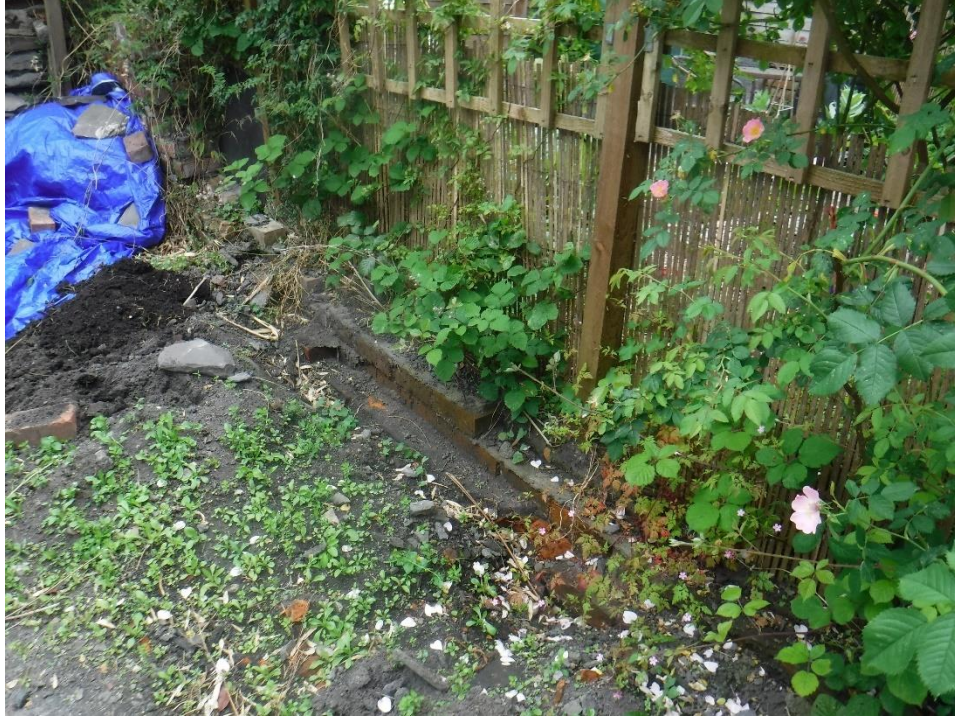
**Photograph 59:** Garden south boundary

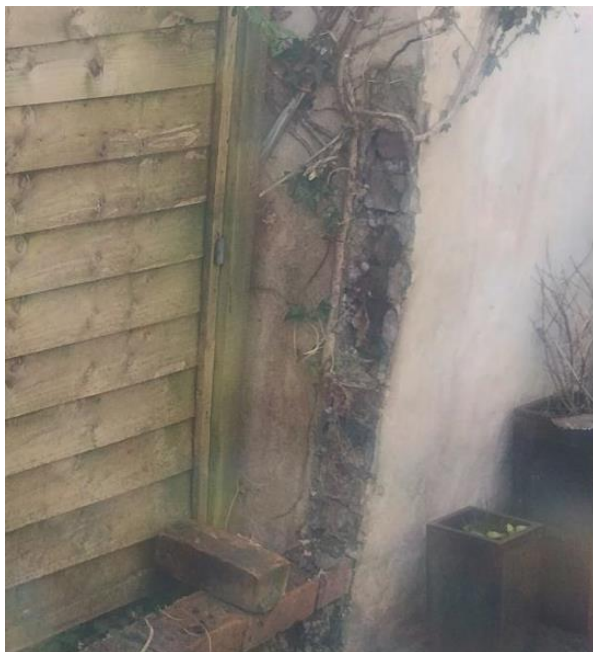
**Photograph 63:** Extension bulge - contrasting the existing quoin with a typical keyed corner (quoin)
