BUILDING SURVEY REPORT

PROPERTY: Pencerrig St,
Pontypridd,
CF37 2HS

**SURVEY
DATE:** 02 June 2025

REF: TN0878

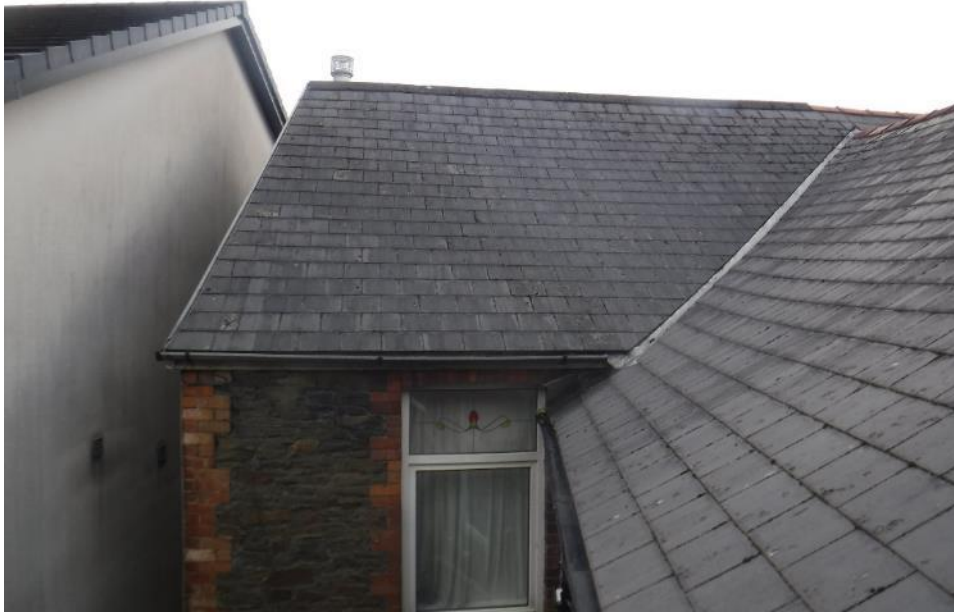
Photograph 5: Rear chimney – removed and roof intact

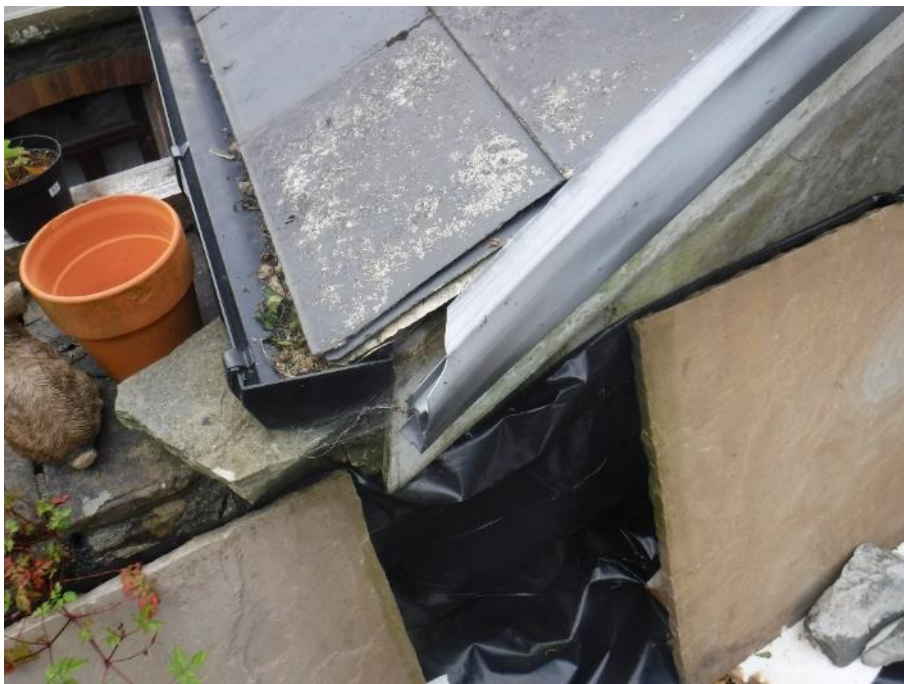
Photograph 6: Extension roof corner - dry-verge had a minor detachment to the east and requires re-attaching, also the guttering require re-attaching

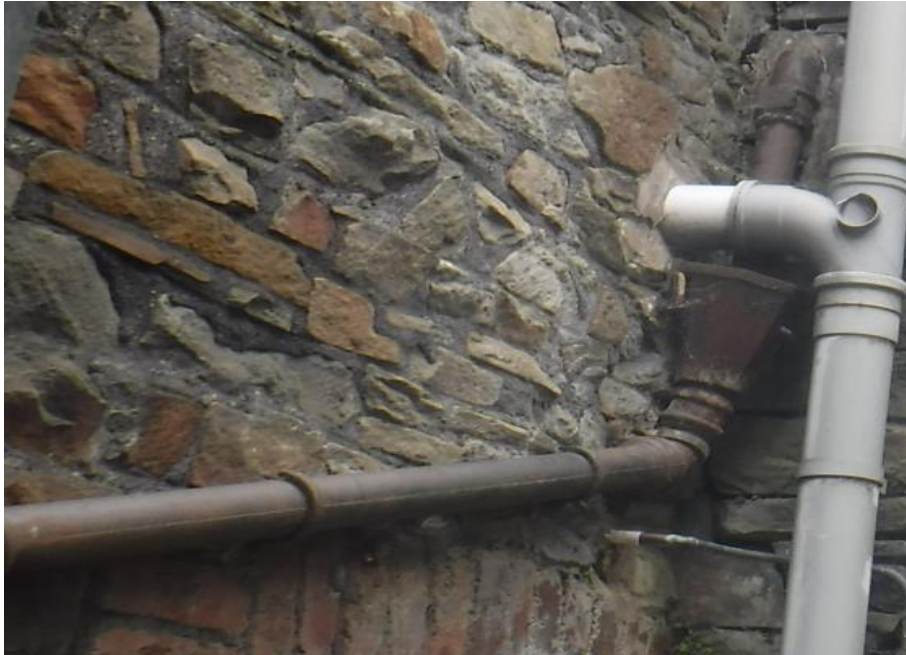
Photograph 13: Cast iron drainage

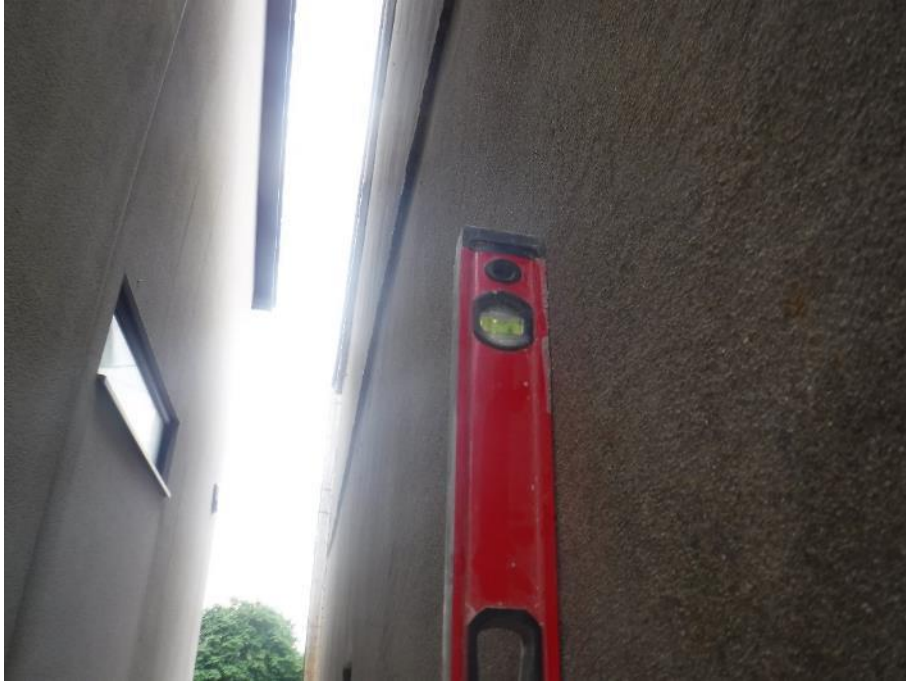
Photograph 17: No significant alignment defects noted

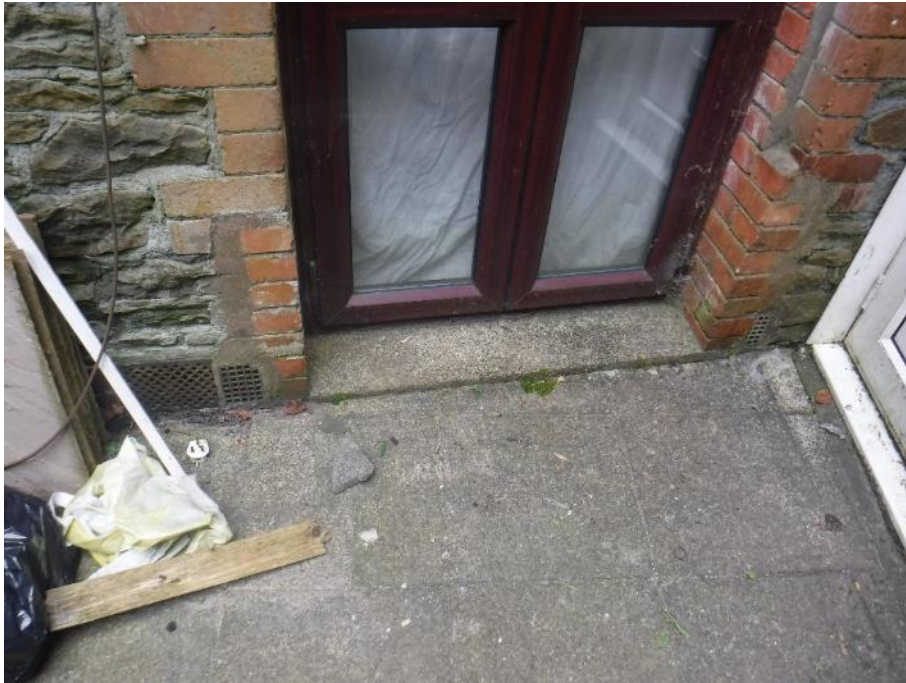
Photograph 25: Three airbricks were noted to the exterior of the property at ground level, believed to pass air downwards to the sub-floor void

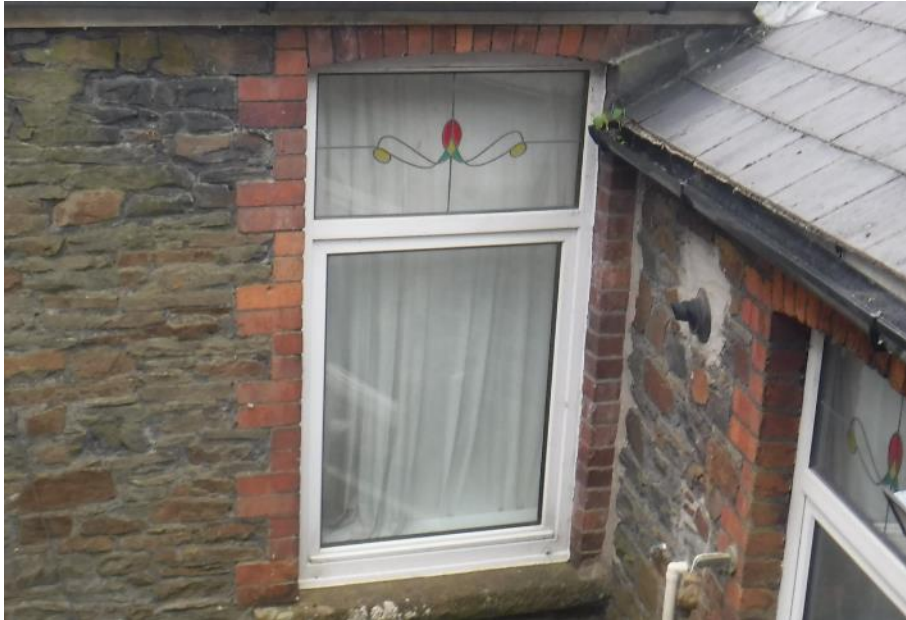
Photograph 27: Typical window condition

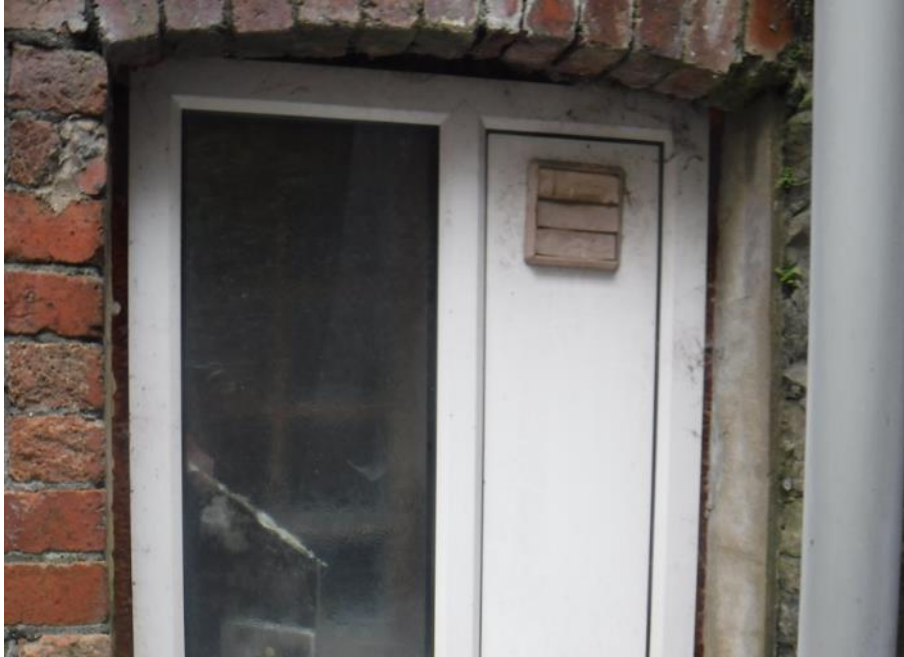
Photograph 29: Far kitchen window requires sealing down the edges with uPVC window trim and silicone

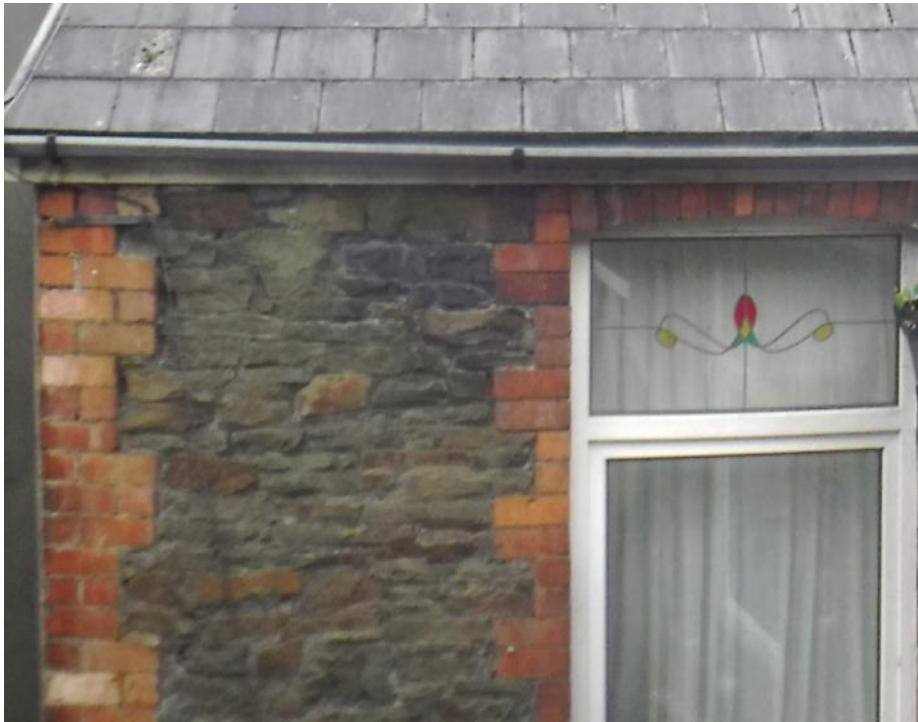
Photograph 31: Fascias – typical condition

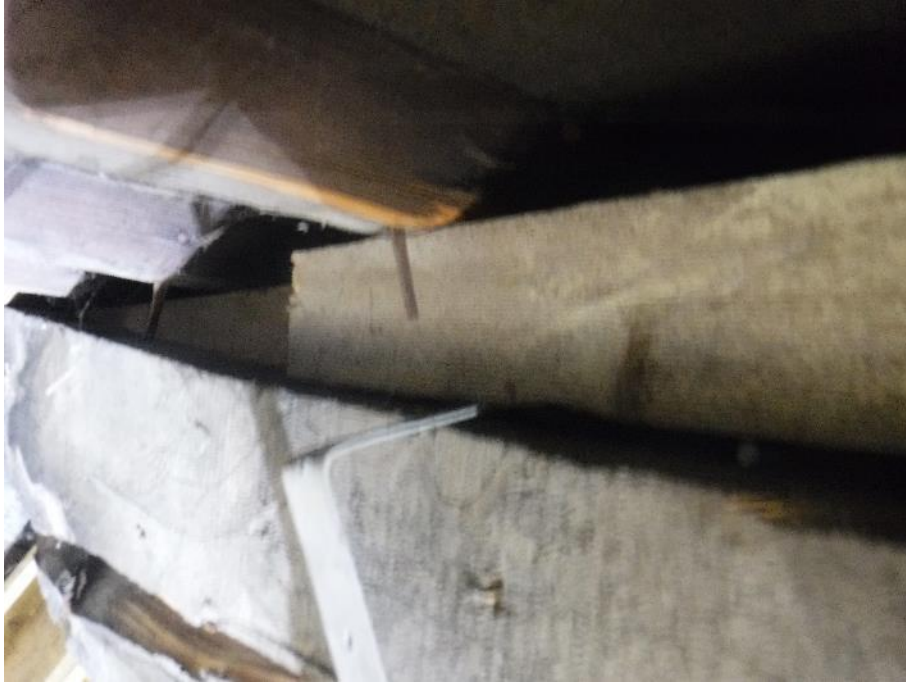
Photograph 35: Roof space - view of sistered purlin

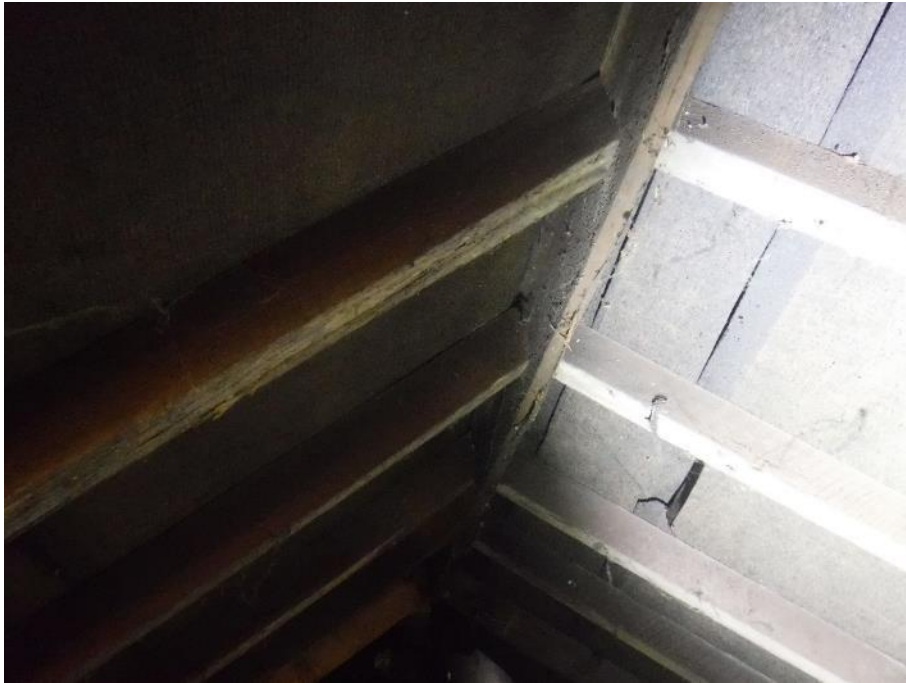
<p>A ridge board is a non-structural member that serves as a prop/nailing board for opposing rafters to rest against and connect to. The ridge board was observed to be mainly straight and dry with no obvious signs of the rafters separating from it (indicative of potential roof spread/failure). (Photo.39)</p> <p>Additionally, there was an issue adjacent to the chimney breast, there appears to have been an addition to the ridge board at some point which has displaced out. This was most likely added when the chimney stack was removed. This would require attention to bring it back into line (we would suggest the structural engineer or competent joiner also confirm this when the purlin is checked). (Photo.40)</p> <p>Moisture levels High moisture levels within roof spaces are responsible for the promotion of the development of timber defects such as rot and infestations by wood-boring insects (commonly known as woodworm). Wood moisture content readings taken were found to be well within normal limits and below the levels normally required for this type of defect. Lap vents were noted in the roof space (Photo.42) and as there are low moisture levels, they appear to be providing adequate ventilation. More information on ventilation can be found here: https://nhbc-standards.co.uk/7-roofs/7-2-pitched-roofs/7-2-15-ventilation-vapour-control-and-insulation/</p> <p>Insulation Other than in those areas that have been boarded, the roof space is laid with approximately 200mm of wool-type insulation at joist level. This is close to the current recommendation of 270mm for maximum energy efficiency. It does, however, limit examination within the roof space as any supporting joists are concealed.</p> <p>Partially boarded The loft was partially boarded, care should be taken when moving around or storing heavy objects in the roof space. The spaces between the floor joists will not support a person's weight or that of large boxes, etc.</p> <p>Party wall (fireproofing) Several large gaps were noted to the party walls. The party walls on both sides of the property should be sealed to the underside of the roof covering with fireproof material. Bricks or fire batt (mineral fiber boards with a fire rated coating) would solve this issue.</p> <p>The wall between terraced houses should be solid and continuous from the ground to the peak of the roof for the prevention of spread of fire from one property to another. There was expanding foam used but it is believed to be the wrong kind as fireproof expanding foam is pink in colour (Photo.43). Your mortgage lender may raise an issue if this is not fulfilled.</p> <p>Combustibles around flues, metal flue uncovered: The metal chimney installation would be non-compliant for use (Photo.45). Metal chimneys (and flues) must comply with Approved Document J of the Building Regulations, If this flue is to be used first, it must be inspected by a HETAS-approved technician. There are various regulations to be considered, such as smoke testing, distance of timber elements from combustible materials and fireproofing. Please see further discussion in the chimneybreast section (5.5)</p> <p>Infestations No evidence was seen of infestations by wood boring insects (commonly known as "woodworm"), other insects, birds, rodents or bats</p>

Photograph 39: Roof space - ridge board in fair condition

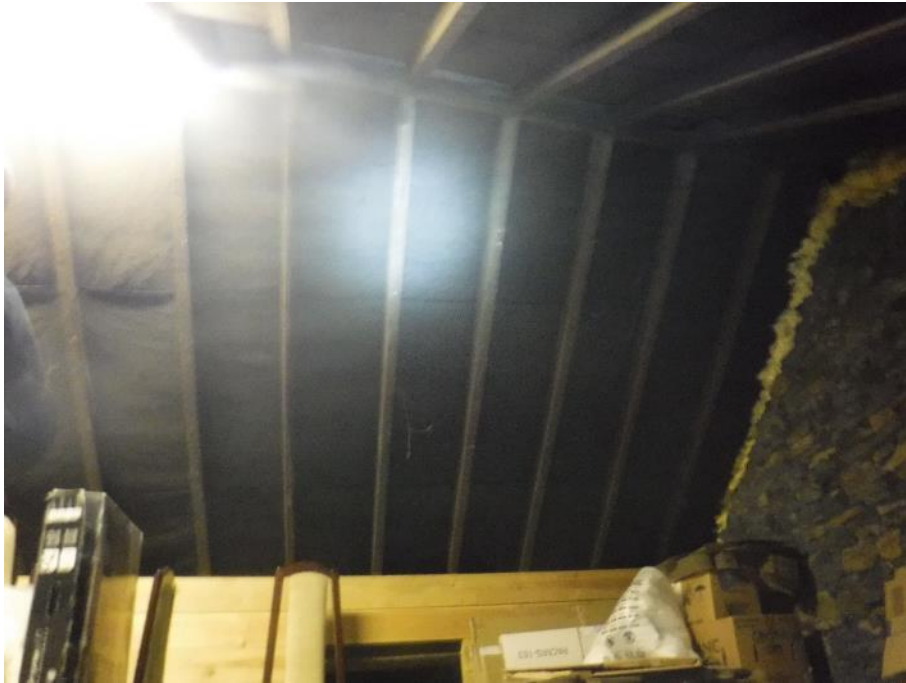
Photograph 41: Roof space - Sarking noted in fair condition overall

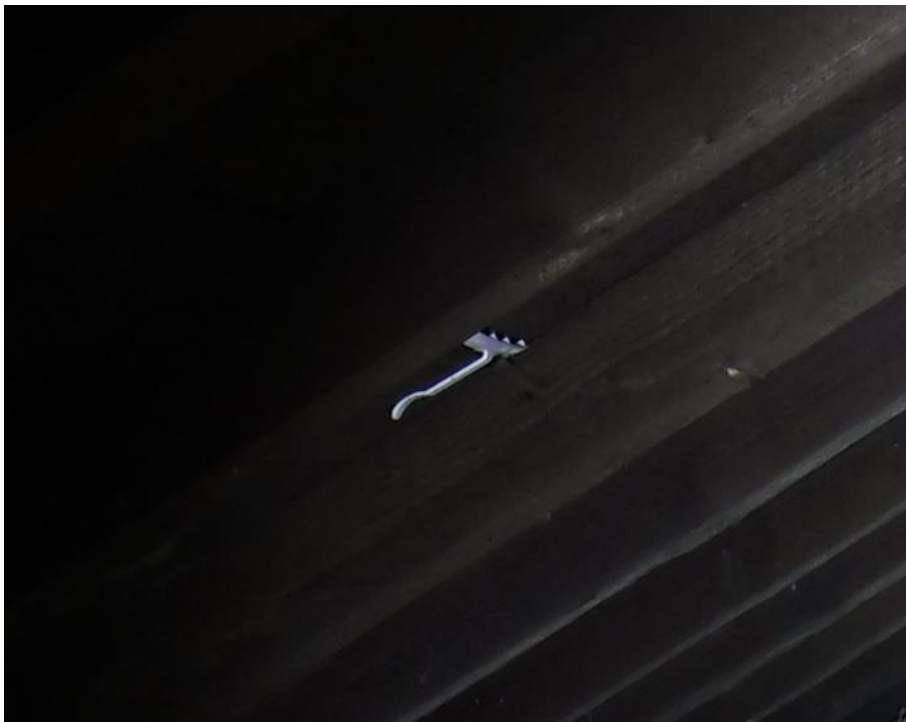
Photograph 42: Roof space - Lap vents observed

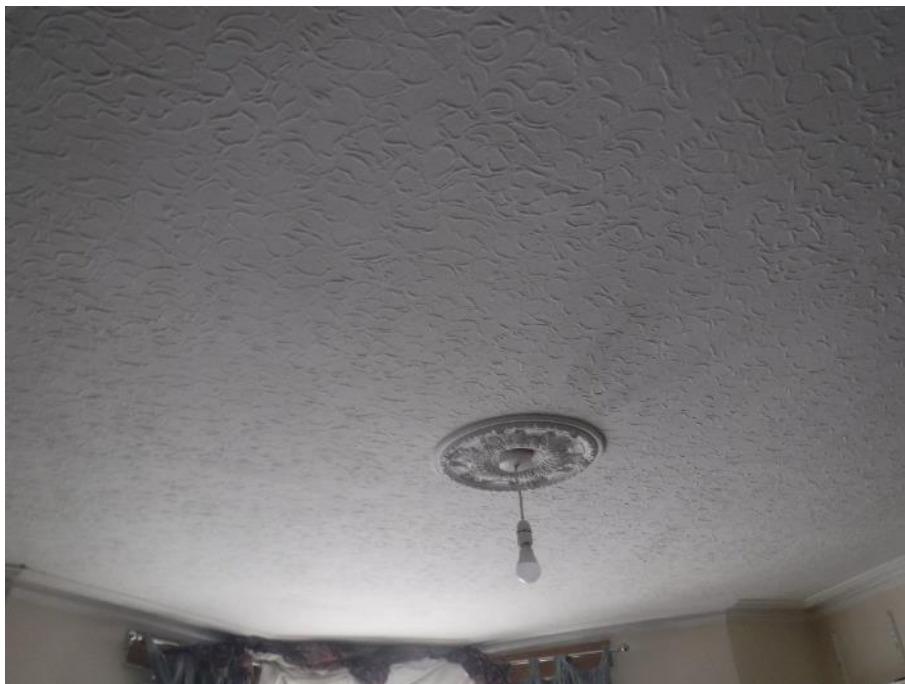
Photograph 46: Sitting room ceiling – textured ceiling

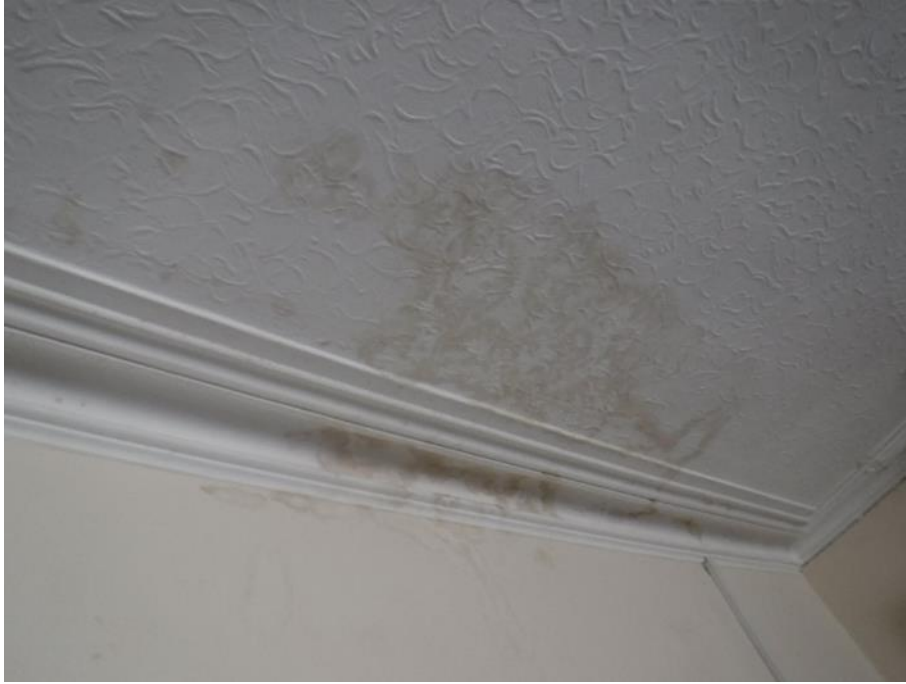
Photograph 47: Sitting room ceiling – historic damp patch

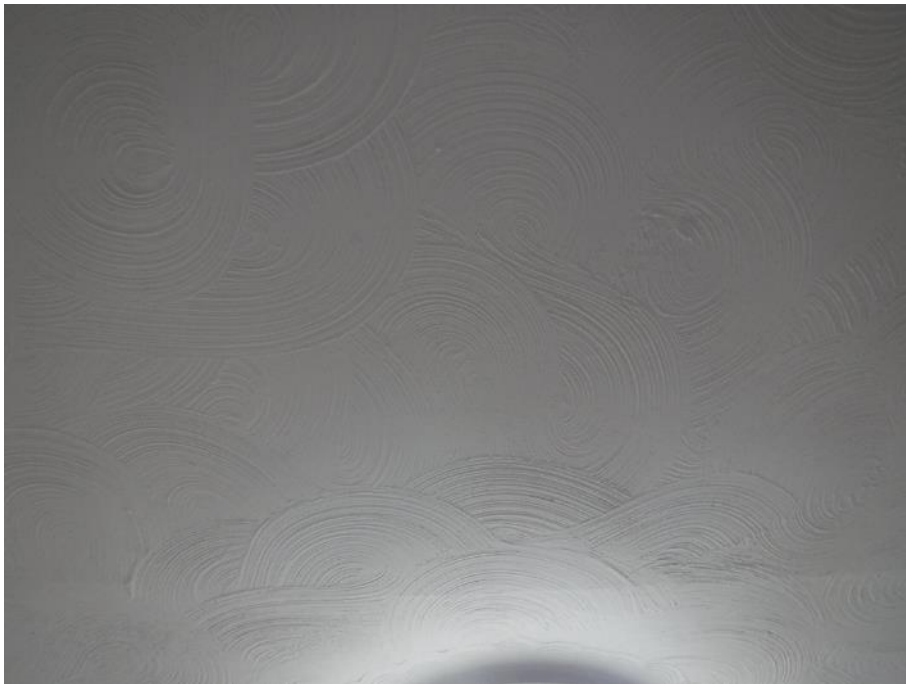
Photograph 48: Artex ceiling in bathroom

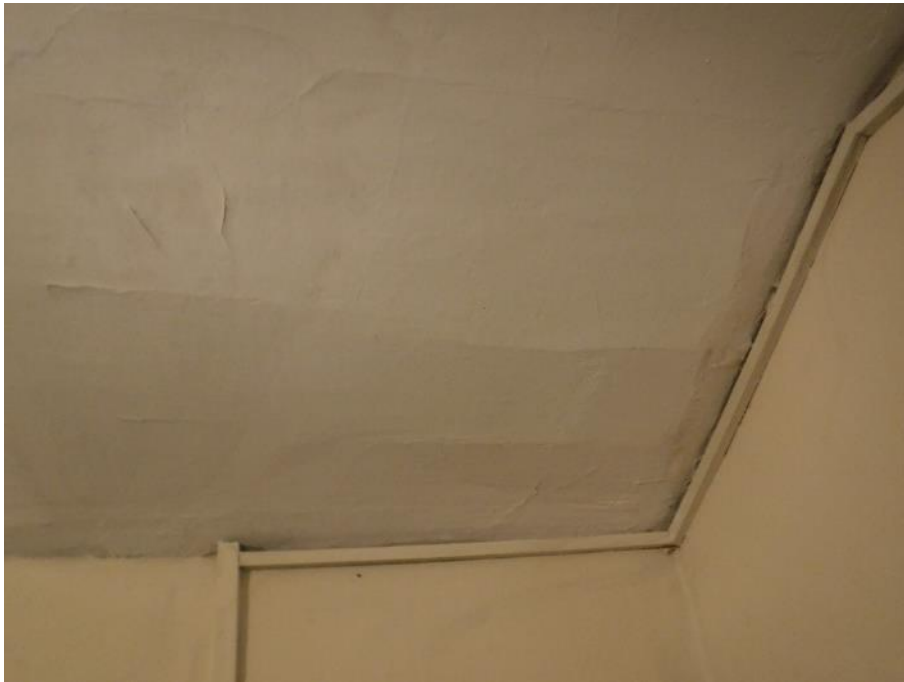
Photograph 50: Ceiling adjacent to boiler

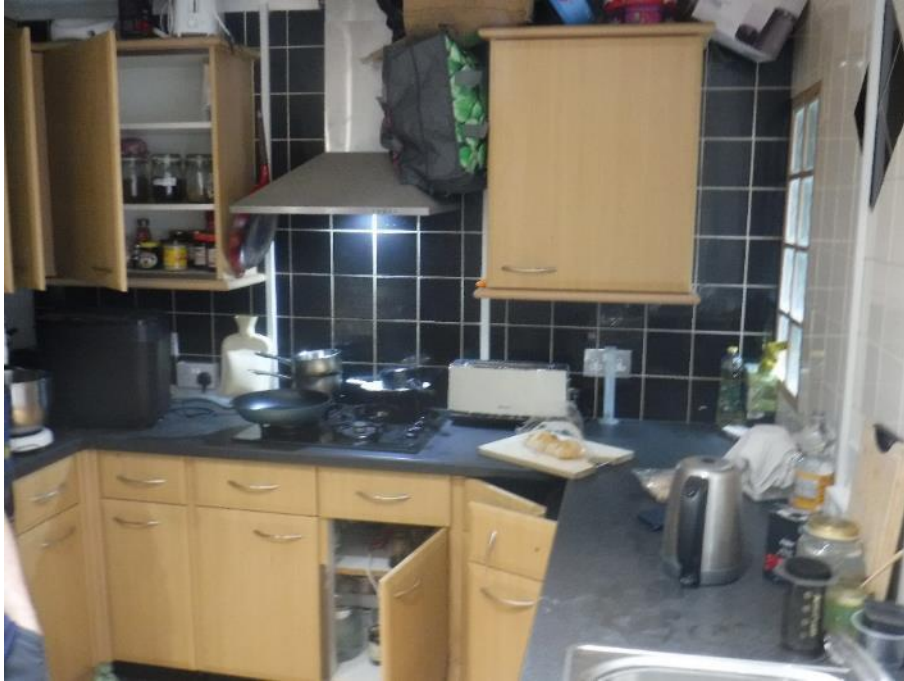
Photograph 57: Kitchen walls - Dry-lined kitchen wall – stood off original wall

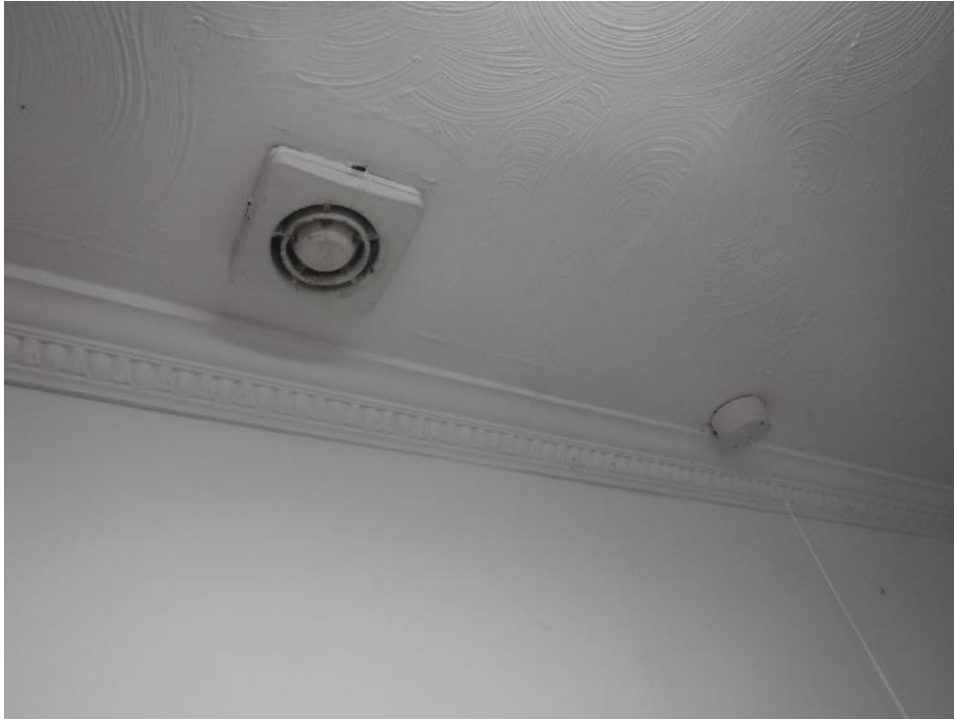
Photograph 73: Bathroom – non-functioning ventilation

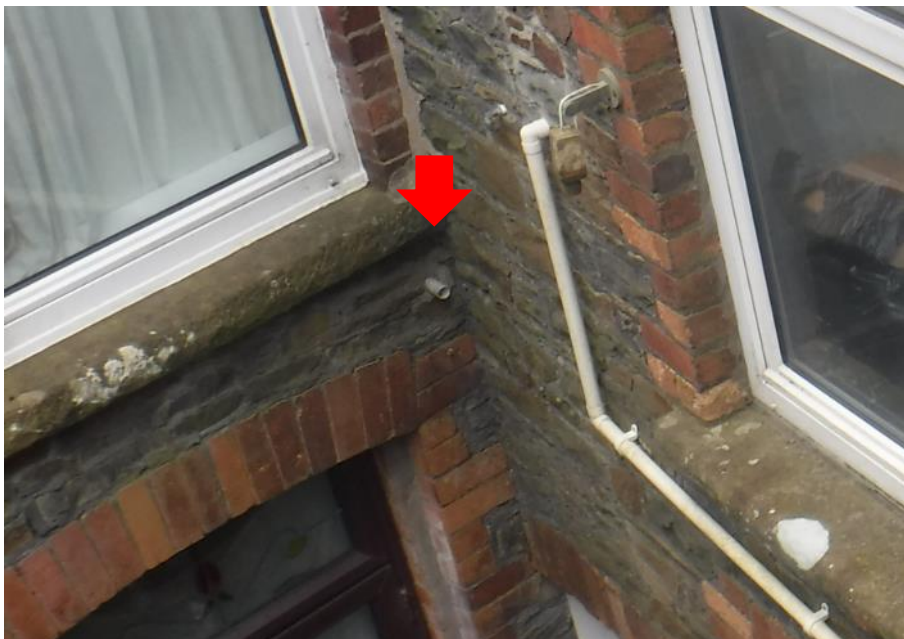
Photograph 76: Sink in the second bedroom outlet (above kitchen door)

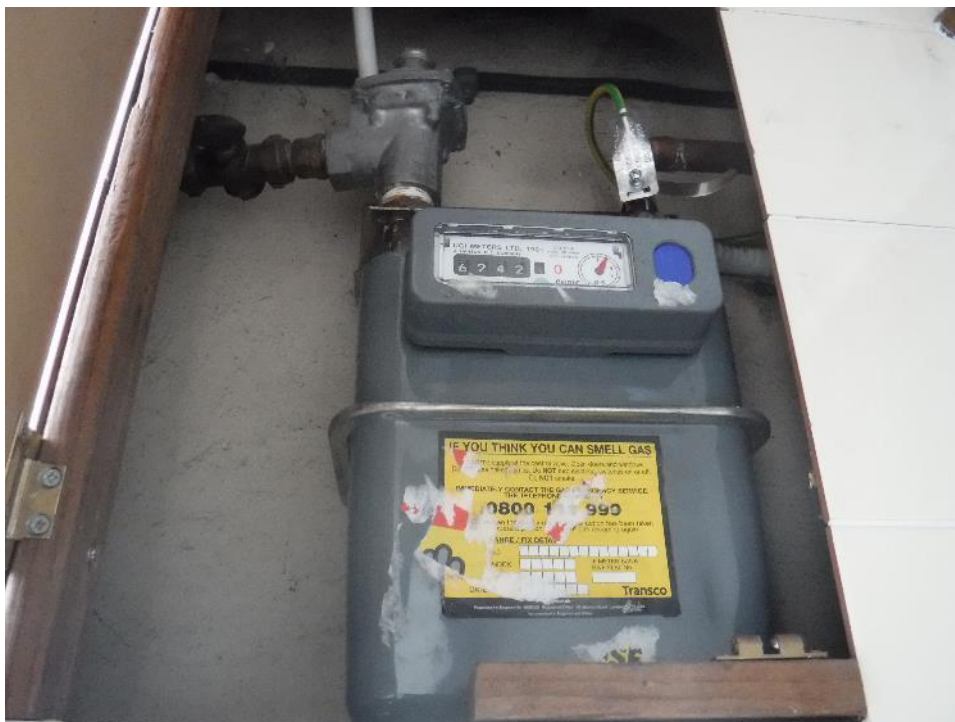
6.2 Gas / oil	Condition Rating	HS
Construction & Type and Limitations	<p>There is a gas supply, and the meter and regulator valve are located in a housing under the stairs (Photo.78)</p> <p>The system was inspected for any obvious signs of damage or leakage.</p>		
Condition	<p>No significant defects were noted; however, refer to recommendation 6.4 (Heating) regarding the need for a full test and inspection.</p> <p>Homebuyers cannot always be sure when the gas appliances in their new home were last safety checked and serviced. Ask your seller for an annual gas safety record which shows that a Gas Safe registered engineer has checked the gas appliances. If your vendor cannot supply an up to date annual gas safety record, you should get a Gas Safe registered engineer to check the gas appliances before you move in.</p> <p>This check should include gas boilers, ovens/hobs and gas fires. The registered engineer will give the vendor a gas safety record, which they should handover to you before you move in. Poorly maintained or badly fitted gas appliances can put you at risk from gas leaks, explosions, fires and carbon monoxide poisoning.</p>

Photograph 78: Gas meter

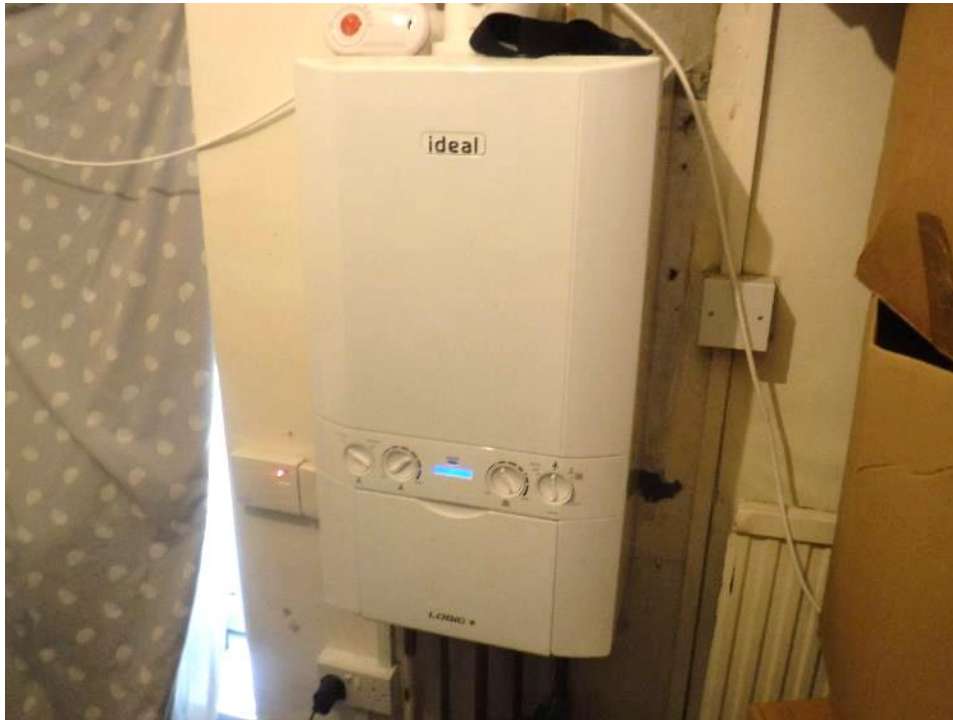
Photograph 79: Boiler condition

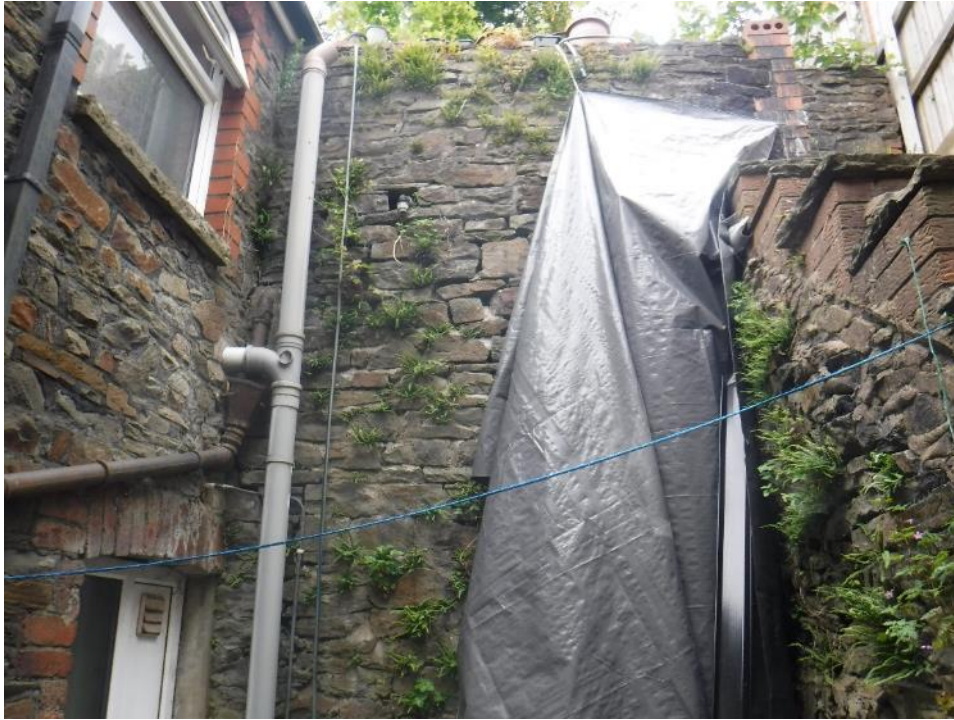
Photograph 81: Overview of retaining wall, adjacent to rear courtyard

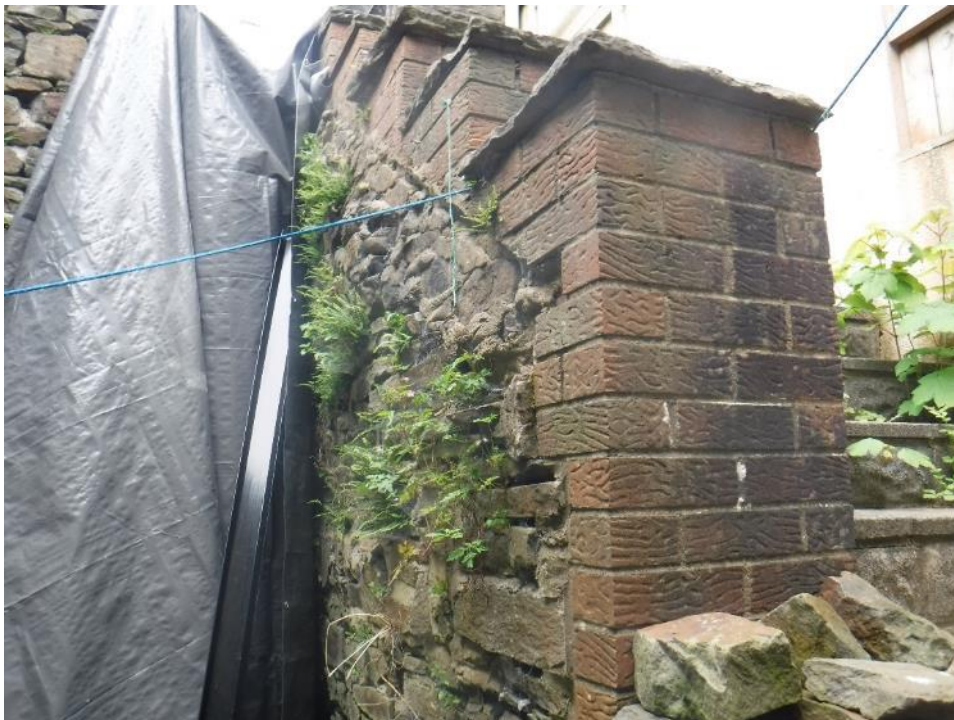
Photograph 82: Further view

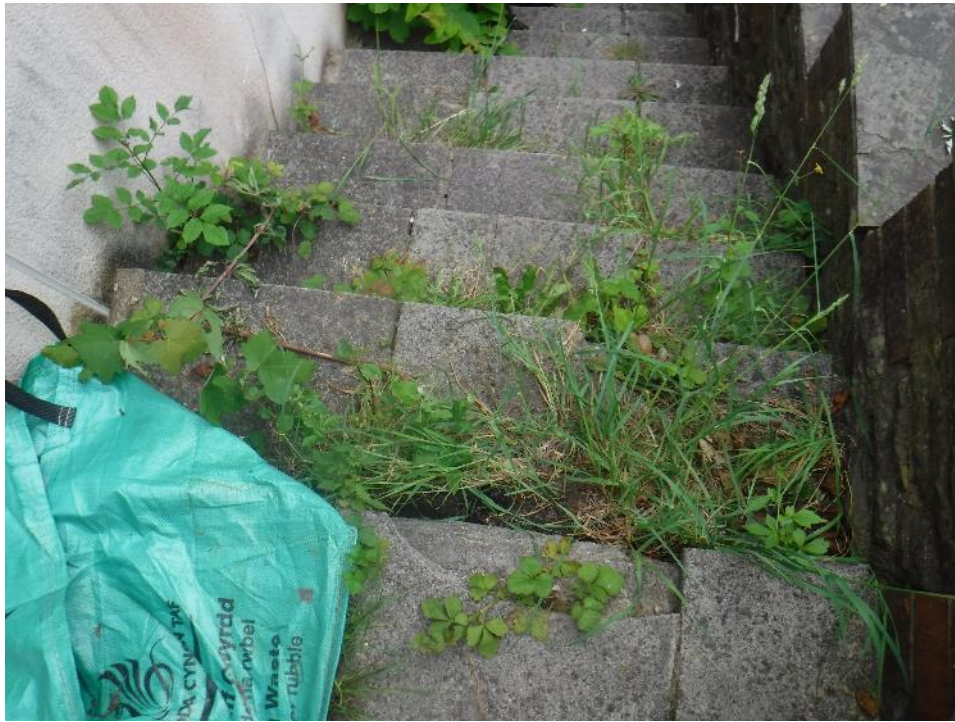
Photograph 83: Steps leading to upper patio garden area

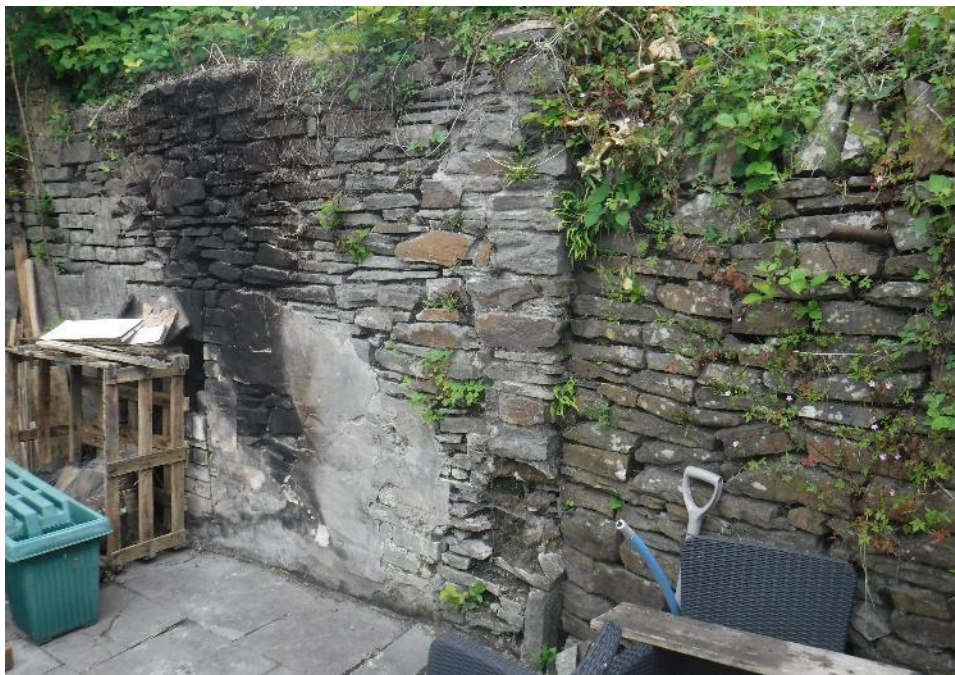
Photograph 84: Further retaining wall to upper patio garden area - supporting upper garden

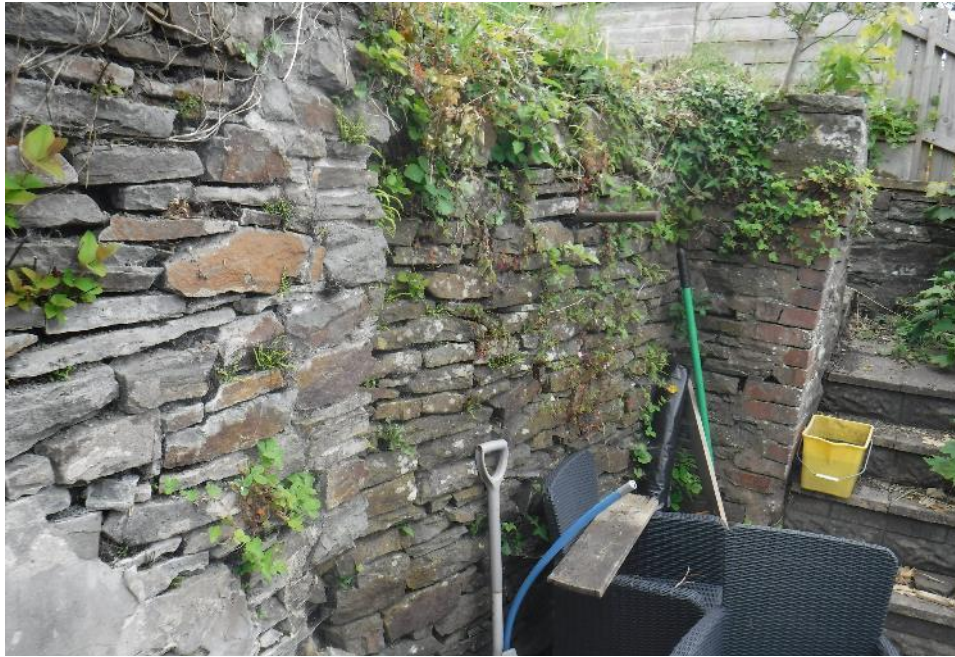
Photograph 85: Further view

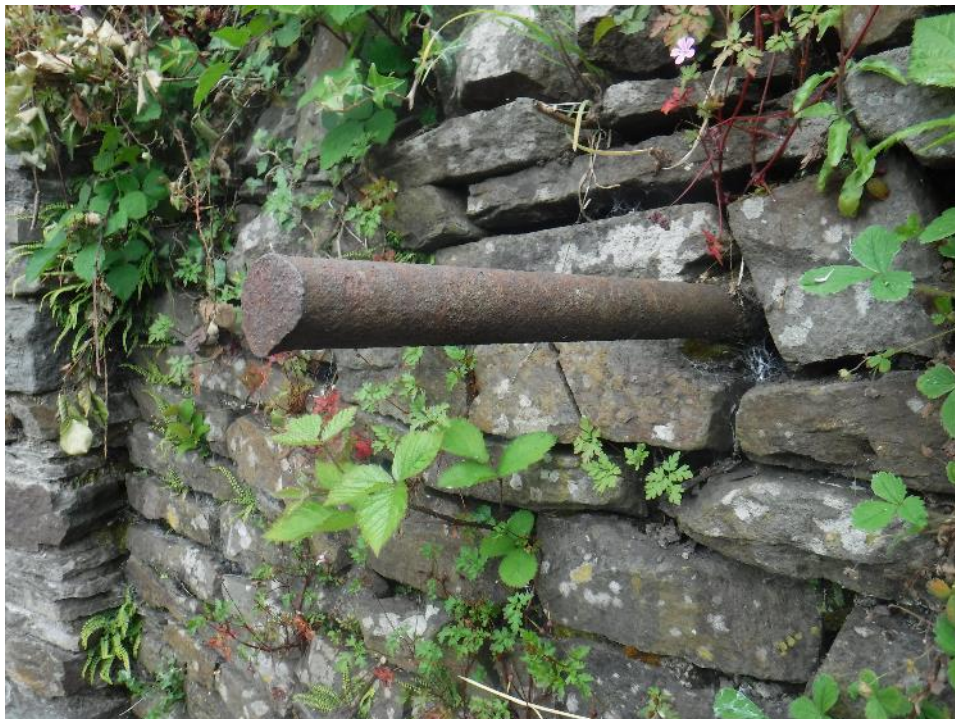
<p>There was evidence of a single (presumed) anchor (Photo.86), presumably over 100 years old at this point. Should the retaining wall show any further problems in the future more anchors would most likely need to be added.</p> <p>In addition to this there was a partially collapsed quoin of approx. 0.25m³ this poses no danger at present however it would need to be remedied by a competent professional in the near future.</p> <p>The retaining wall requires partial rebuilding in areas and pointing and the addition of weepholes to allow any moisture to escape. The wall has had some isolated cement repairs. A civil engineering company would be most suitable to advise on these additions. The addition of some more stabilising rock anchors and weepholes would also be welcome.</p> <p>Please note – as noted above you have a large retaining wall butting up to the rear of the property, it is likely that this is partially responsible for the damp experienced in the kitchen and to the condition of the brick elements at the rear of the house (Photo. 87-88). This would also explain the existence of the (non-functioning) extractor fan adjacent to the kitchen. I suggest you seek a damp specialists' advice in this regard as it is a non-standard property feature.</p> <p>Front retaining wall (Photo.91-92) The retaining wall at the front of the property was in overall fair condition, weepholes were noted and no alignment issues. There were some minor open joints which would require attention and a pressure wash to get rid of dirt/efflorescence buildup.</p> <p>There was a minor vertical crack to the screen wall on the side of the property. It is along the perp joint and would require repointing. No significant alignment issues were noted to the newel post or retaining wall. We believe this is due to seasonal expansion and contraction cycles and would simply require repointing.</p> <p>Garden steps The steps leading up to the garden were in poor condition, vegetation growing through them indicating they were not laid on a compacted subbase or concrete-work. Also, there was loose mortar joints, fragmented sections and alignment issues. (Photo.83)</p> <p>Upper patio drain (Photo.89) There was a drain noted which would relieve some groundwater pressure on the main retaining wall.</p> <p>Greenhouse safety concern The greenhouse glazing does not have markings to confirm the presence of toughened or laminated safety glass. This increases the risk of injury from accidental breakage, particularly for young children. Extra caution is advised.</p> <p>Lack of edge protection & handrails There is no significant edge protection for higher ground levels or handrails for the garden steps, posing a significant health and safety risk. Installing edge protection and handrails is strongly recommended to prevent injuries from falls.</p> <p>Overgrown grounds The grounds are significantly overgrown with shrubs and waste materials, creating a potential safety hazard. Proper grounds maintenance is required (Photo.90).</p>

Photograph 86: Tie bar to upper patio garden retaining wall

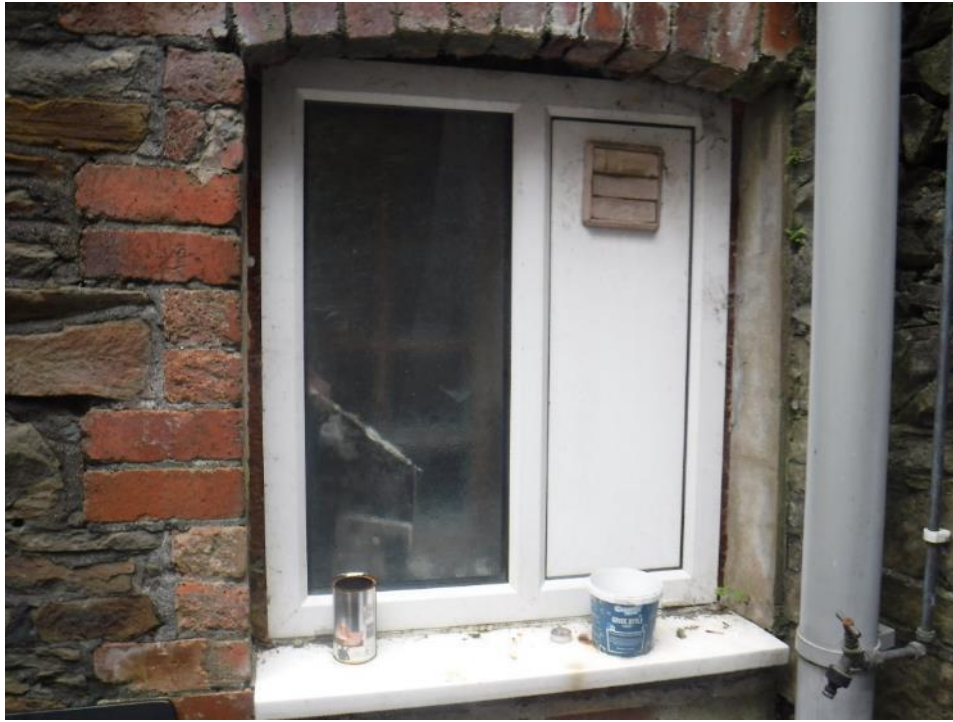
Photograph 87: Vent adjacent to retaining wall

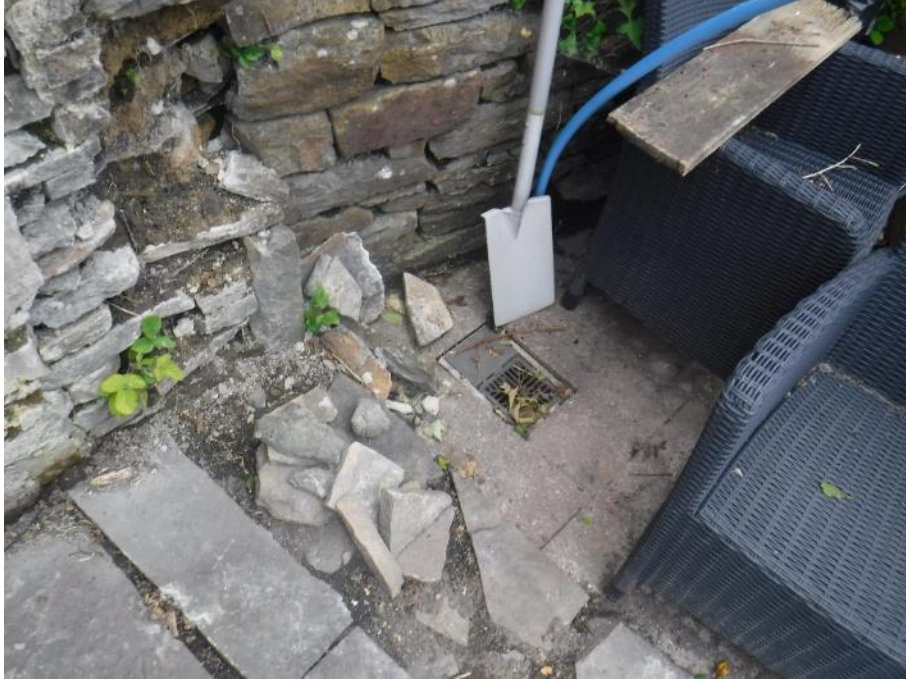
Photograph 89: Drainage to upper patio garden

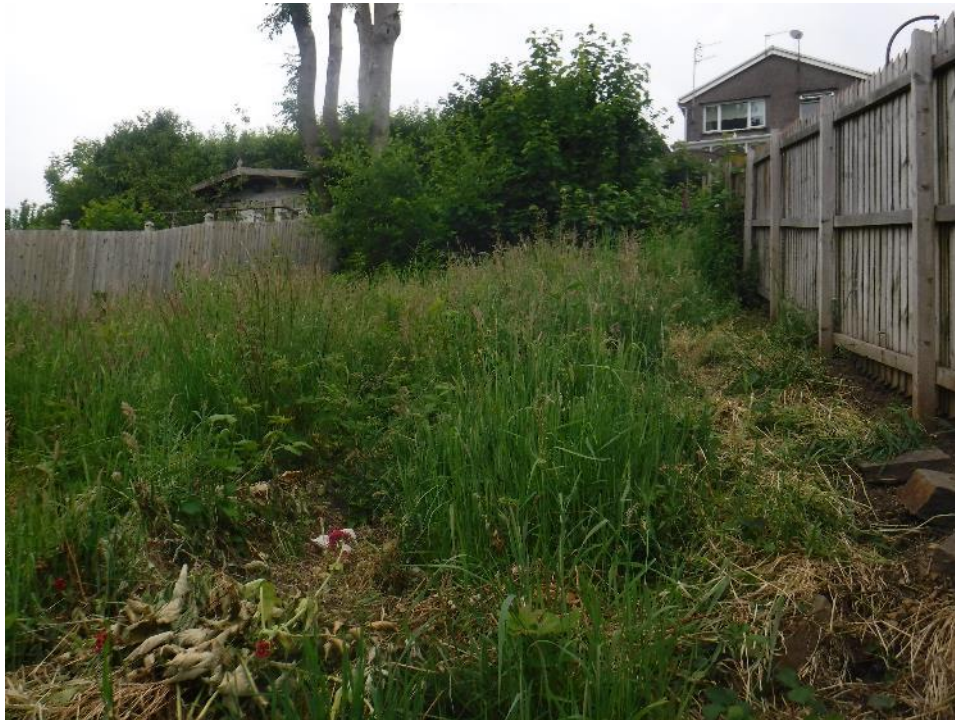
Photograph 90: Upper garden view - overgrown

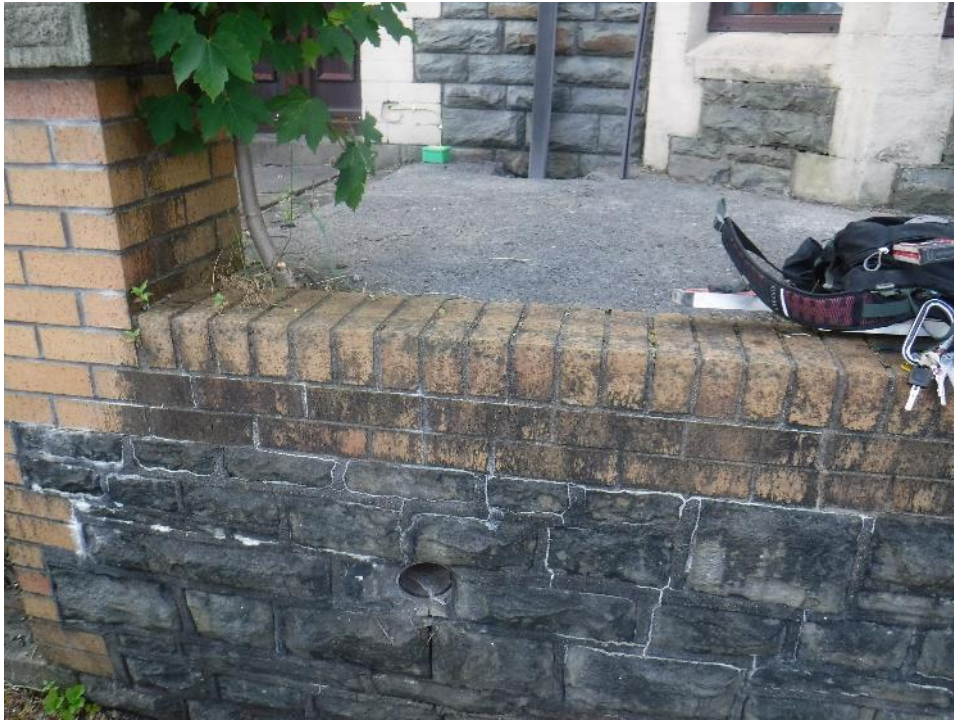
Photograph 91: Retaining wall to front of property

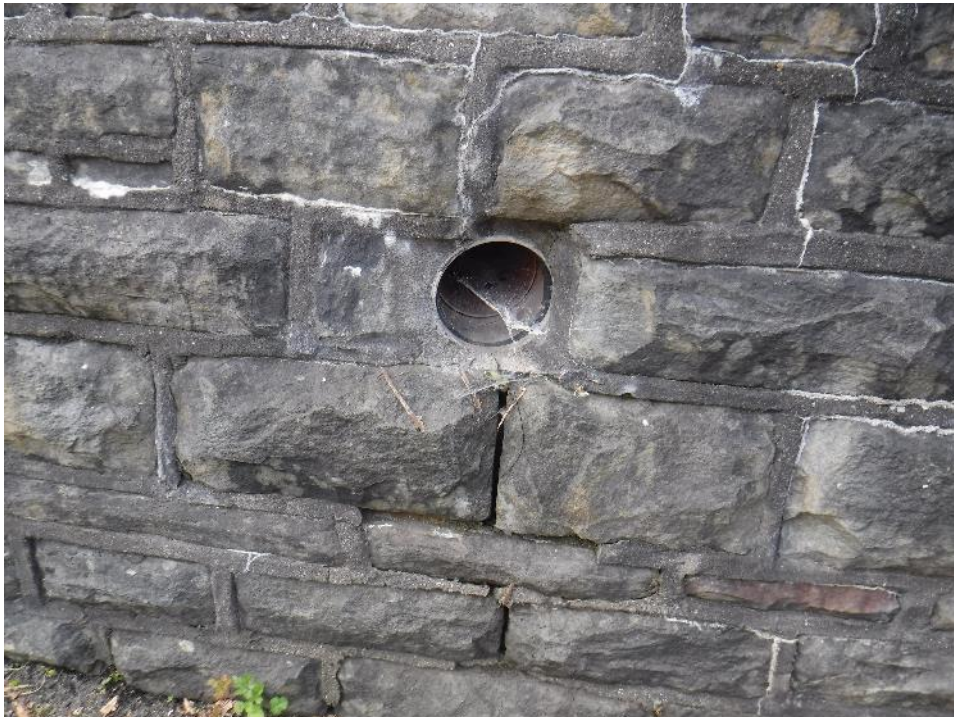
Photograph 92: Retaining wall to front of property - weephole
