BUILDING SURVEY REPORT

PROPERTY: Pencerrig St,
Pontypridd,
CF37 2HS

**SURVEY
DATE:** 02 June 2025

REF: TN0878

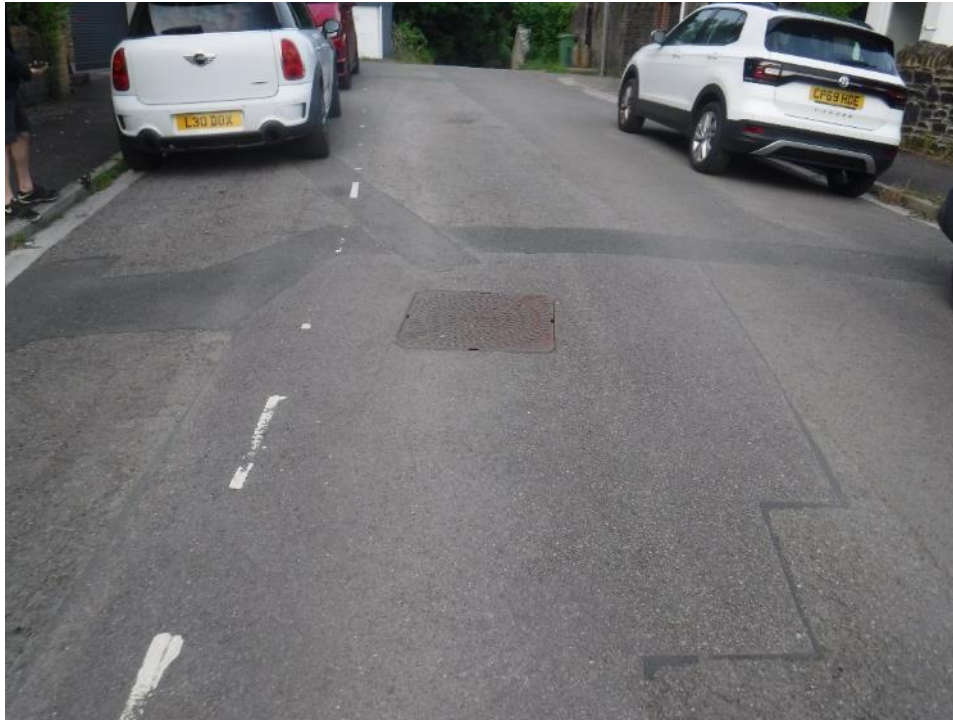
<p>Uneven and hazardous pathways & patio The paths and patio areas are uneven, loose, and cracked in several places, with moss growth making surfaces slippery. Repairs and ongoing maintenance are required to eliminate these safety risks.</p> <p>Roadway subsidence (front) No subsidence or obvious cracking was observed on the road outside the property (Photo.93)</p>
--	--

Photograph 93: Roadway to front
